# Jaguar S-Type - Ticking Sounds From Instrument Panel Area | HELLA

**Jaguar**

**S-Type (X200)**

**Model Year: 1999 – 2008**

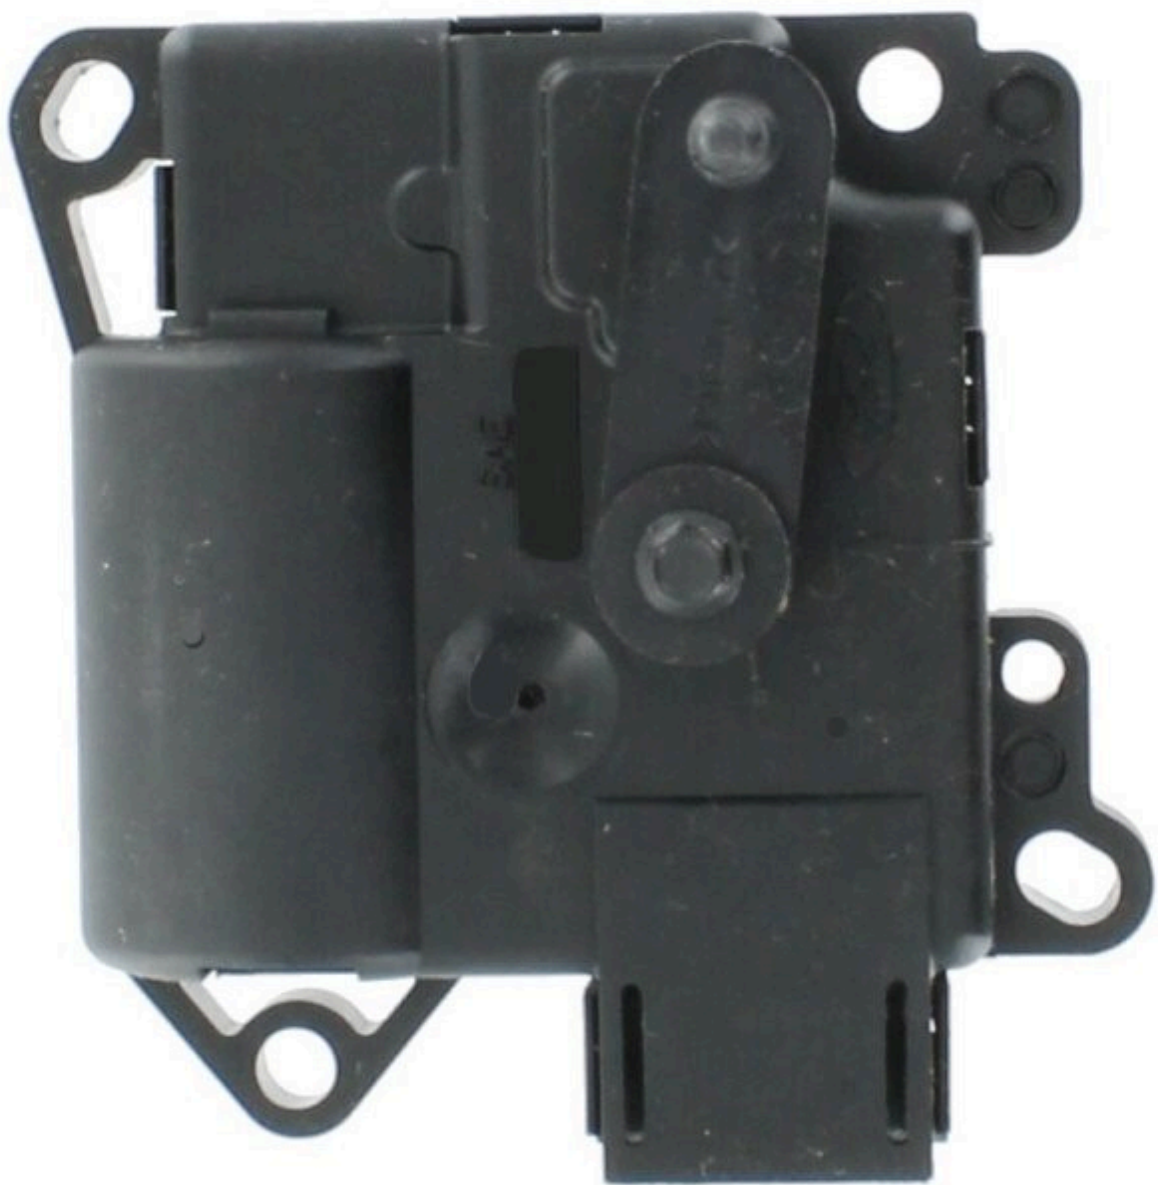
In the vehicles listed above, ticking noises can arise from the instrument panel or the instrument cluster area.

The potential cause for this is one or more actuator motors of the heating/air-conditioning system.

Vehicles with the following chassis numbers may be affected: N53000 - N91220

- Exactly locate the source of the noise
- If required, carry out an actuator test
- Replace the affected actuator motors
- Read out/clear the error memory
- Program the actuator motors
