## Mini F56 - ##### ## ##### ####

## Malfunction of the signal horn caused by faulty connecting cables in the steering wheel

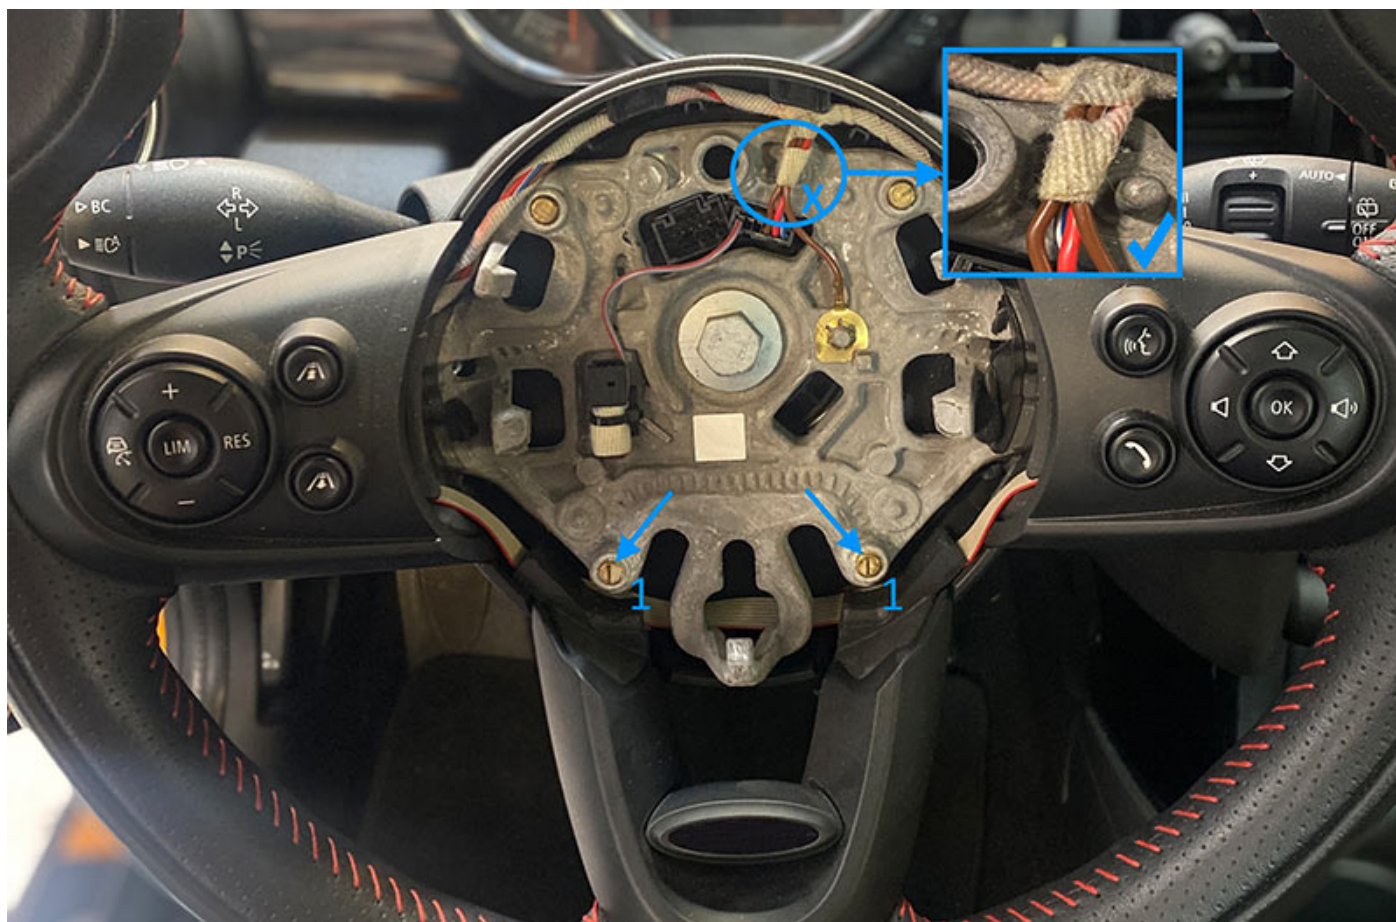
Incorrect routing of the connecting cables in the steering wheel or an unfavourable material pairing on the signal horn contacts between the steering wheel and the airbag unit may be responsible for this defect. Both problems can also occur simultaneously. An error memory entry that indicates a defect is not stored.

If the connecting cable is not laid correctly (see illustration), this has to be rectified. If the cable is visibly damaged, it must be replaced. If contamination is detected on the contact surfaces, a steering wheel with optimised contacts must be installed in accordance with the manufacturer's specifications. The problem has been identified by the vehicle manufacturer and rectified by means of a service solution using modified components.
