# **Peugeot 307 - Poor acceleration performance | HELLA**

**307 HDI**

**Engine code: 9HZ (DV6TED4)**

**Poor acceleration performance**

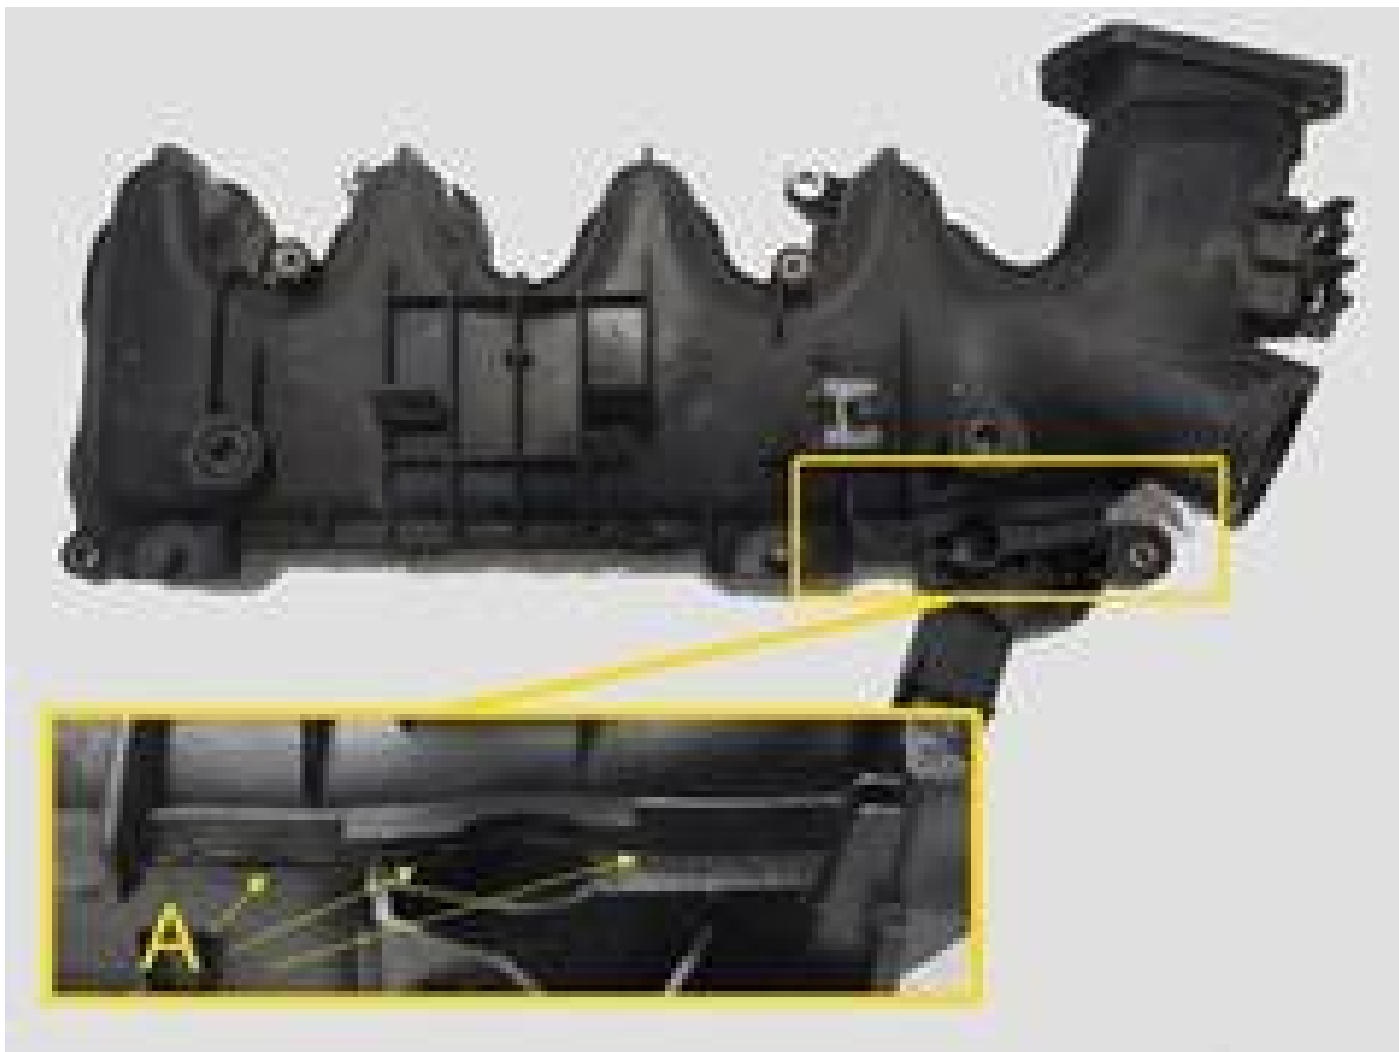
If the vehicle listed above demonstrates poor acceleration performance in conjunction with flapping noises in the vicinity of the splash wall, this may be caused by a defective intake manifold.

The intake manifold consists of two plastic housing halves bonded together. A leaky bonded joint (A) causes air to escape as boost pressure increases, while also making a distinctive noise. Depending on the size of the leak, the following fault entries may occur in the engine control unit.

P0100 - Air-mass sensor malfunction

P3008 - Air flow too strong

If a leak is detected, the intake manifold must be completely replaced. It cannot be repaired. Replacing the intake manifold requires removing the high-pressure fuel lines for the injection valves (injectors).

In order to avoid leaks later, carefully remove and re-install the lines.

Carry out an extensive test drive!
