# VW Golf V - Poor engine starting performance | HELLA

Golf V

1.9D TDI PD

Engine code: BKC

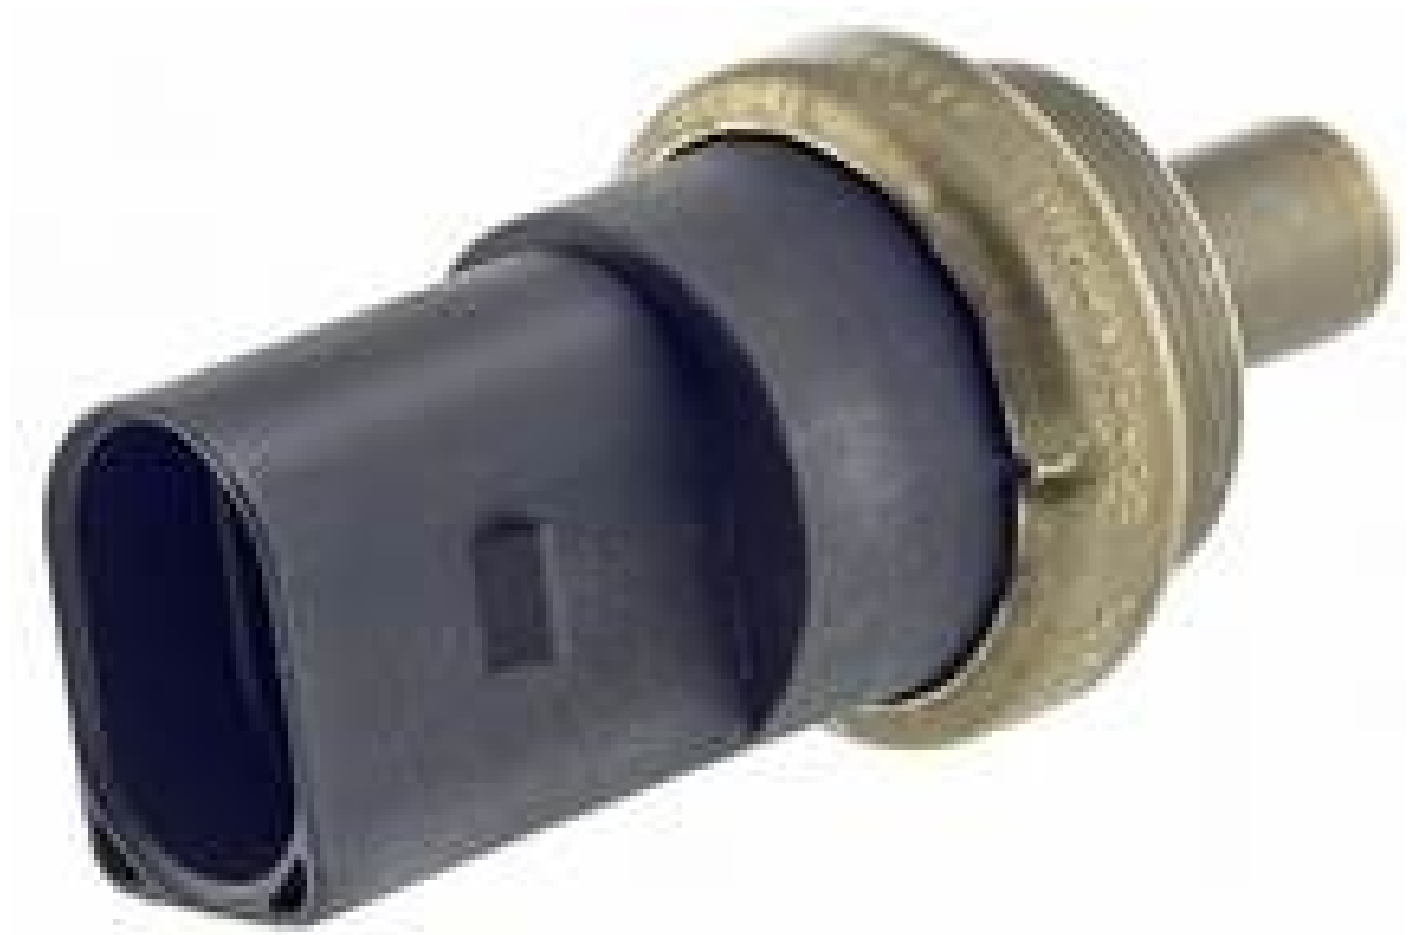
Figure 1.

If the fault pattern listed above is reported, the cause may be a defective coolant temperature sensor. In addition, error codes (triggered by implausible sensor values) may be stored in the engine control unit.

Replace the sensor if necessary (see Figure 1.).

Hella coolant temperature sensor: 6PT009309-331
