## ##### VW Passat - #####

## Whistling noises from the exhaust system during acceleration

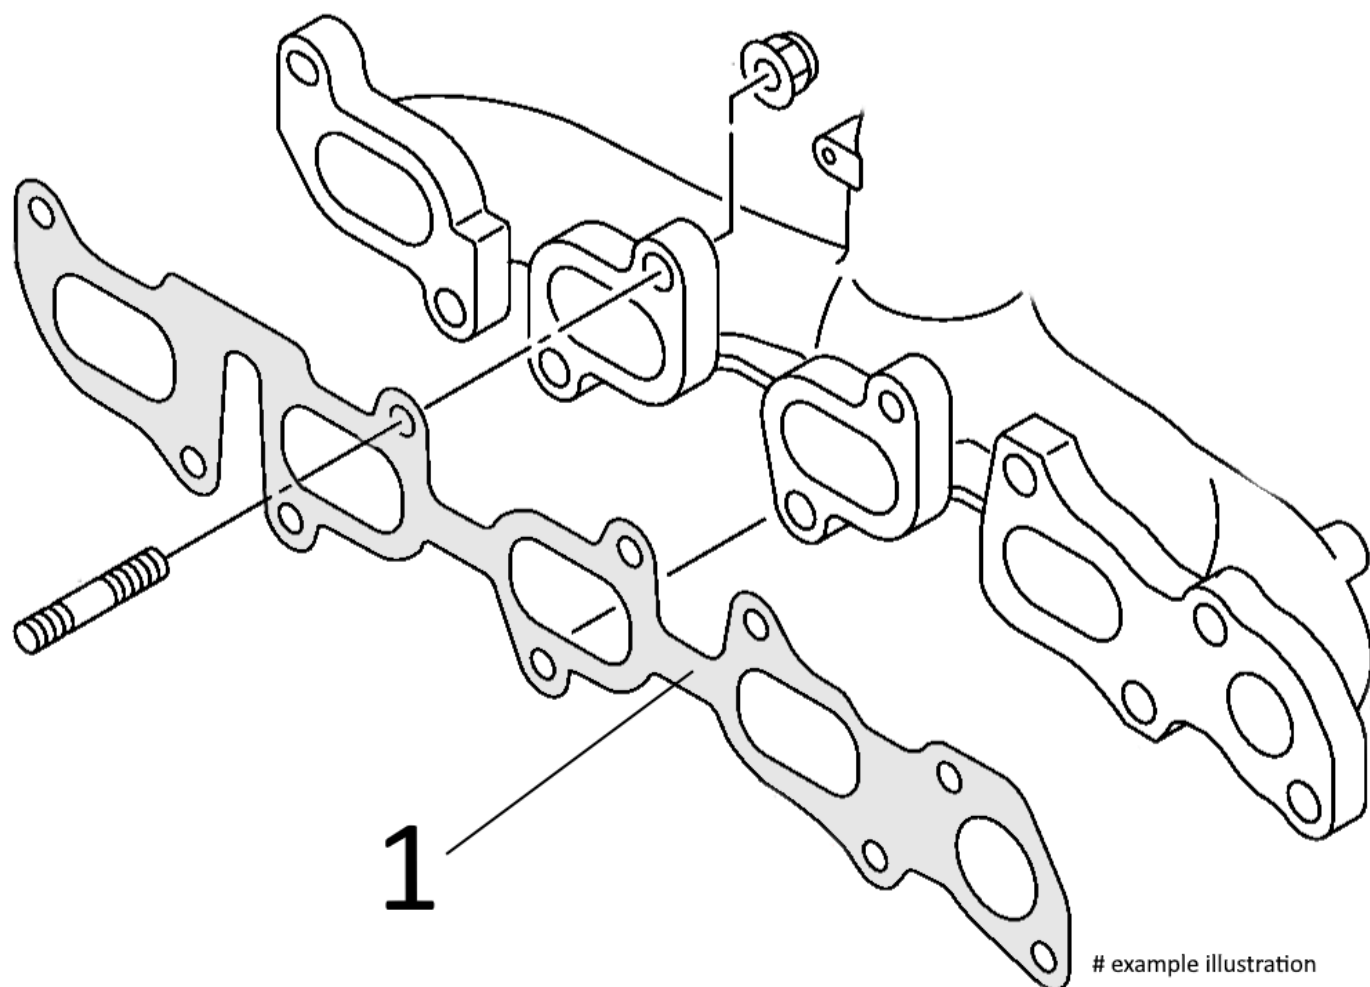
Figure 1

If whistling noises are detected coming from the area of the exhaust system during acceleration, a possible cause may be a defective gasket on the exhaust manifold.

In certain cases, leaks may occur on the sealing surfaces of the first and fourth cylinders as a result of the vehicle design. If no other defects are found in the exhaust system during the fault diagnosis, the seal (1) should be checked and replaced if necessary.

- Visual inspection of the exhaust manifold to check for leaks
- Removal of the exhaust manifold and thorough cleaning of the sealing surfaces
- Installation of the exhaust manifold with new gasket and new fastening nuts

- Exhaust manifold gasket: 04L 253 039G
- Fastening nut: N 908 946 01
