## Mazda CX5 (KE) - Fault code P0299 boost pressure too low

| Data sheet | |
|---|---|
| Vehicle model | CX5 (KE) |
| Engine | 2.2 CDI Skyactiv-D |

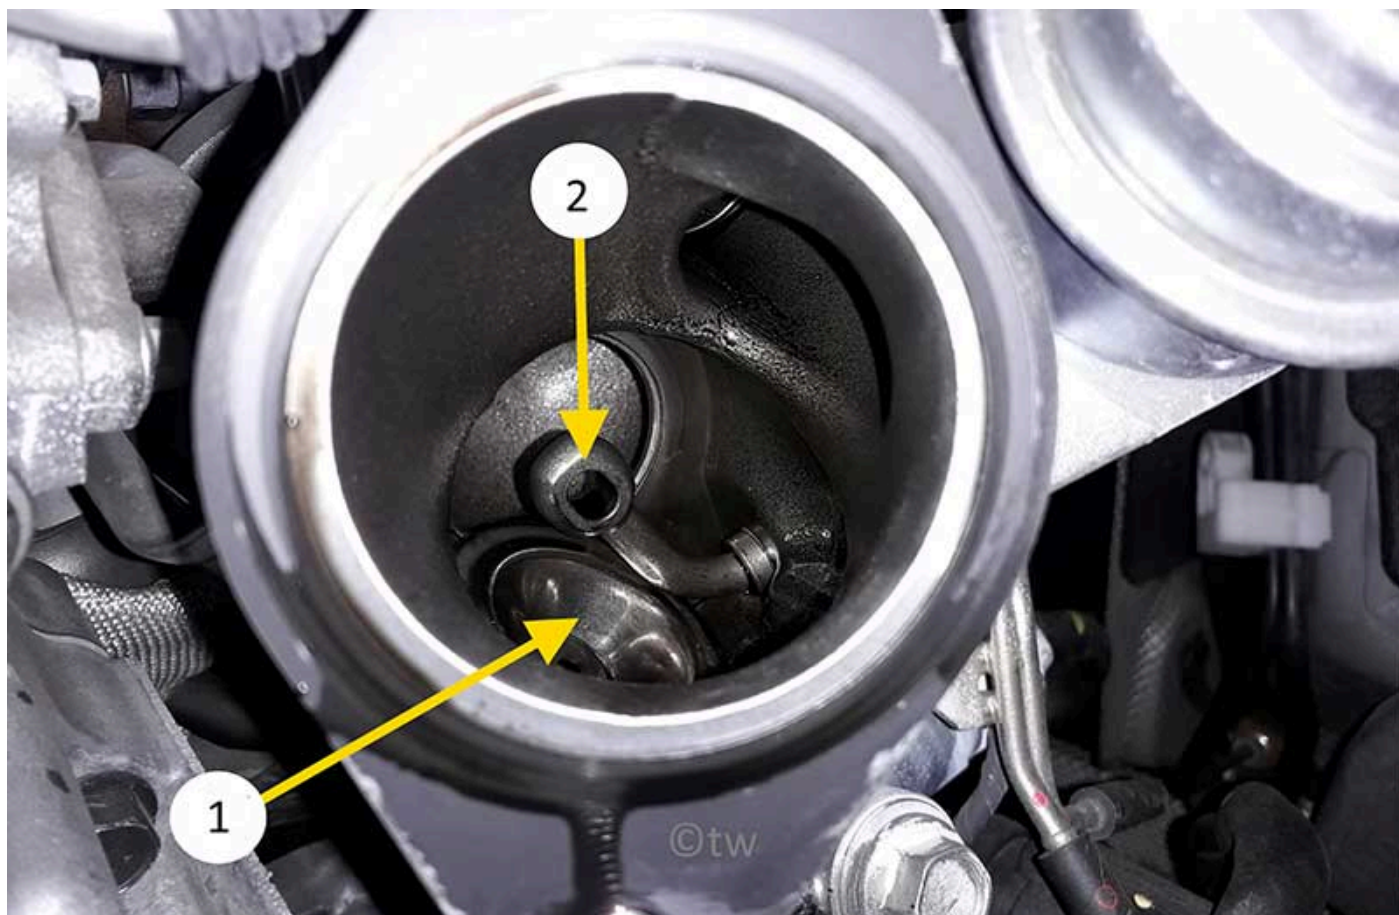
If the fault mentioned above is detected, it may also be related to a defective bypass flap on the small turbocharger. A mechanical defect ensures that the flap does not close properly and thus cannot build up sufficient boost pressure. In this case, the charge air hoses on the turbocharger should be removed and the flap control visually inspected. In our case study, the flap (1) had already completely detached from the lever (2). (Picture)

In a repair case, the complete turbocharger unit must be removed and replaced. The vehicle manufacturer does not offer the option of repairing the bypass flap's operating device.

Please follow the repair instructions from the vehicle manufacturer in this regard.
