## Mini F56 - water ingress in the vehicle interior

## Moisture in the vehicle interior caused by condensation draining from the air-conditioning system

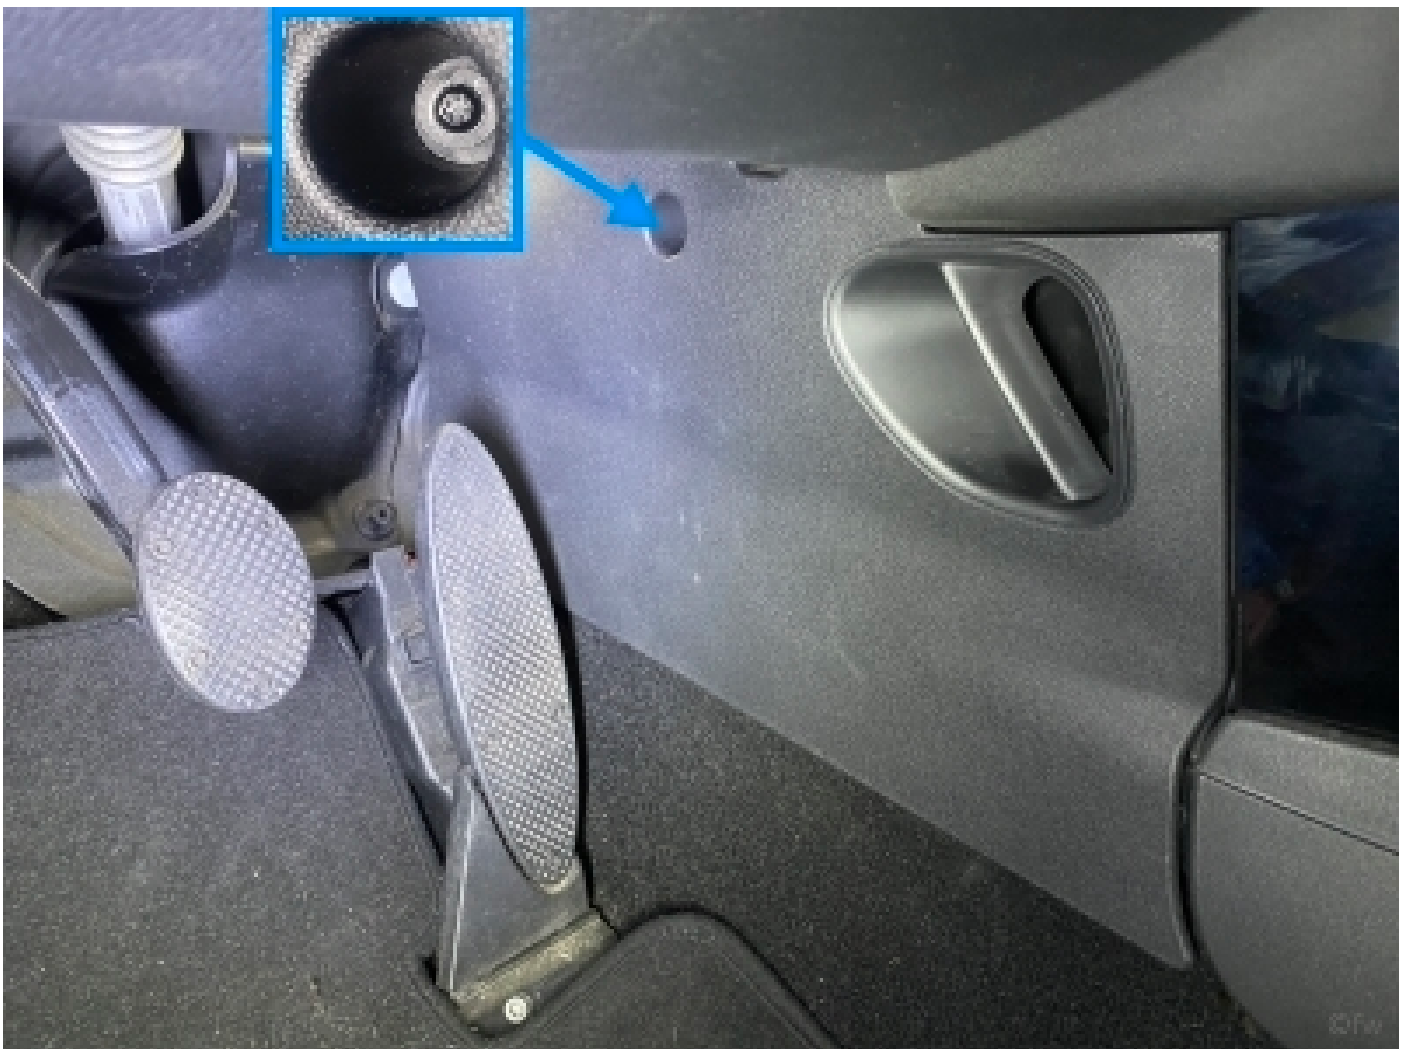
The side panelling (Fig. 1) in the footwell must be removed to carry out the necessary checks. In order to do this, the fastening screw has to be undone and the panelling removed from the brackets. The carpet can be pressed down slightly on the side underneath the air-conditioning unit in order to check it. The rubber seal of the water drain must fit all the way round the air-conditioning unit (Fig. 2) and have no kinks in it.
