# Opel Insignia - Loss of engine power

Model year: from 2008 onwards

Engine: 2.0 CDTI

## Loss of engine power, Report registered in combination instrument

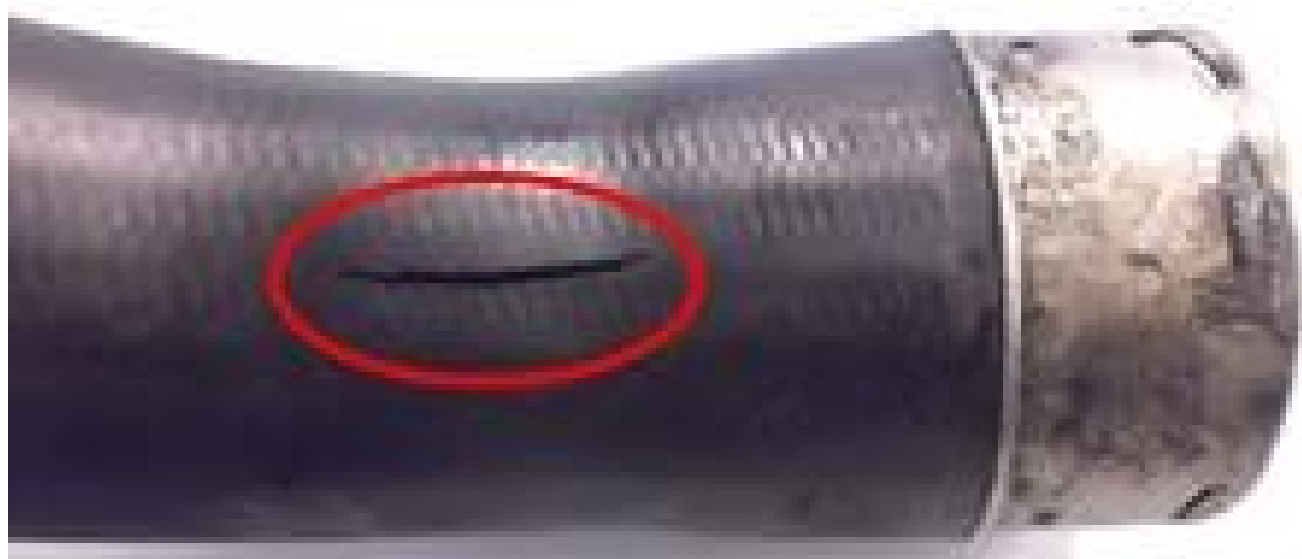
With the above-mentioned vehicle, it is possible that a crack (see picture) in the charger intake hose brings about the posting of the error message, "Service Vehicle Soon." This error message is usually given in conjunction with a sudden loss of engine power. In some cases the engine warning light also comes on in the combination instrument.

When this is the case, Code P0299 (air intake pressure too low) and/or Code P2282 (incorrect air intake pressure) can be seen filed in the error memory .

The following steps should be taken to rectify the problem:

- Read error memory
- Carry out visual inspection of the air intake routing
- Replace any defective component
- Erase error / fault code memory
- Test drive vehicle to check performance
