## BMW - vehicle has no power. FC 244C00

## Vehicle is experiencing a loss of power – error code 244C00 boost pressure control - control deviation

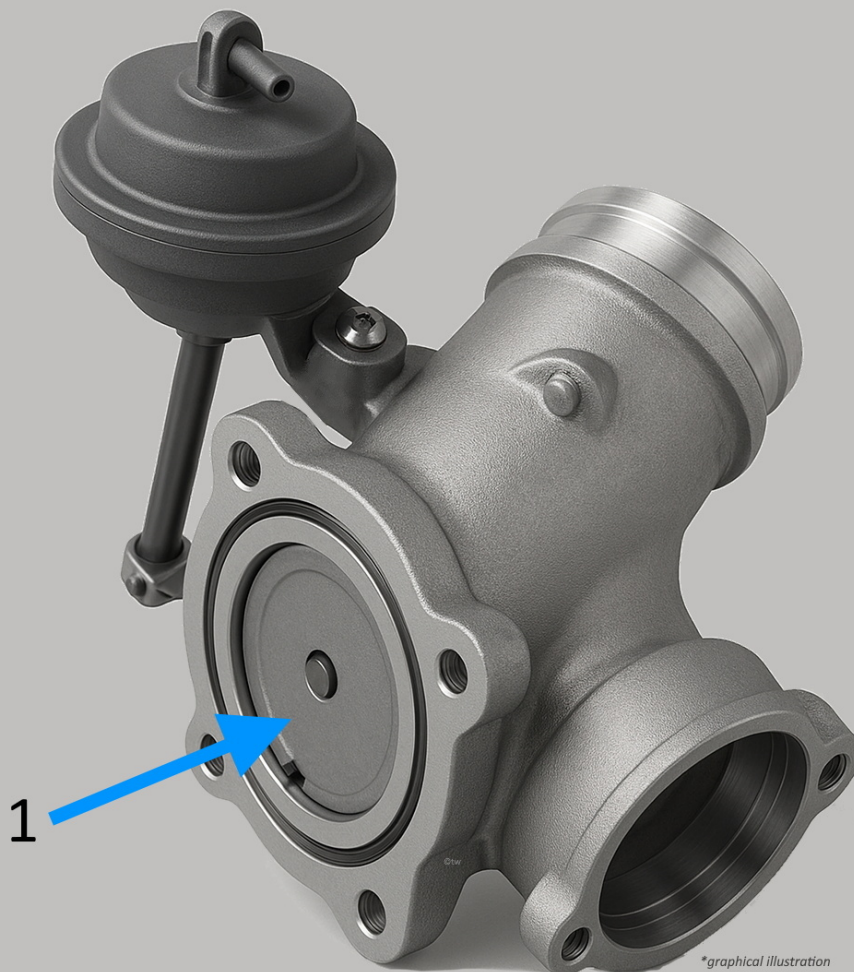
If the fault symptoms described above are observed in conjunction with error code 244C00, a possible cause may be a faulty bypass flap on the turbocharger.

A mechanical fault in the flap actuator may cause the bypass flap to jam. The fault usually occurs sporadically after a longer motorway journey.

As a result of such a fault, the flap remains slightly open, which means that boost pressure cannot build up.

Example illustration of the turbocharger valve unit with the bypass flap (1) closed

In this case, the bypass flap is to be checked and replaced where necessary. At the same time, the vacuum hoses, the electric changeover or switch valves and the two electro-pneumatic pressure transducers should be inspected for any damage so as to ensure that they are in good working order.

Once the repair is complete, all error codes are to be cleared and a test drive is to be carried out.
