# Opel Insignia - malfunctioning of hatchback

| Vehicle model | Insignia A |
| Symptoms | Malfunctioning of hatchback lift |

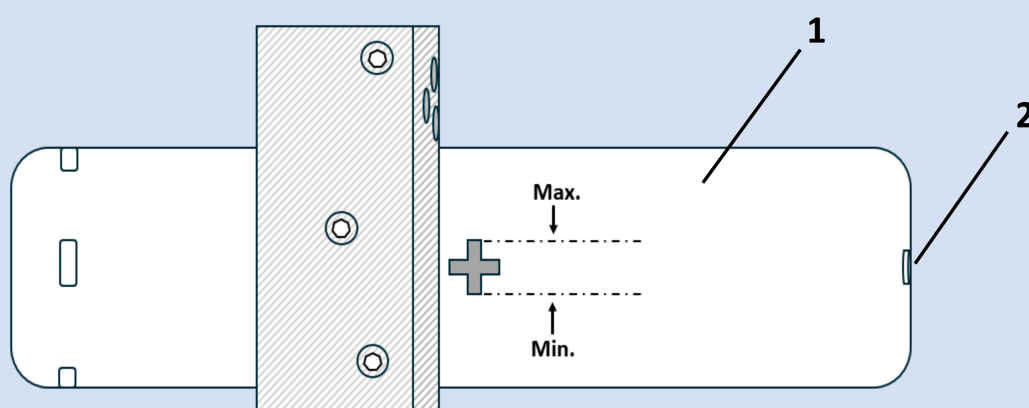
With the above-mentioned vehicle type, it can happen that the hatchback does not reach its end position or it may drop again abruptly shortly before the top end position is reached.

If the above-mentioned fault arises and no definite faults were found in the periphery of the affected systems during troubleshooting, special attention should be paid to the hydraulic pump of the hatchback lift. The first step in troubleshooting is to check whether the hydraulic pump starts up audibly when pressure is applied to the hatchback's open button. If this is the case, the oil level in the hydraulic pump's expansion tank should be checked. If this is too low, the pump sucks air into the hydraulic system and the opening and closing process can no longer be carried out correctly.

The hydraulic pump is installed behind the side panel on the right in the luggage compartment. In order to carry out the oil level adjustment correctly, the pump must be removed from the vehicle in accordance with the manufacturer's instructions and placed horizontally to the "+" sign on the expansion tank (1) on a straight, clean surface. Leave the pump rest in this position for one minute. The oil level should be at the maximum mark after the specified waiting time. If this is not the case, the fill level must be corrected.

To do this, turn the pump unit with the filler screw (2) upwards and loosen the screw. Fill with the hydraulic oil approved by the manufacturer up to the specified maximum fill level mark. Make sure that no dirt gets into the container during the filling process. Screw the locking screw back into place and reinstall the pump first without the casing to carry out the functional test. By activating the hatchback several times, the system will be refilled with oil.

Finally check the oil level in the expansion tank once again. If necessary, top up the oil again and once more set the hatchback in motion several times. The hatchback should open and close smoothly again after the completion of these measures. Once the oil level has been adjusted, visually check the hydraulic cables, connections and also the hydraulic damper for any sign of oil loss. If any abnormalities are visible here, the defective components must be replaced.
