## BMW X5 F15 - coolant level warning message in the instrument cluster

## Coolant loss caused by a leak at the coolant flange

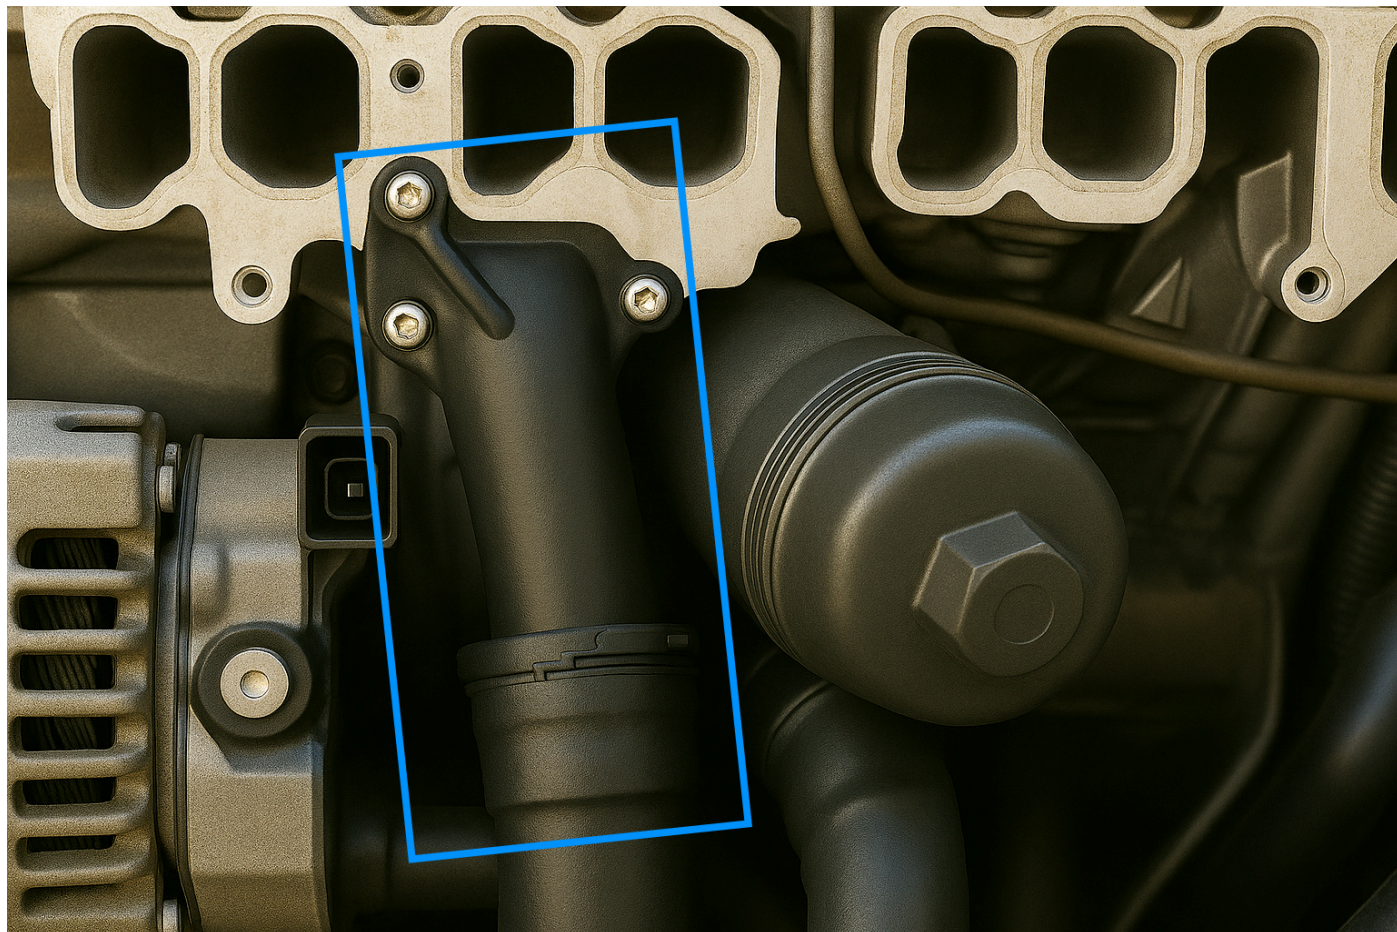
If the fault mentioned above applies, particular attention must be paid to the coolant flange (coolant neck) on the cylinder head (see illustration – installation location of the coolant flange). The component is made of plastic and, because of its installation position, is subjected to high thermal loads. Material fatigue may lead to hairline cracks in the area of the connection neck or spigot or also to leaks at the seal. As a result, coolant leaks out, particularly when the engine is at operating temperature and system pressure is rising. Because the installation location is concealed, the leak often goes unnoticed at first.

Example illustration – coolant flange installation location

In order to troubleshoot the problem, the area around the coolant flange on the cylinder head has to be visually inspected thoroughly. Where necessary, a mirror or endoscope might need to be used. In addition, the cooling circuit should be pressurised using suitable test equipment in order to pinpoint the exact location of the coolant leak. If a leak is detected, the coolant flange, including the seal, must be replaced in accordance with the manufacturer's instructions. As part of the repair, adjacent coolant pipes and hose connections must be checked for any further leaks, brittleness or damage.

Once the work has been completed, the cooling circuit must be filled, bled and pressure-tested again in accordance with the manufacturer's specifications.
