# MERCEDES Classe C - Allumage du témoin d'ESP/ABS | HELLA

Classe C (W 203)

## Allumage du témoin d'ESP/ABS

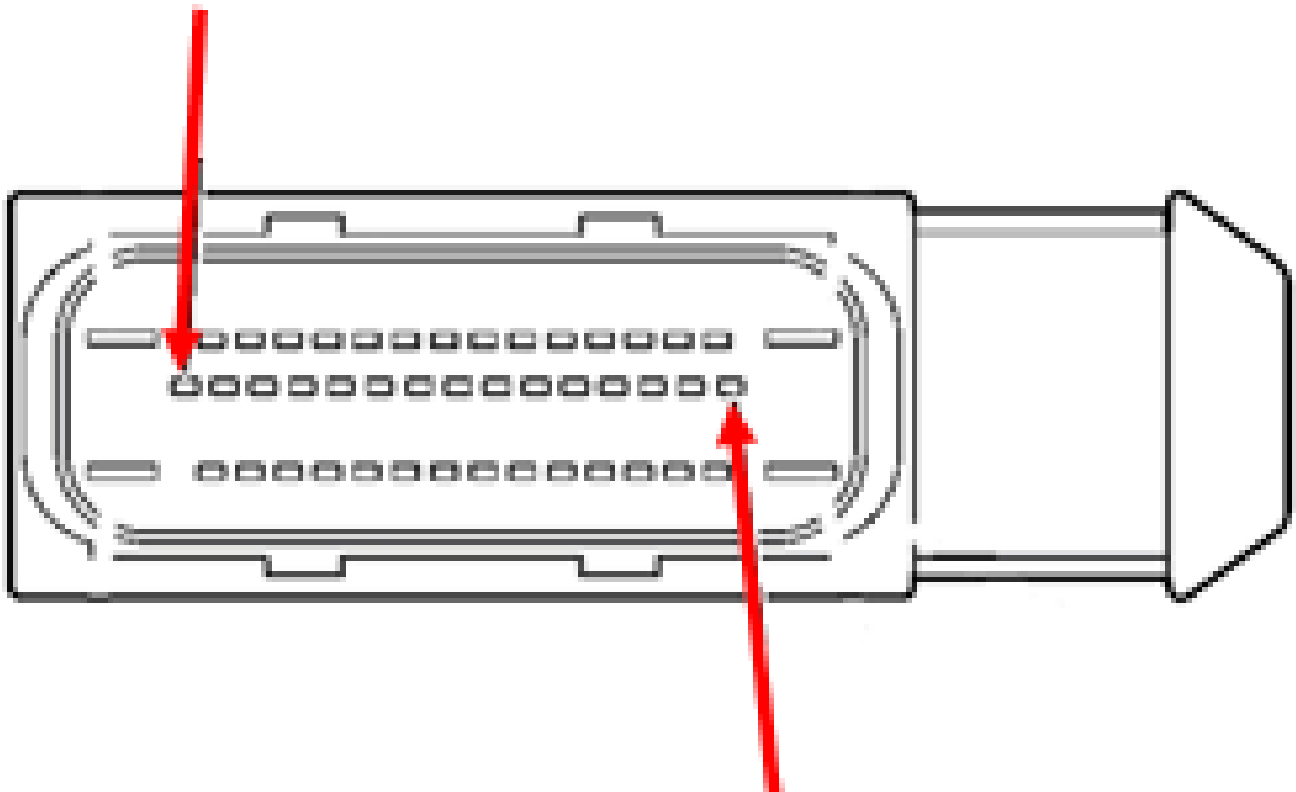
Si un client signale le problème mentionné ci-dessus, un connecteur corrodé peut être en cause. Il peut en outre également y avoir les codes d'erreur C1140 (capteur d'angle du volant, signal erroné) ou C1145 (capteur ABS de vitesse de rotation de roue AD, interruption).
