## Volkswagen T6 — Ruídos sibilantes provenientes do compartimento do motor

| Modelo | Transporter T6 (SF/SG) |
| Motor | 2,0 TDI (CAAC/CXFA/CXHA) |
| Sintoma | Ruídos sibilantes provenientes do compartimento do motor |

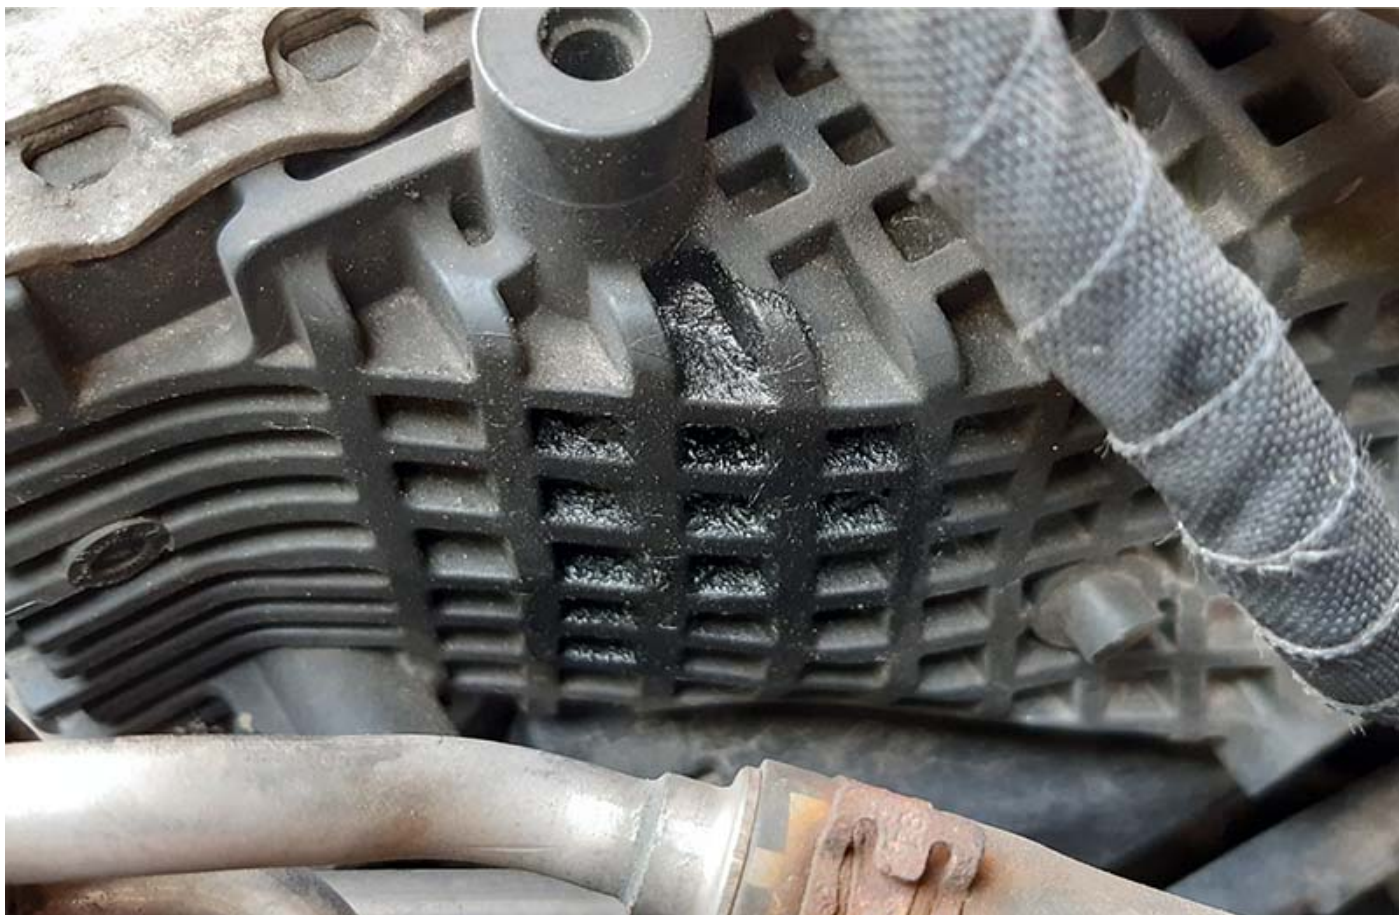
Além disso, existe também a possibilidade de o próprio Intercooler estar danificado. Na maioria dos casos, a causa do ruído pode ser facilmente detetada através de uma inspeção visual. Vestígios de óleo na superfície ([Figura 2](#)) são sinal de uma fissura, que produz os ruídos previamente referidos.

Figura 2: Vestígios de óleo no Intercooler
