# Ford Probe; Explorer, Windstar - compressor failure | HELLA

Ford

Type: Probe; Explorer, Windstar.

## Refilling additional coolant oil for models older than 1996 - compressor failure

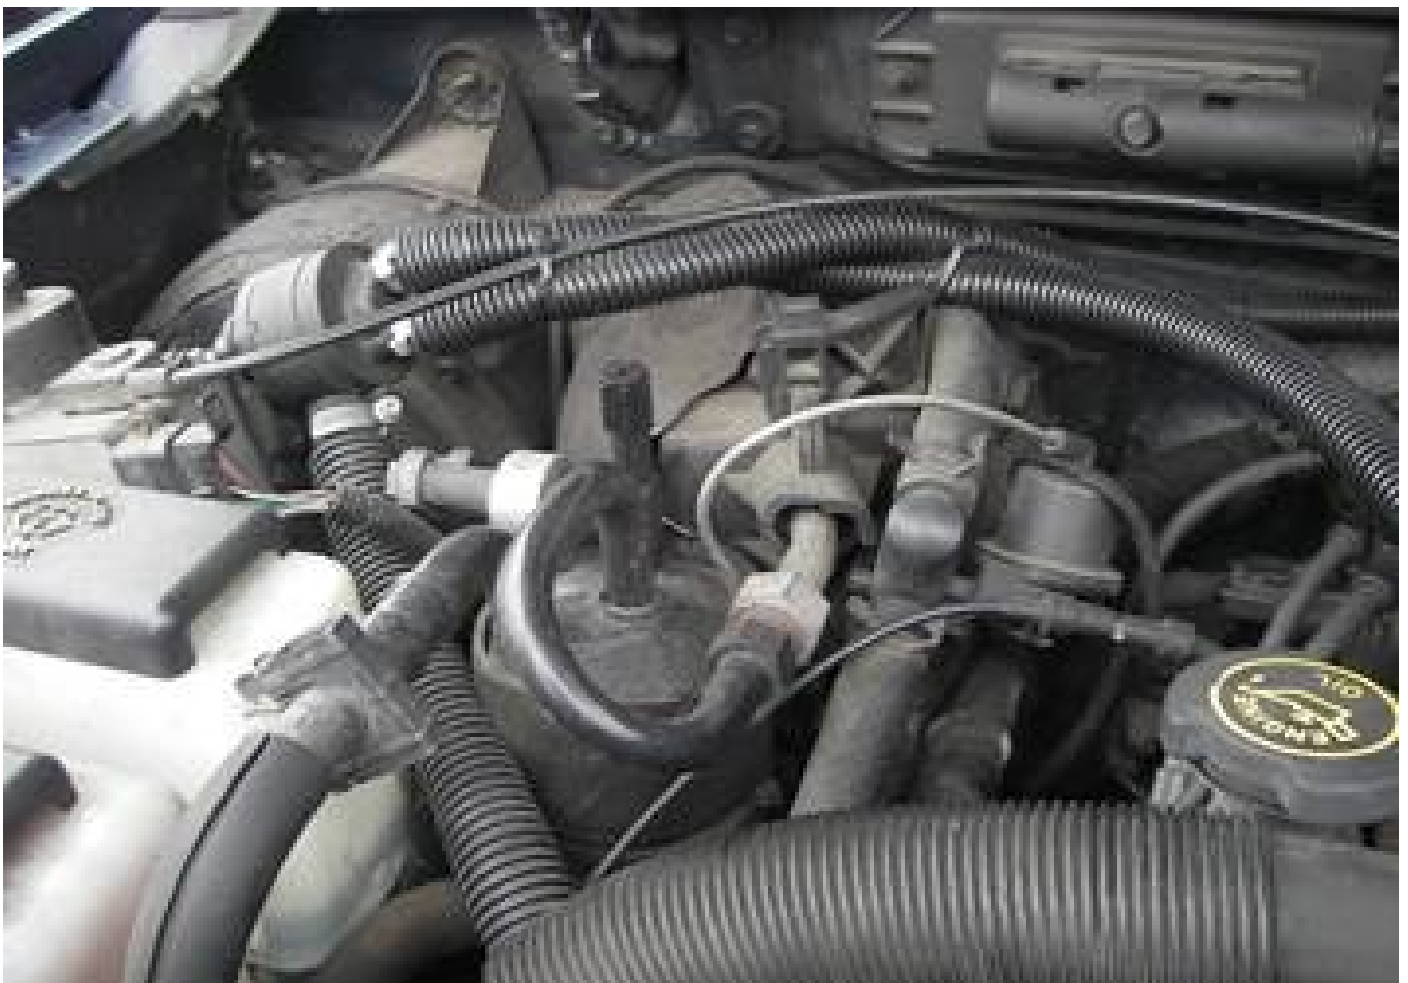
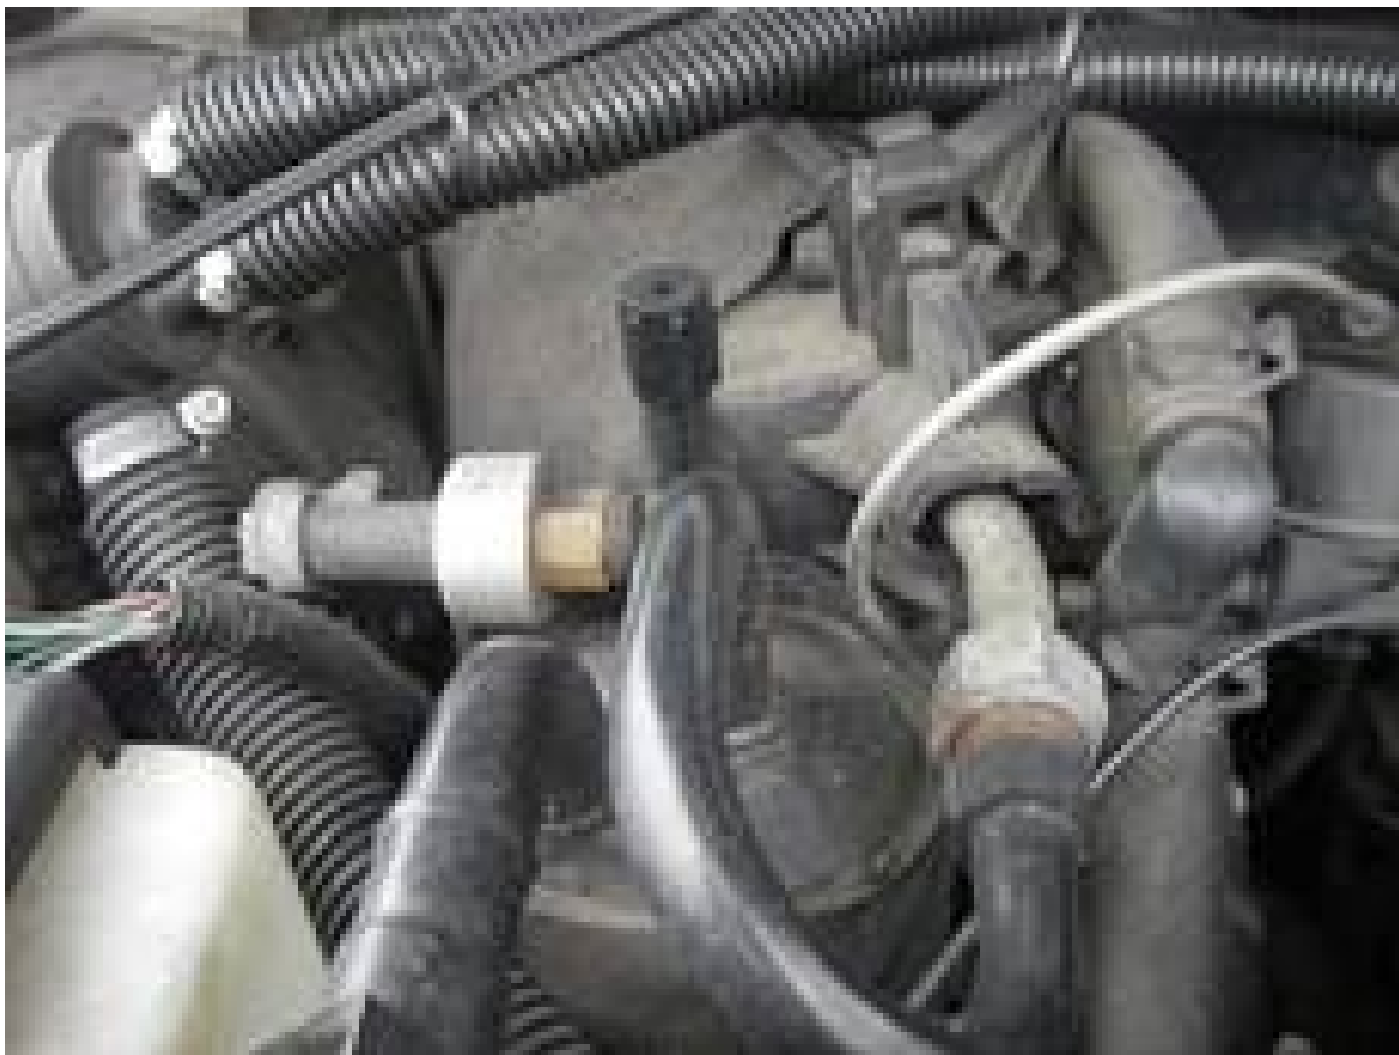
Ford recommends e.g., refilling approx. 60ml of oil during maintenance or minor repairs on the original air conditioning system. This quantity must be added before the system is filled with coolant. Ford's R134a systems can be distinguished from R12 systems by a special sticker on the underside of the motor hood and a beige-coloured ring on the low-pressure switch (see figures).
