# **Audi A4 - Bad or fluctuating idling behaviour | HELLA**

**Audi A4**

**2,0i 16V TSFI Quattro**

**Engine code: CDNC**

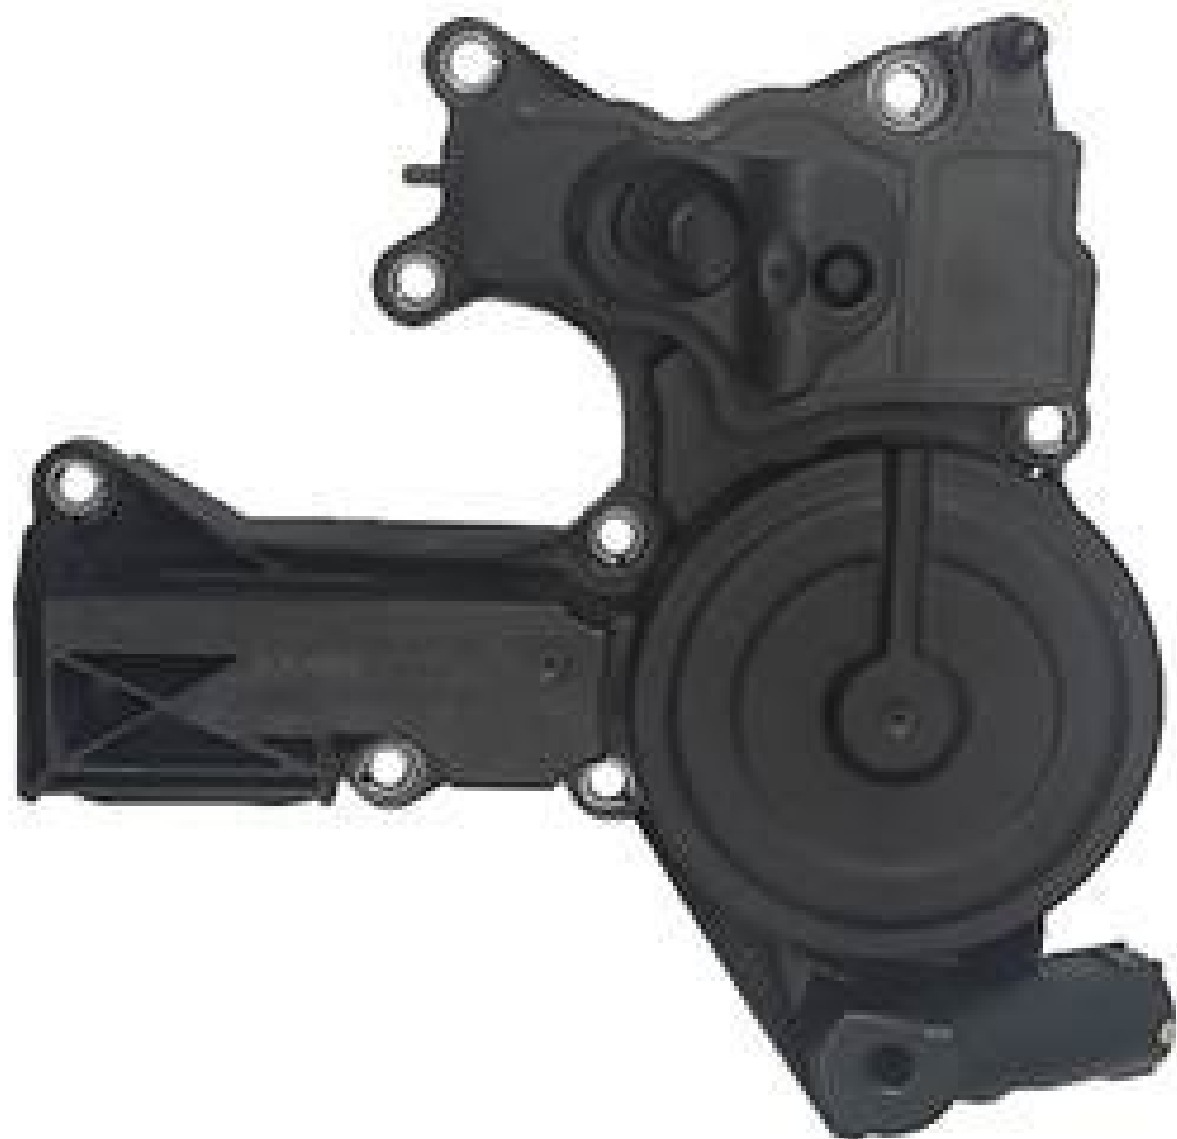
If the defect mentioned above is discovered in combination with the fault codes described, a faulty oil trap (figure) in the crankcase ventilation at the cylinder head cover may be a possible cause.

There are pressure control and check valves installed in the oil trap housing. They regulate the suction of the blow-by gases according to the engine speed and the pressure ratio. An error in this area can cause speed fluctuations and a higher consumption of oil. In some cases, the vehicle switches off right after it is started.

The oil trap must be completely replaced in the event of damage as it cannot be disassembled or cleaned.
