# Opel Corsa E - straight-line driving impaired: Vehicle pulls to one side

## Data sheet

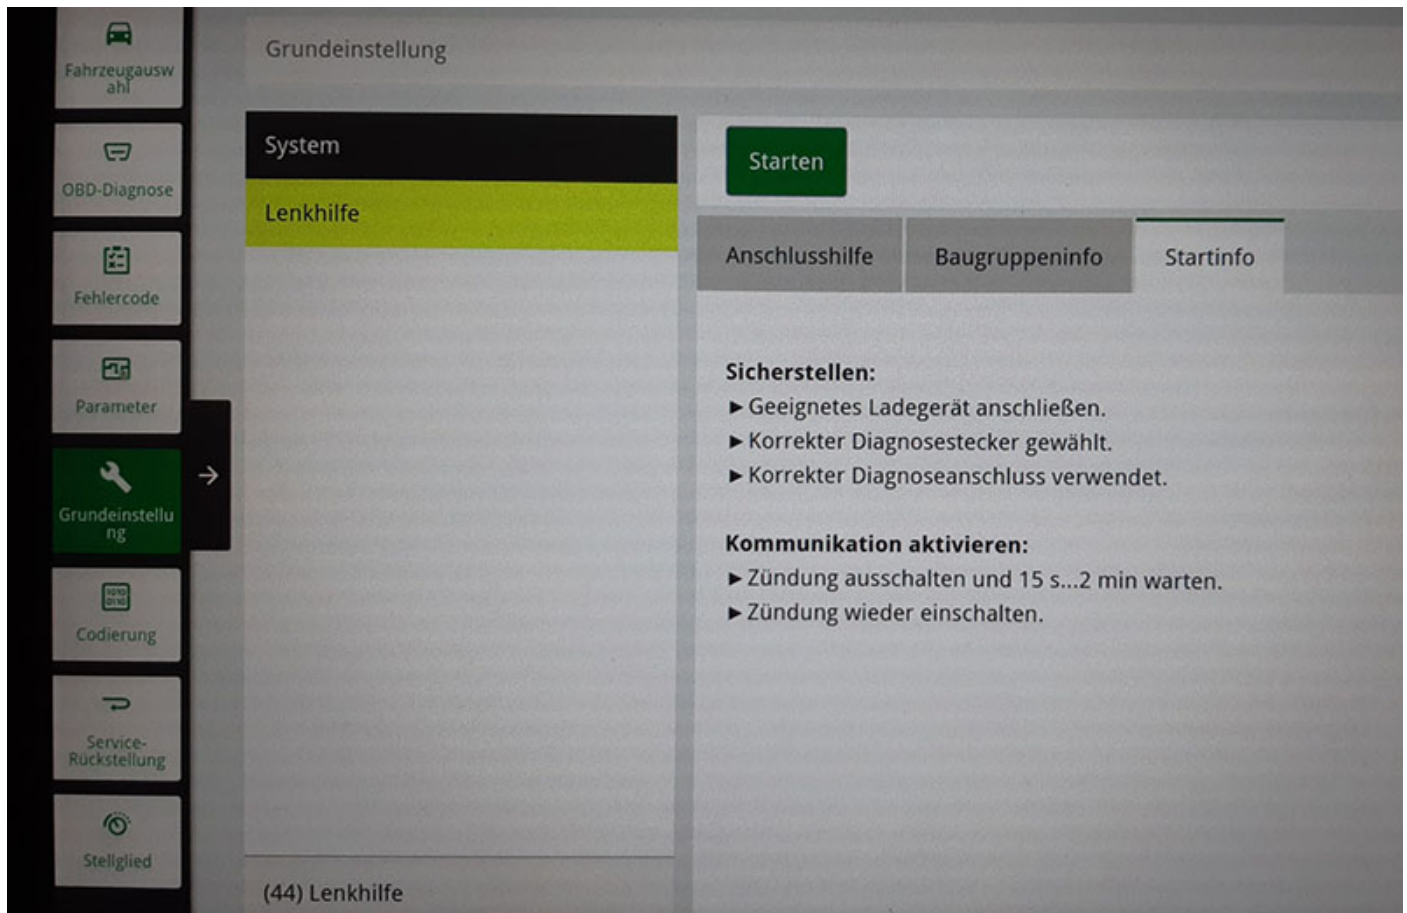
On the vehicles mentioned above, the vehicle may pull to one side even though the steering wheel is in the straight-ahead position.

To remedy this, the steering angle sensor can be recalibrated using a diagnostic device. Experience shows that the vehicle then runs straight again.
