# Opel Insignia - malfunctioning of hatchback

| Data sheet | |
|---|---|
| Vehicle model | Insignia A |
| Symptoms | Malfunctioning of hatchback lift |

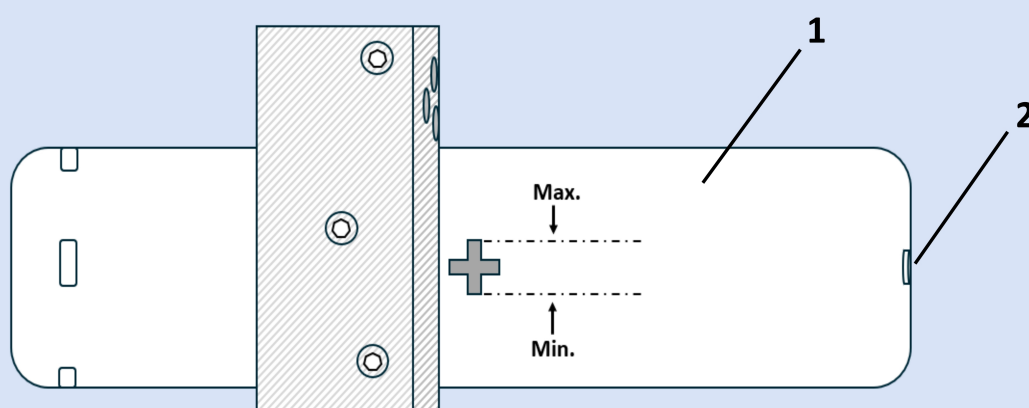
With the above-mentioned vehicle type, it can happen that the hatchback does not reach its end position or it may drop again abruptly shortly before the top end position is reached.

If the above-mentioned fault arises and no definite faults were found in the periphery of the affected systems during troubleshooting, special attention should be paid to the hydraulic pump of the hatchback lift. The first step in troubleshooting is to check whether the hydraulic pump starts up audibly when pressure is applied to the hatchback's open button. If this is the case, the oil level in the hydraulic pump's expansion tank should be checked. If this is too low, the pump sucks air into the hydraulic system and the opening and closing process can no longer be carried out correctly.

The hydraulic pump is installed behind the side panel on the right in the luggage compartment. In order to carry out the oil level adjustment correctly, the pump must be removed from the vehicle in accordance with the manufacturer's instructions and placed horizontally to the "+" sign on the expansion tank (1) on a straight, clean surface. Leave the pump rest in this position for one minute. The oil level should be at the maximum mark after the specified waiting time. If this is not the case, the fill level must be corrected.

To do this, turn the pump unit with the filler screw (2) upwards and loosen the screw. Fill with the hydraulic oil approved by the manufacturer up to the specified maximum fill level mark. Make sure that no dirt gets into the container during the filling process. Screw the locking screw back into place and reinstall the pump first without the casing to carry out the functional test. By activating the hatchback several times, the system will be refilled with oil.

Finally check the oil level in the expansion tank once again. If necessary, top up the oil again and once more set the hatchback in motion several times. The hatchback should open and close smoothly again after the completion of these measures. Once the oil level has been adjusted, visually check the hydraulic cables, connections and also the hydraulic damper for any sign of oil loss. If any abnormalities are visible here, the defective components must be replaced.
