## VW, Audi, Seat, Skoda: insufficient headlamp range and headlamps dazzle

| Manufacturer | VW Audi Seat Skoda |
| Vehicle model | Various models |
| Symptom | Insufficient headlamp range, headlamps dazzle |

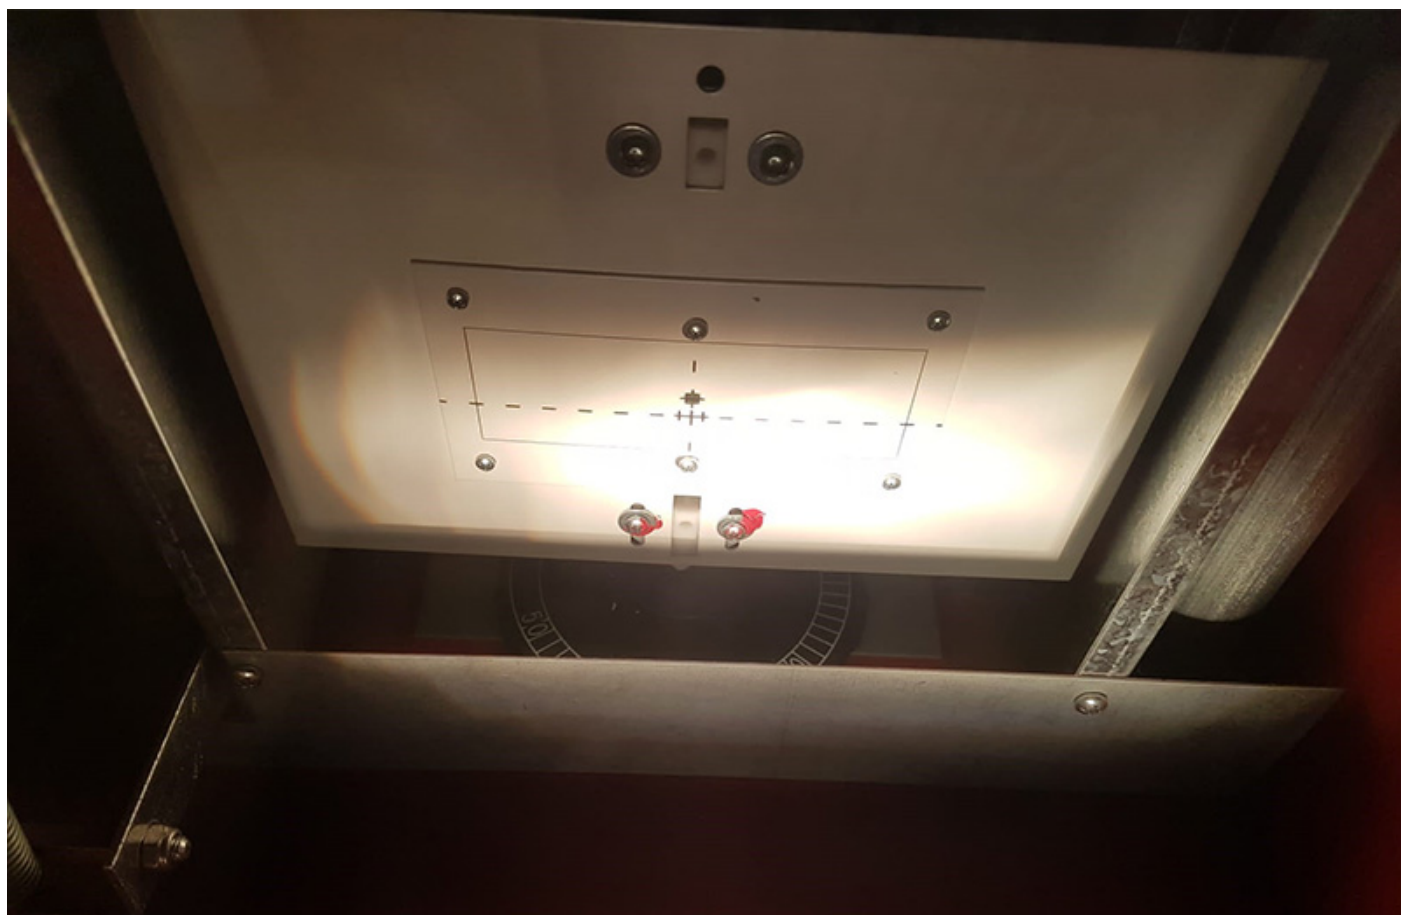
After the main headlamp bulbs have been changed on the vehicles mentioned above, there may be insufficient illumination of the road or oncoming traffic may be dazzled. This is especially true when using H7 bulbs. There are two reasons for this. Either the headlamp's bulb socket allows different mounting positions or the bulb has not been correctly inserted (twisted) during mounting. This leads to uncontrolled scattering of the light (Fig. 1).

Figure 1: uncontrolled scattering of light

Therefore, checking that the bulb is installed correctly is strongly recommended after every bulb replacement. The light pattern can be checked using a headlamp tester. Figure 2 shows that the installation has been done correctly. Here, the light/dark boundary and also the asymmetric angle are clearly visible.

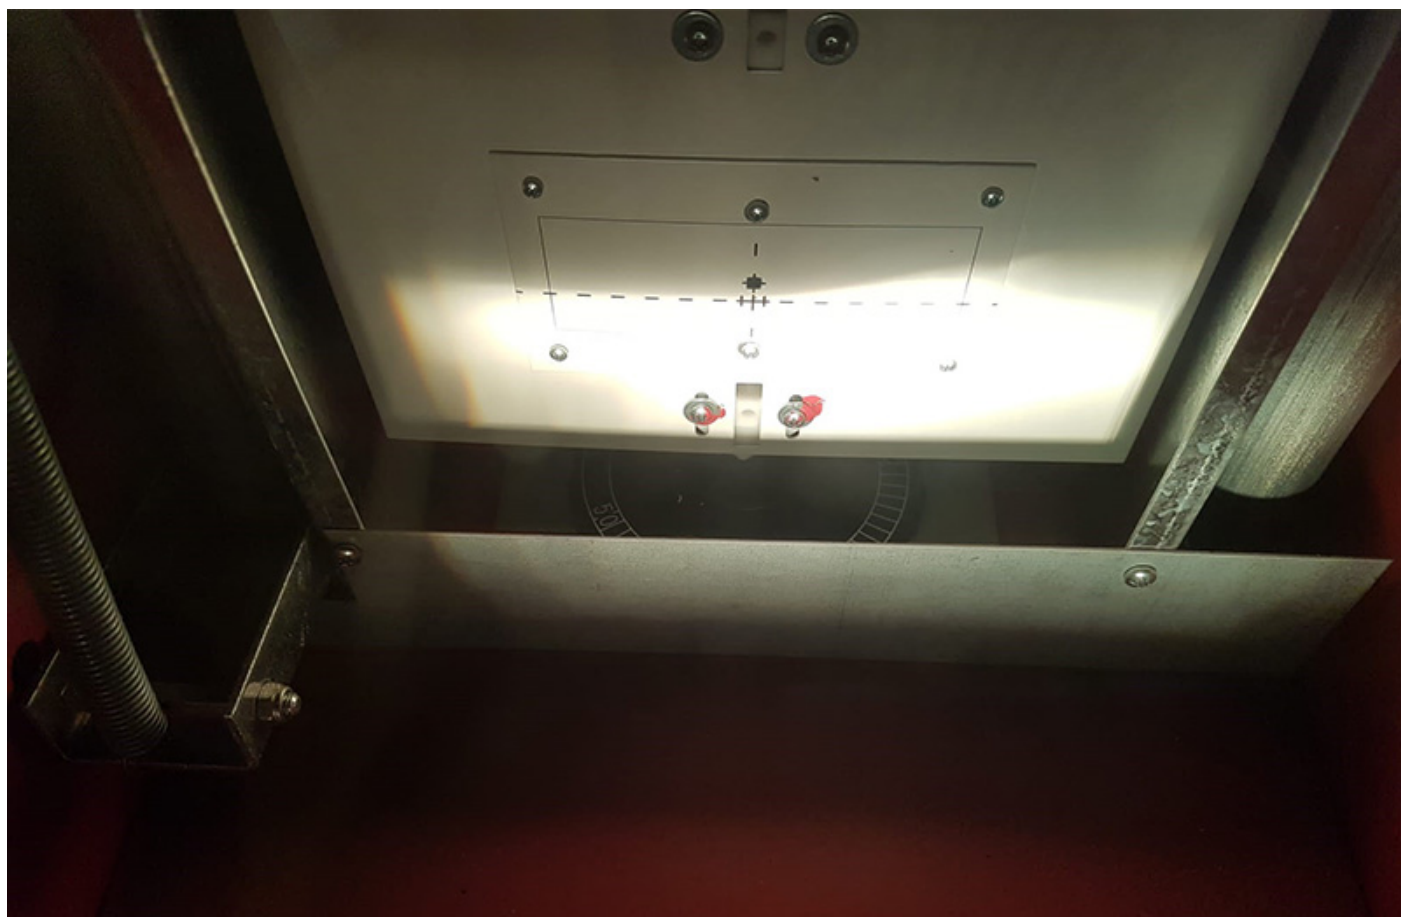
Figure 2: Light/dark boundary and asymmetric angle clearly visible
