## VW T6 - fuel loss

### Data sheet

| Vehicle model | Transporter T6 |
| Engine | 2.0 TDI |

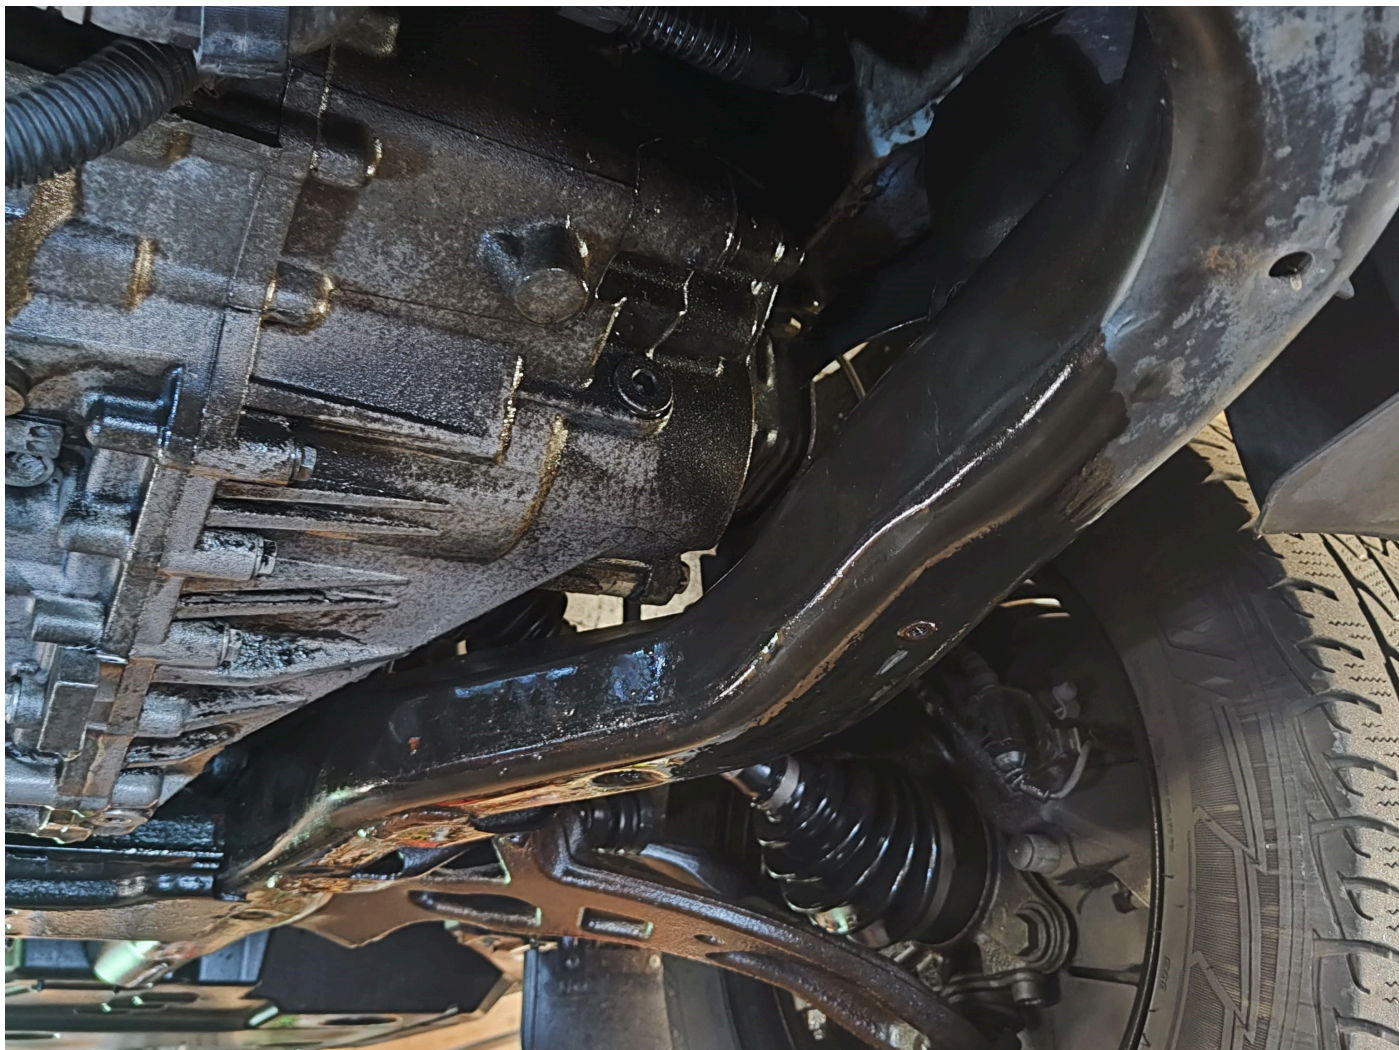
On the vehicle mentioned above, it can happen that a strong smell of diesel suddenly becomes very noticeable. Leaking fuel may also have accumulated in the engine compartment or under the vehicle. The cause of this is not always immediately recognisable. Firstly, the fuel lines and their connections in the engine compartment should be checked. If no leak is found, the fuel filter housing may be the cause of the diesel loss.

Fuel loss T6
