## VW Touran - fault code 148C/148B and water ingress in the A-pillar area

| Vehicle model | Touran with panoramic sunroof |
| Error code | 148C / 148B |

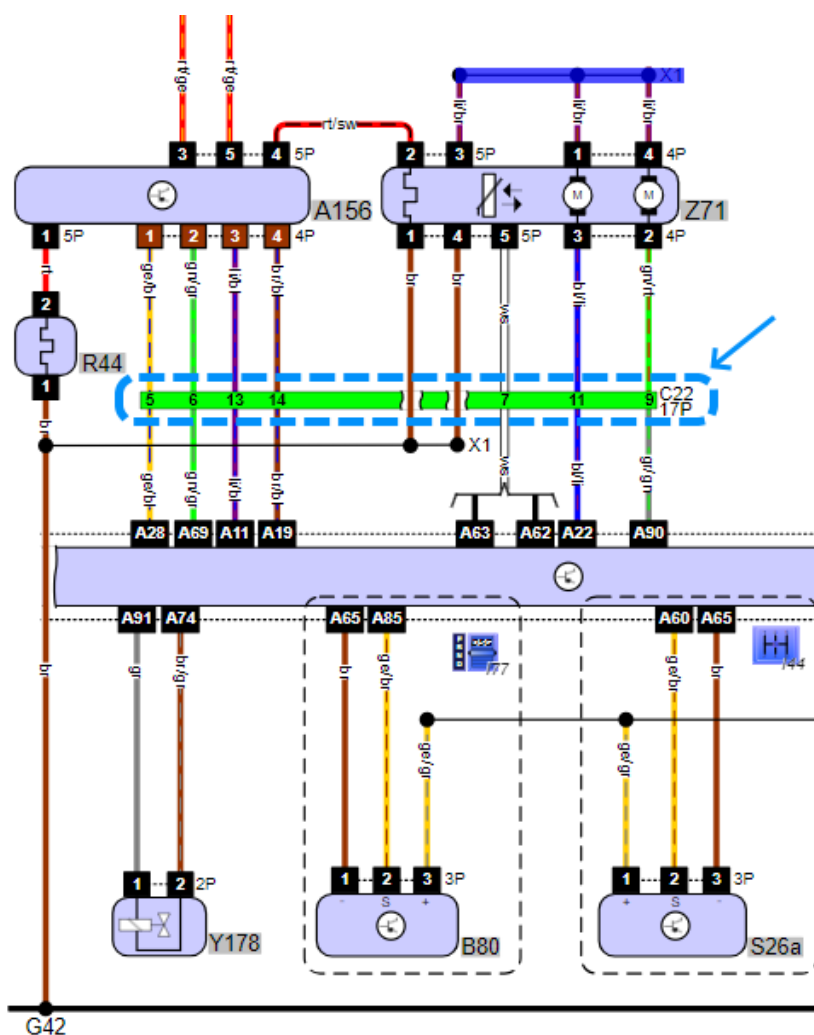
If moisture or corrosion is detected on the pins of these plug connections, special attention should be paid to the water drains of the panoramic sunroof.

These can become clogged with dirt. The water builds up, flows over the roof cassette into the passenger compartment of the vehicle and enters the plug connections, among other things. To

check this, open the glass roof and pour water directly into the drains. If water builds up in the sunroof cassette and does not drain away immediately, the drains should be cleaned. This can be done, for example, with a cleaning brush that is specially designed for cleaning the water drains.

Once the sunroof drains have been completely cleaned, the damaged pins of the plug connections should also be repaired in order to re-establish a perfect electrical connection.
