# VW Transporter T6 - coolant loss

| Vehicle model | Transporter T6 |
| Engine | 2.0 TDI |
| Symptoms | Loss of coolant |

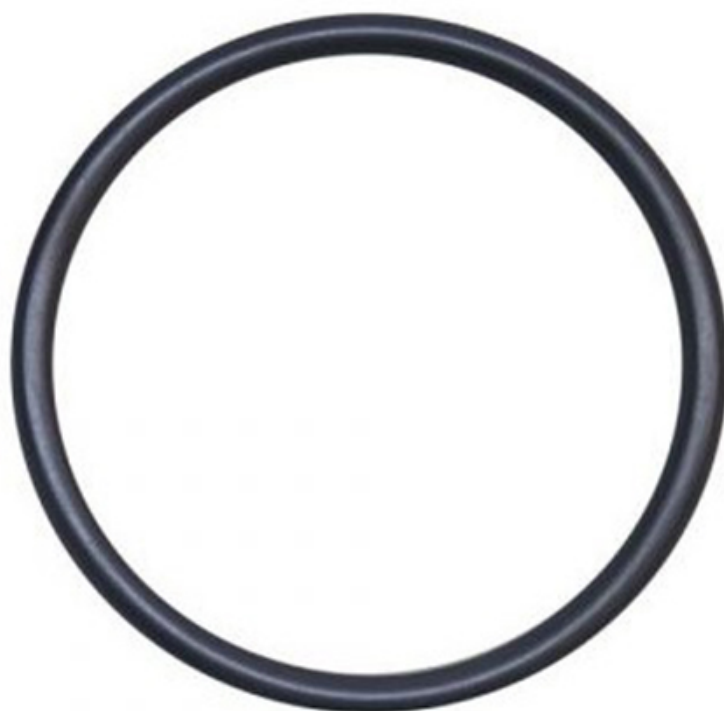
When identifying the leak, pay special attention to the thermostat housing. Coolant loss here may be caused by a faulty O-ring. When replacing the O-ring, make sure that the contact surfaces on the thermostat housing and engine block are sufficiently cleaned.

Simultaneously also replace the thermostat when replacing the O-ring (06B1211119B)
