# VW Up / Seat Mii / Skoda Citigo - poor engine performance

| Data sheet | |
|---|---|
| Engine | 1.0 MPI |
| Engine code | CHYA |

## Poor engine performance: Error codes P0010, P0016, P0088, P0341 stored in the control unit

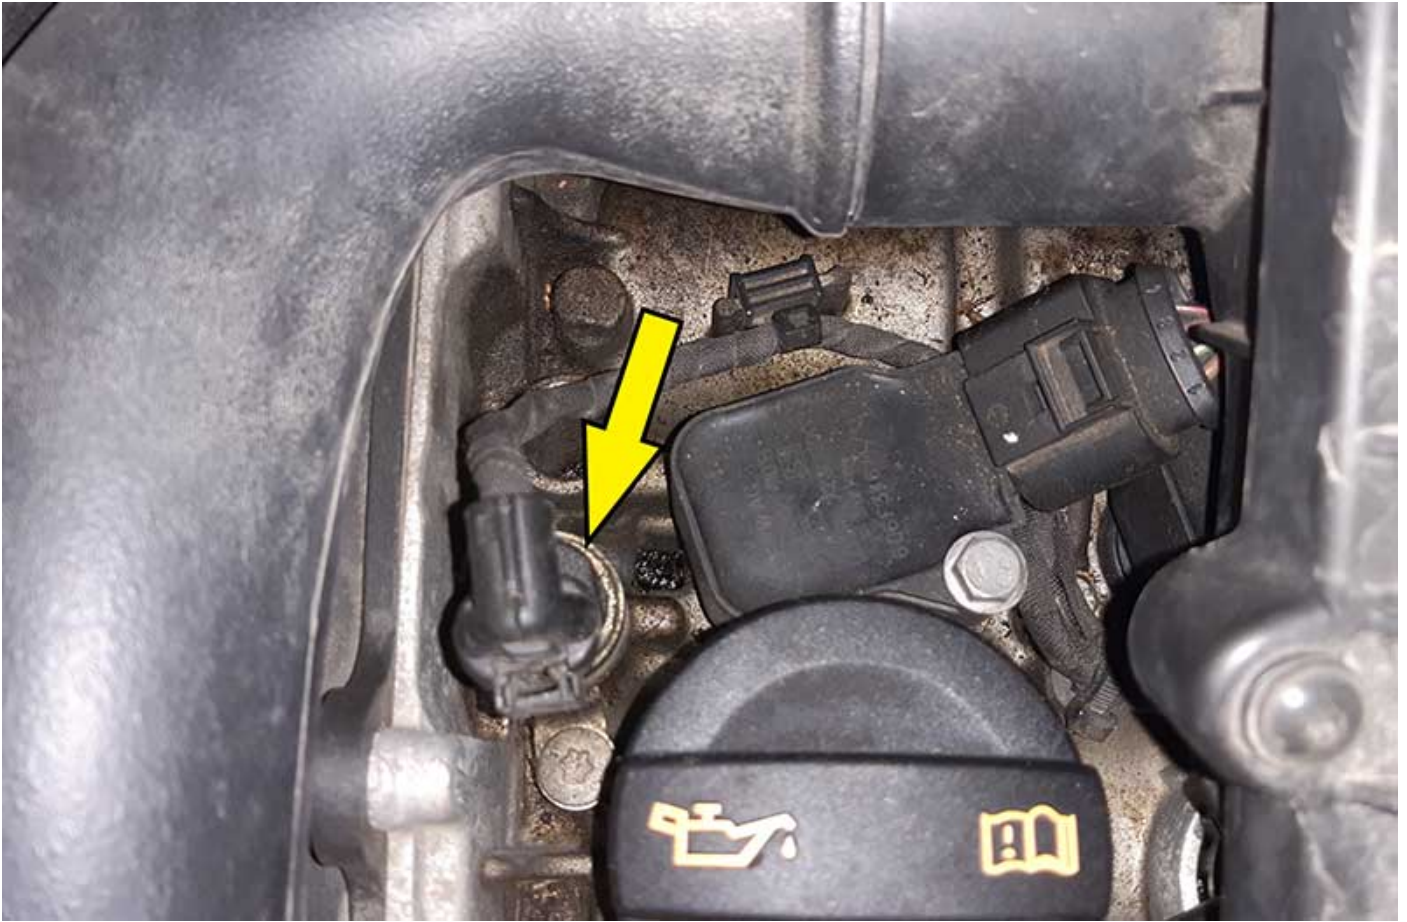
In addition to the classic sources of faults when it comes to the timing belt drive, particular attention should be paid to the oil pressure valve of the variable camshaft control (see picture). Blockages or coking of the oil bores can lead to the above-mentioned symptoms. These usually contribute to faulty camshaft adjustment.

In order to remedy this, the oil pressure valve of the camshaft control can be cleaned. In some cases, an immediate replacement is the best option. It is advisable to also inspect the area of the oil bore in the cylinder head and to check for contamination.

With the help of a diagnostic device (e.g. Hella Gutmann mega macs X), the error memory should then be deleted. Finally, a test drive has to be carried out.
