Citroën C3 Pluriel - Vandindtrængen i baglygte | HELLA

C3 Pluriel (HB)

Water entering rear combination lamp

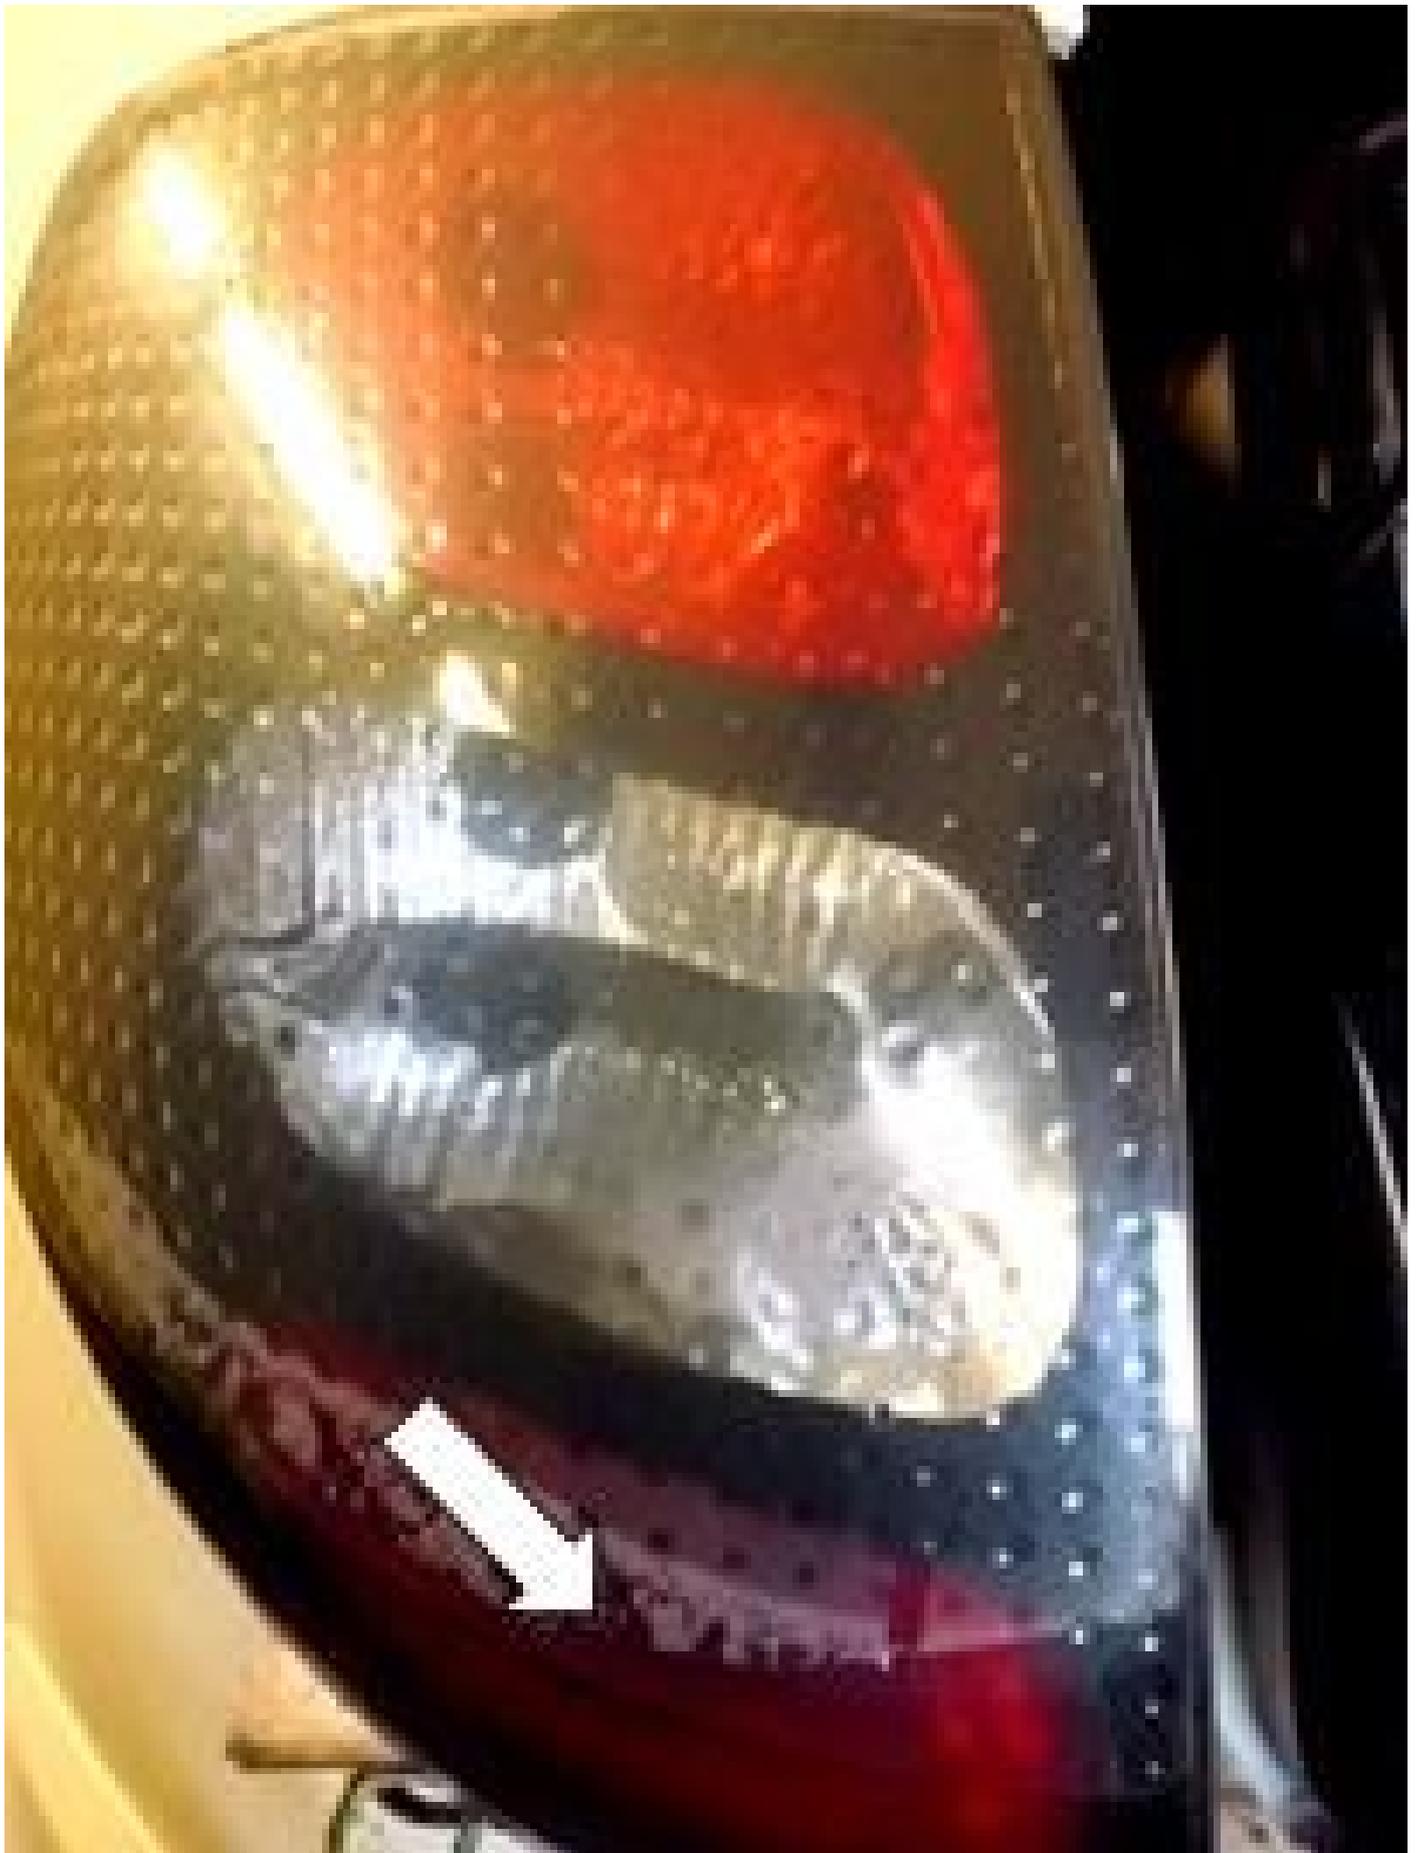
Figure 1 Figure 2

On the vehicles mentioned above, there is a risk of the rear combination lamp functions failing due to water ingress (Figure 1).

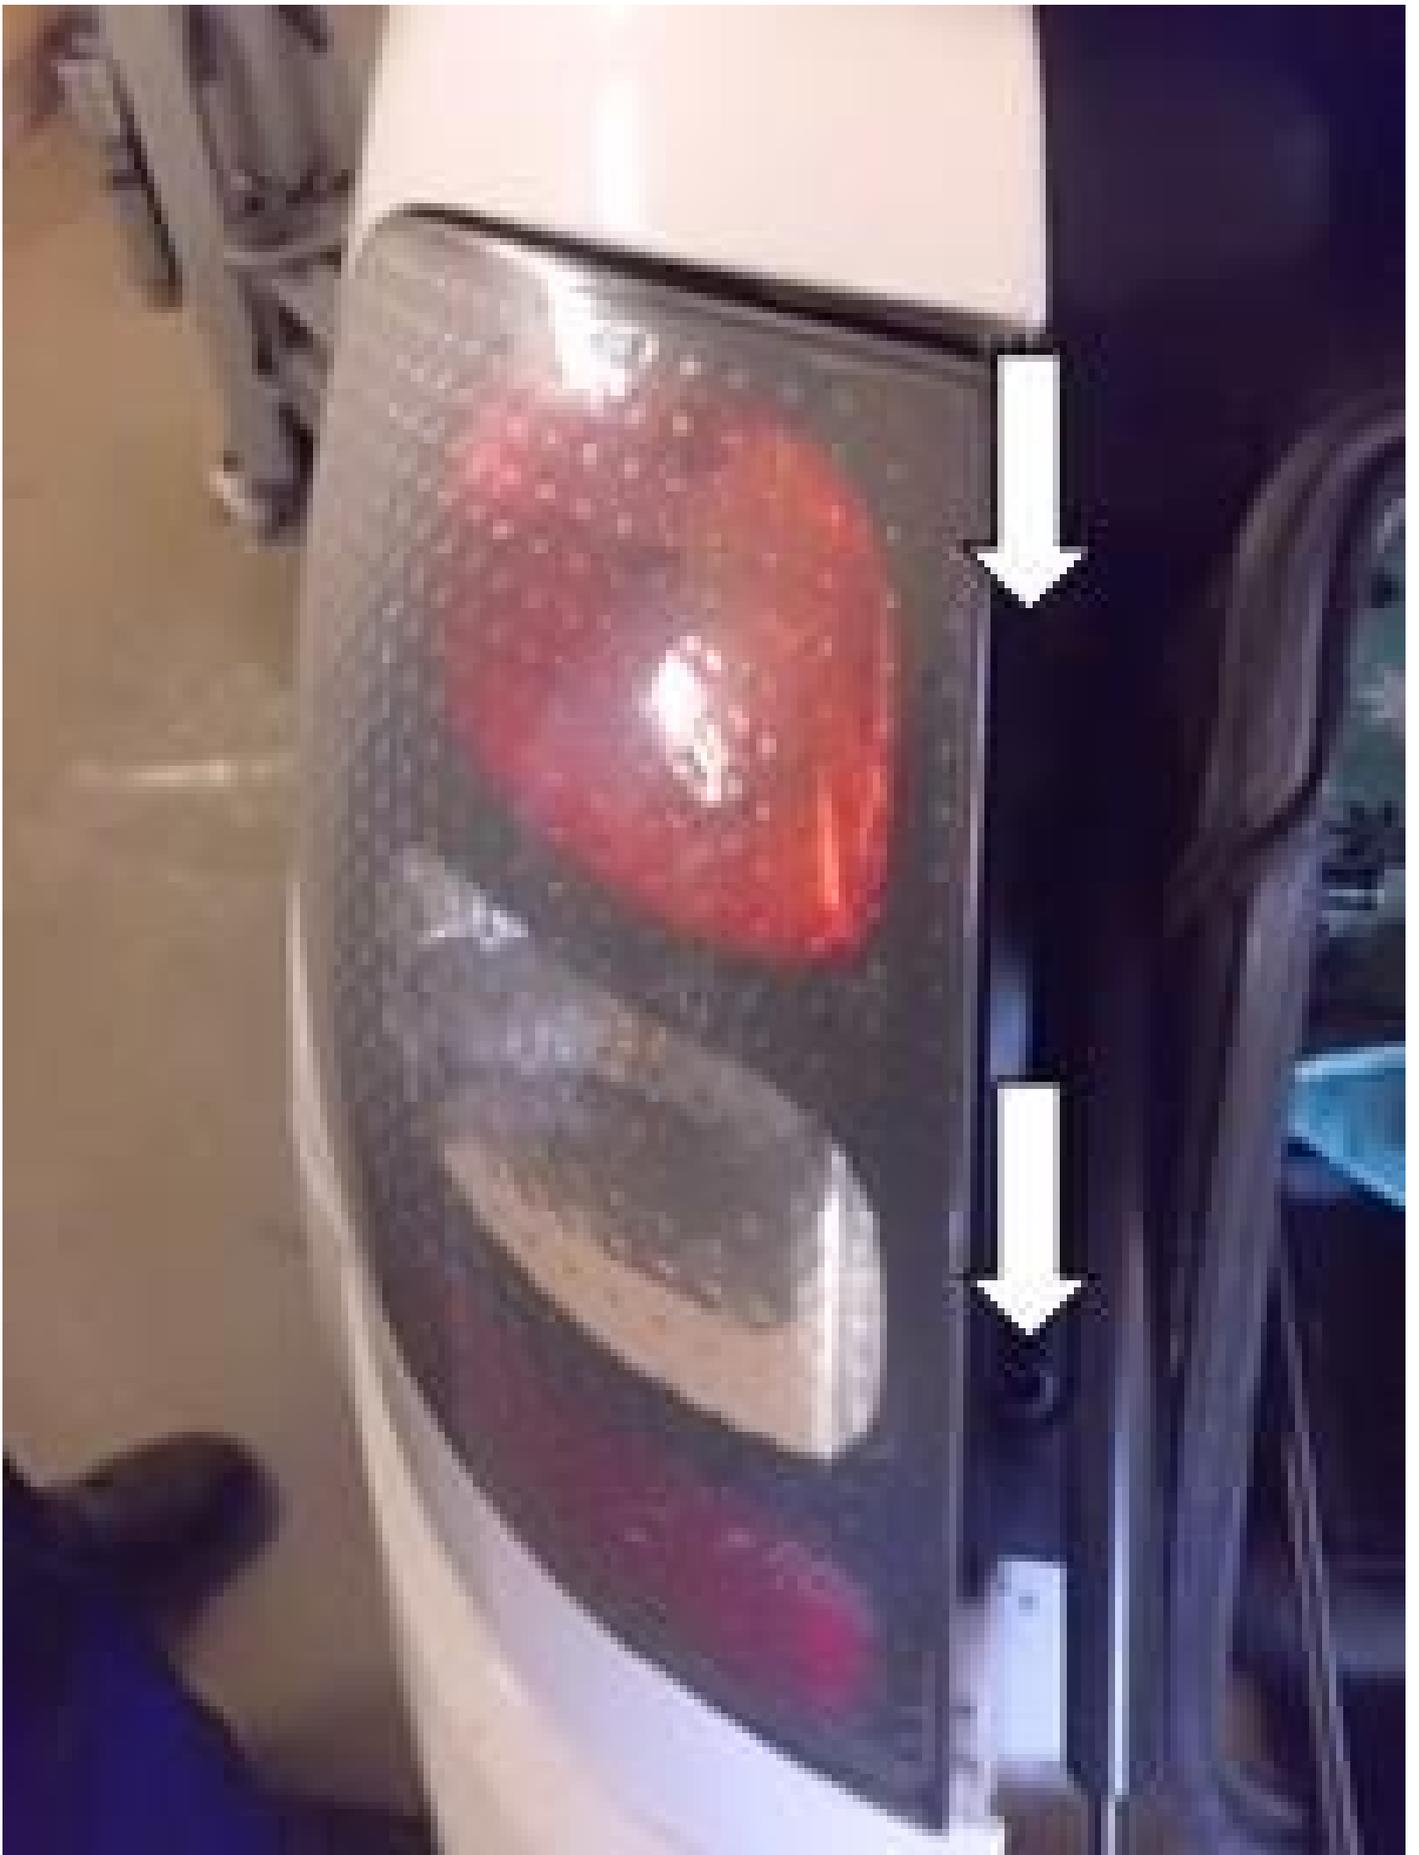
Citroën C3 Pluriel (HB) Vandindtrængen i baglygte ovennævnte modeller kan funktionerne i baglygterne svigte som følge af indtrængende vand (fig. 1). Baglygten skal afmonteres for at der kan foretages en bedømmelse. Det gøres ved at afmontere de to skruer (fig. 2). Derefter klikkes lygten fri til siden (fig. 3), tages ud, og pærerne tages ud. Se efter forureninger og korrosion (fig. 4). I de fleste tilfælde skyldes utætheden en defekt svejsesøm i plastmaterialet (over lygten) (fig. 5). Fig. 1 Fig. 2 Fig. 3 Fig. 4 Fig. 5
