# Citroen Dispatch / Jumpy - Illumination of the engine control light and sporadic problems on engine start | HELLA

Dispatch / Jumpy

Models I/II from 20 March 2006

## Illumination of the engine control light and sporadic problems on engine start.

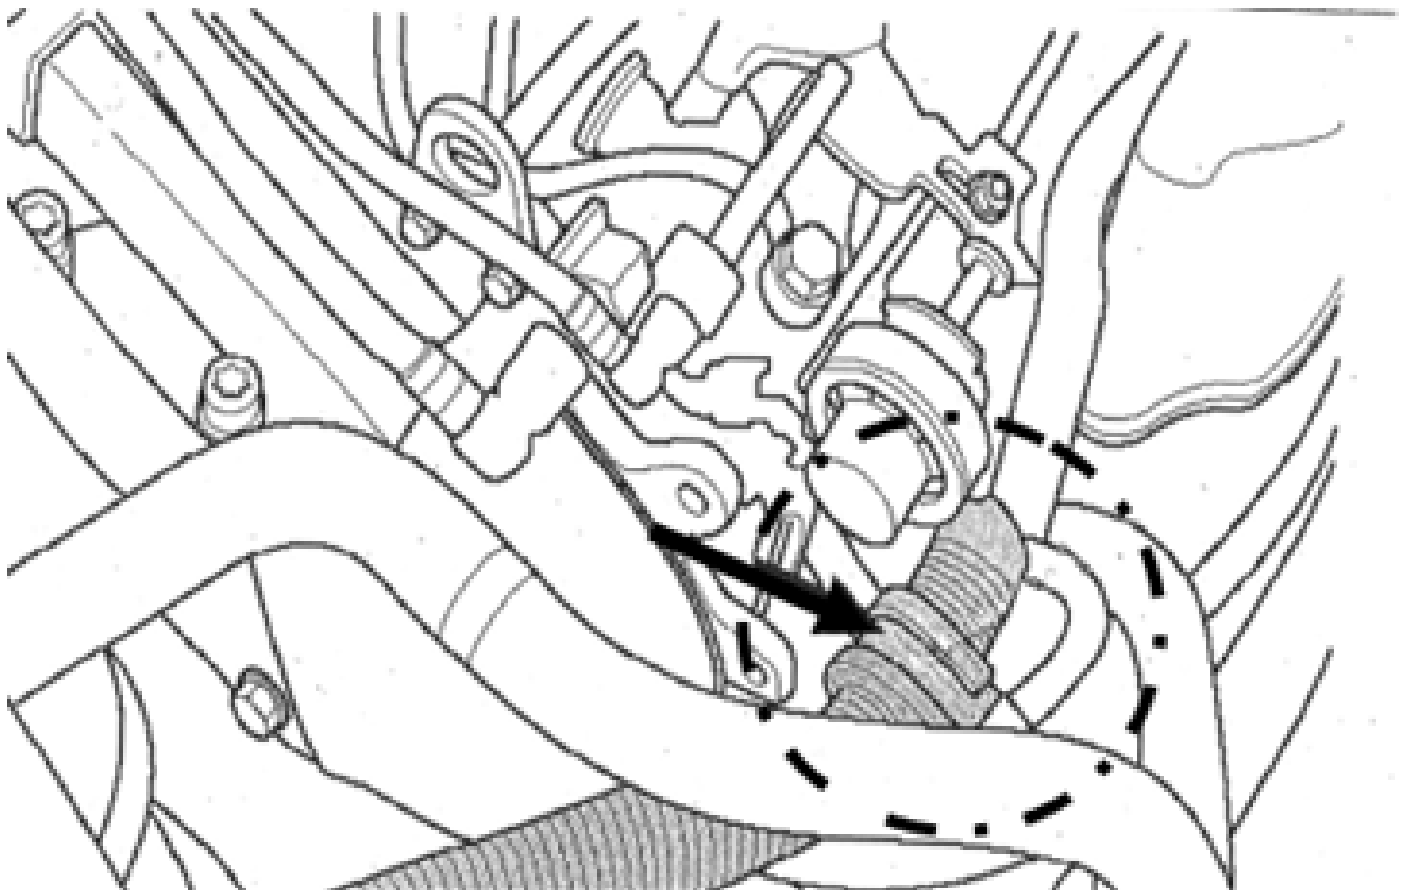
On the above mentioned vehicles sporadic problems may occur on engine start or the engine may die. In addition the engine control light may illuminate. This problem may be caused by a damaged wiring harness above the power steering pump (see figure). The fault on the wiring harness may be caused by "chaffing" on the cable harness guide. To rectify this problem, the wiring harness should be checked. Repair / renew damaged areas and fasten correctly (incl. protector).
