Ford Maverick - Motorkontrollampen (Mil) lyser | HELLA

Maverick

2,0L / 3,0L

Engine not running smoothly

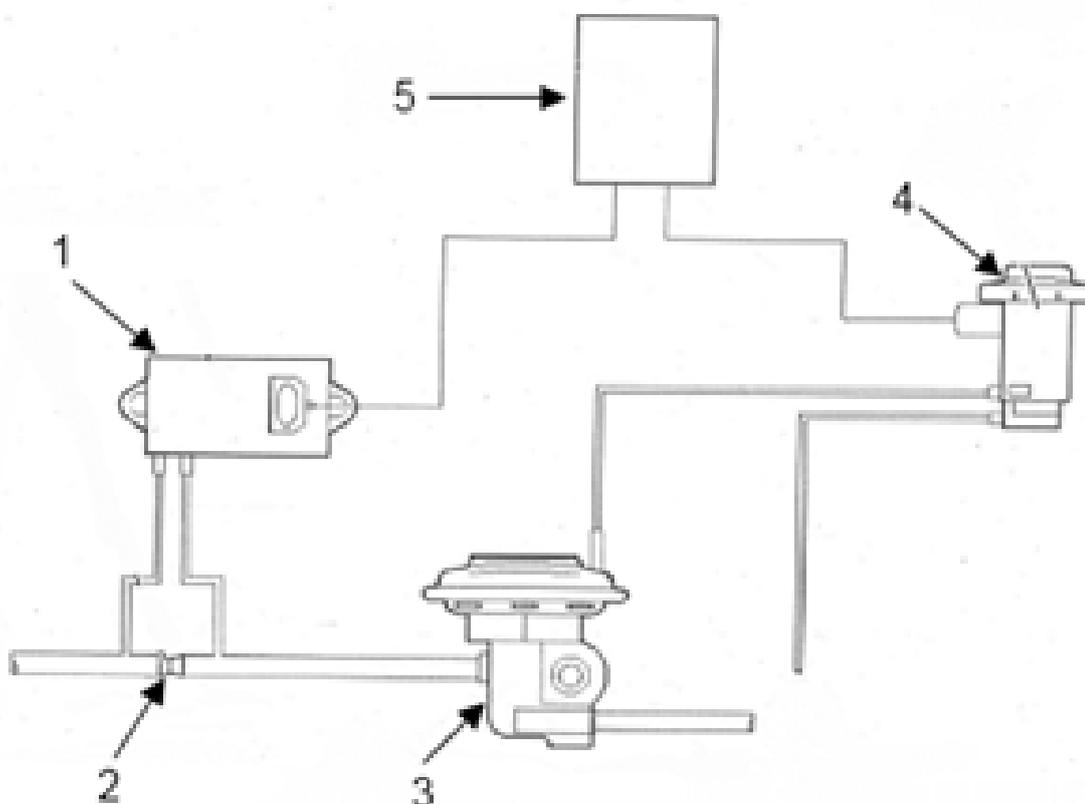
Fig. 1

If complaints are made about the above-mentioned vehicle, i.e. that the engine is irregular and not running smoothly and also that the engine control lamp is lit, these could be signs of a defect in the exhaust gas recirculation system (EGR system).

- Pos. 1 = Differential pressure sensor

- Pos. 2 = Differential pressure measuring point
- Pos. 3 = EGR valve
- Pos. 4 = Exhaust gas recirculation solenoid valve
- Pos. 5 = Engine control unit

The measured values of the exhaust gas return rate are measured by the differential pressure sensor at the differential pressure measuring point (see Fig. 1). These values are forwarded as a voltage signal to the engine control unit. A technical fault could bring about an erroneous measurement of the amount of exhaust gas actually recirculated.

First of all, the pneumatic EGR valve is to be checked.

If no fault is found here, the differential pressure sensor should be regarded as a possible source of the trouble.

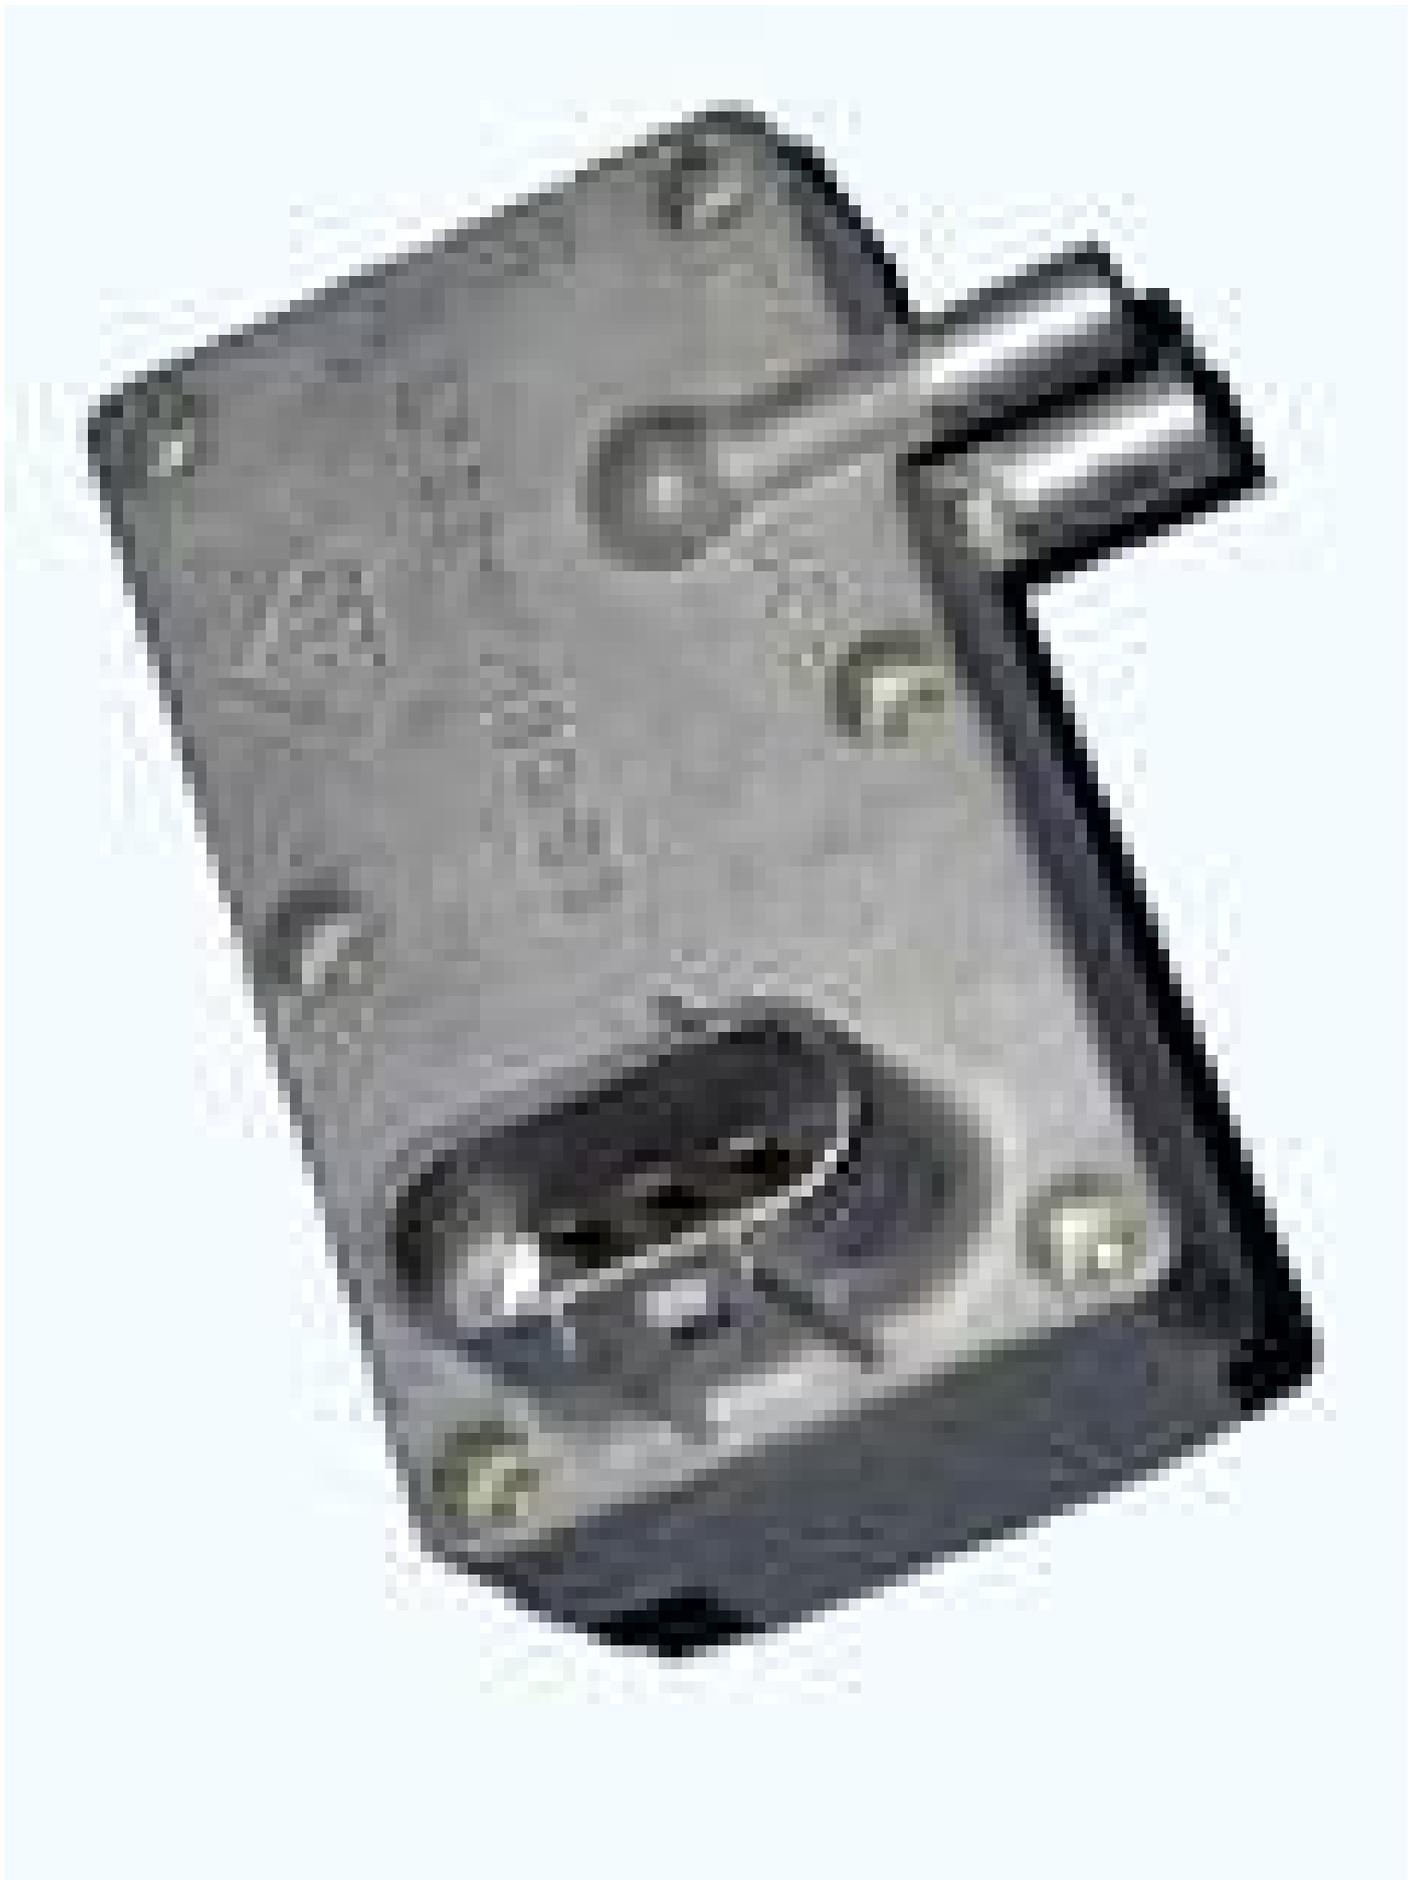
Fig. 2

The two hose connections on the housing (see Fig. 2) are to be checked to ensure that they are in the correct position (input and output) and checks should also be run to search for any possible damage to the hose connections.

If no fault shows up here, everything points to a defect with the differential pressure sensor, in which case this sensor should be replaced.

A modified differential pressure sensor is available from the vehicle manufacturer.
