Mazda 6 - Funktionsfejl for kompressor | HELLA

6 (GG/GY)

Model year: 2002 - 2008

Compressor malfunction

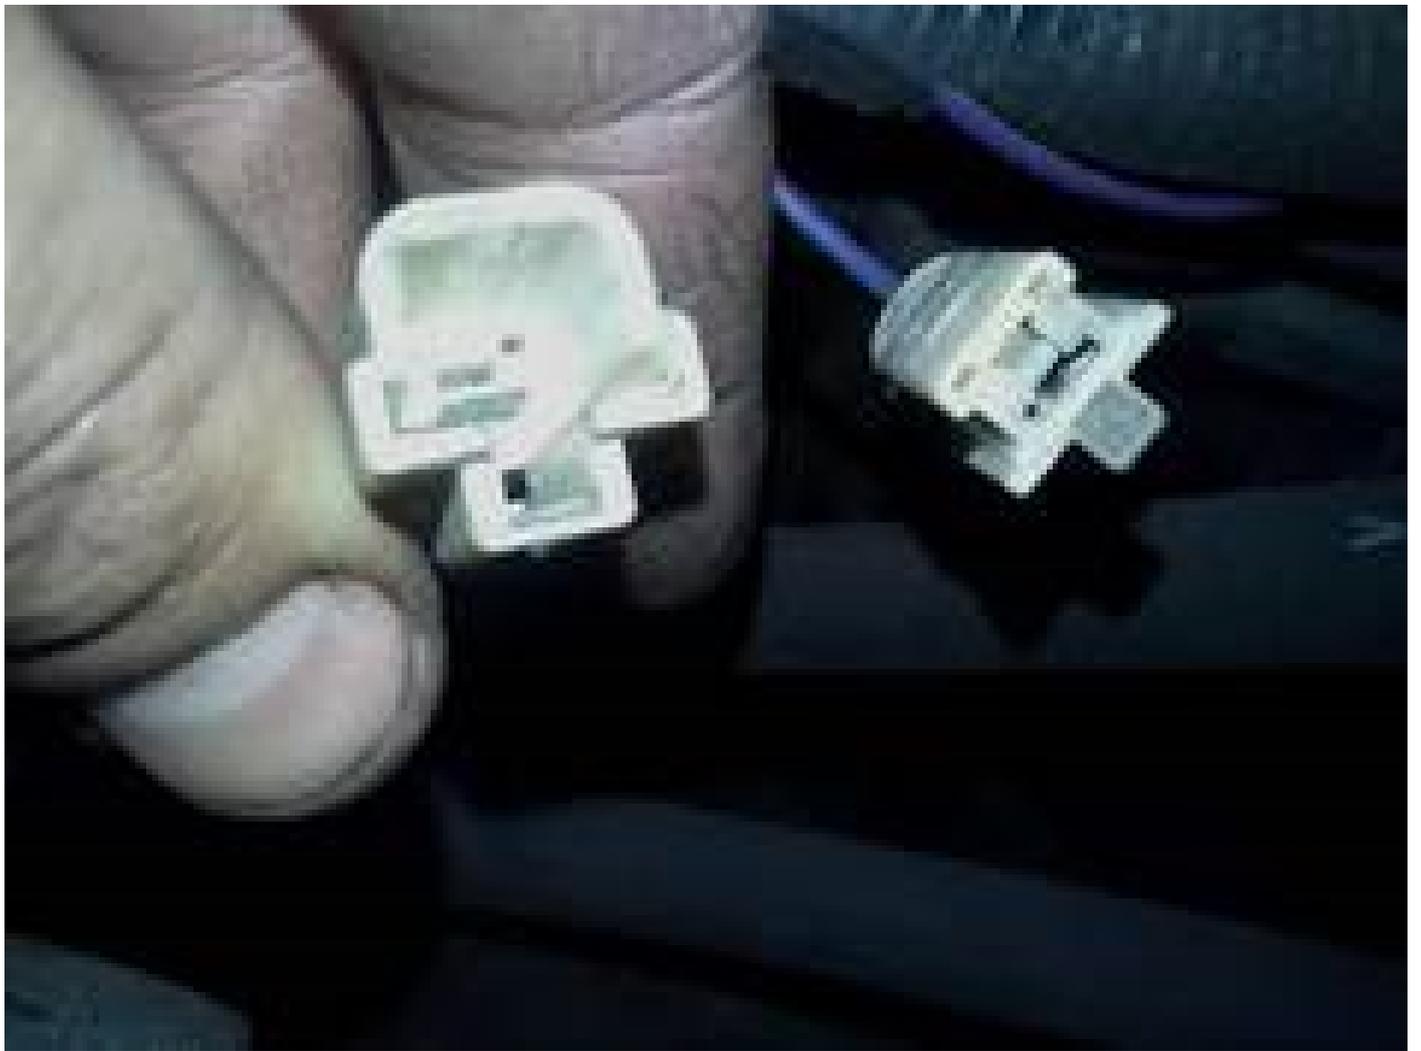
The electrical cable for the magnetic clutch power supply (+) is routed to the compressor through the engine block area.

Water leaking into the connector housing (figure) can cause corrosion to form. This can lead to contact problems or a power failure.

In order to remedy this issue, the damaged electrical connection should be renewed.
