1 column area 10668 Warning note BI - 10668

A-Class

Model years: 2004 - 2009

Rear combination lamp with reduced luminosity

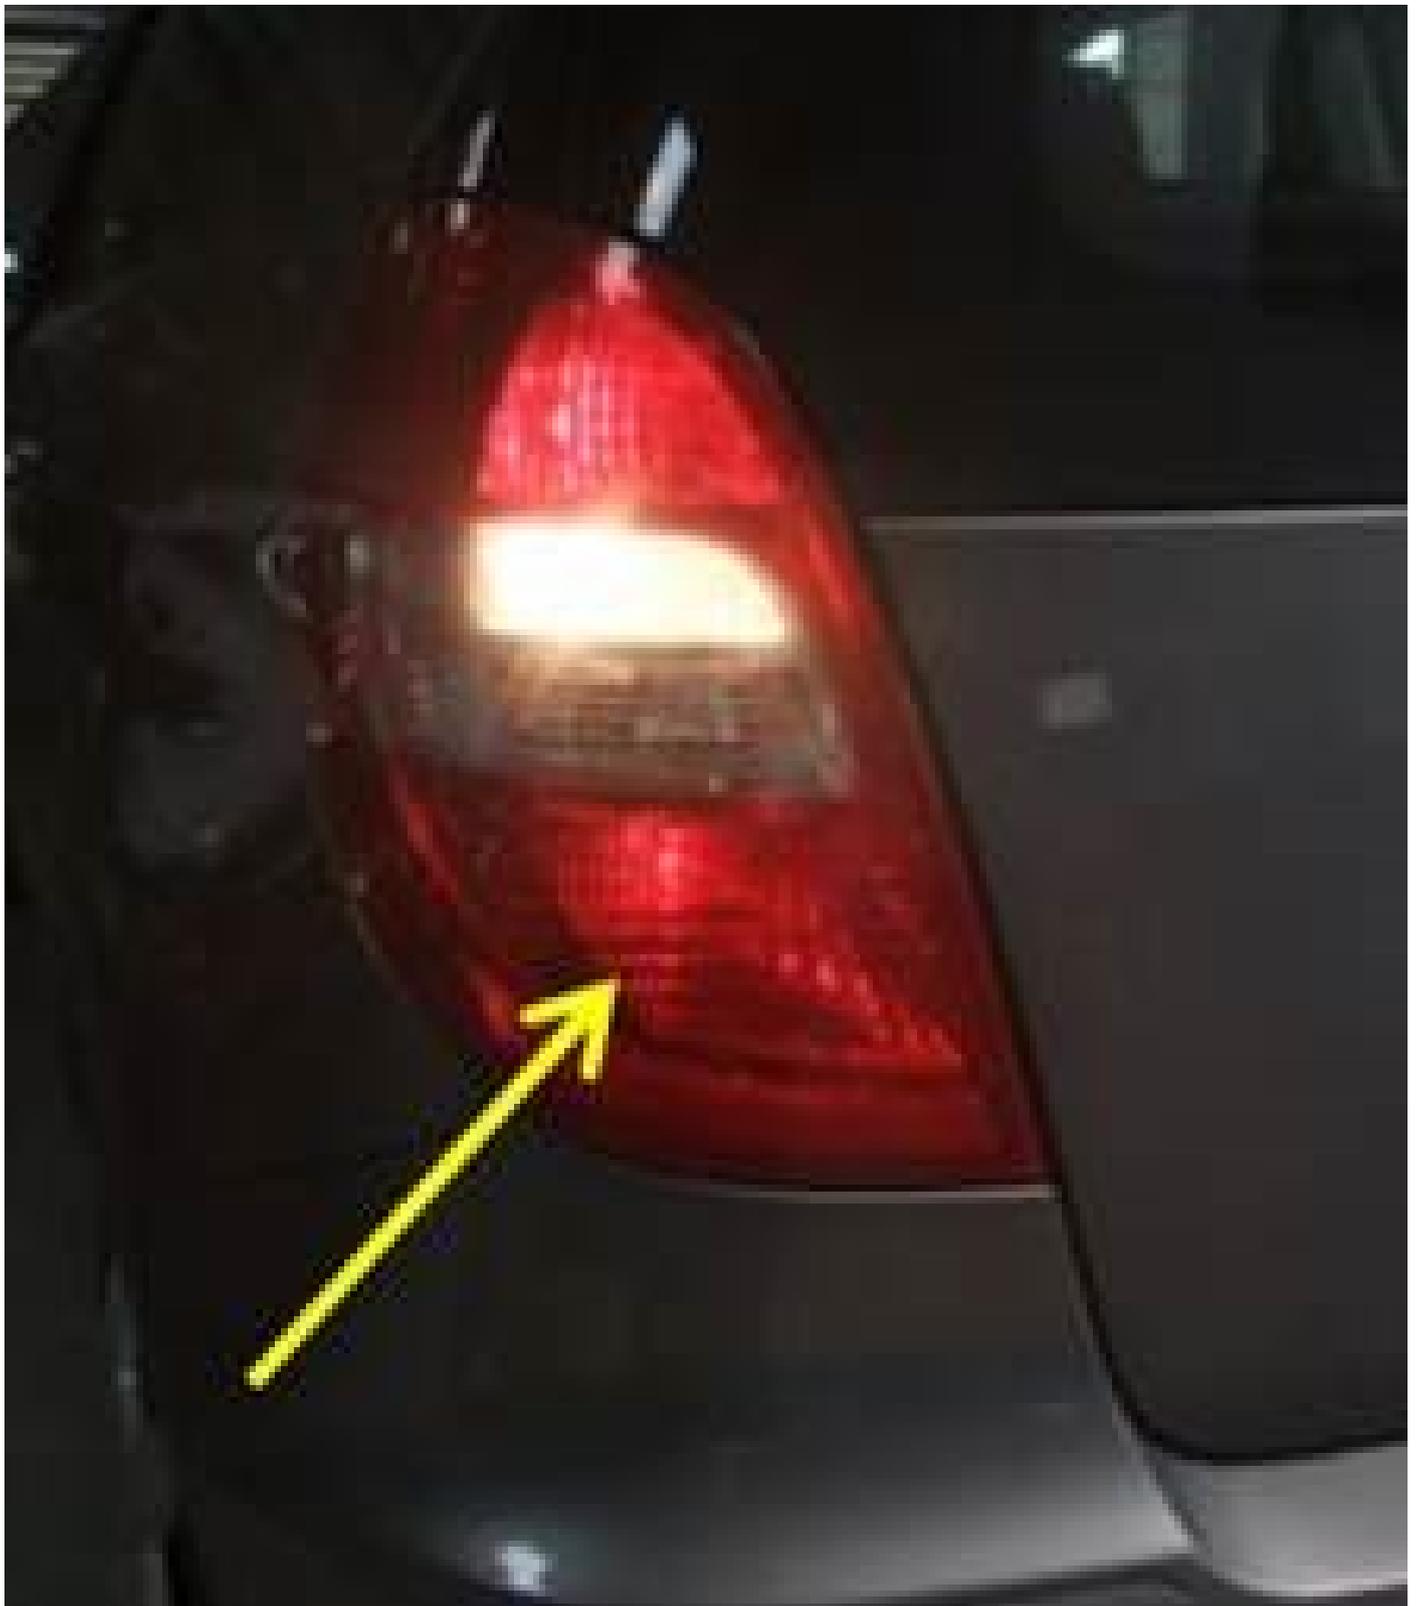
Fig.1

If the indicated problem occurs in the above vehicle, a contact problem/ charred bulb holder of the rear combination lamp could be the possible cause.

- before, with reduced luminosity

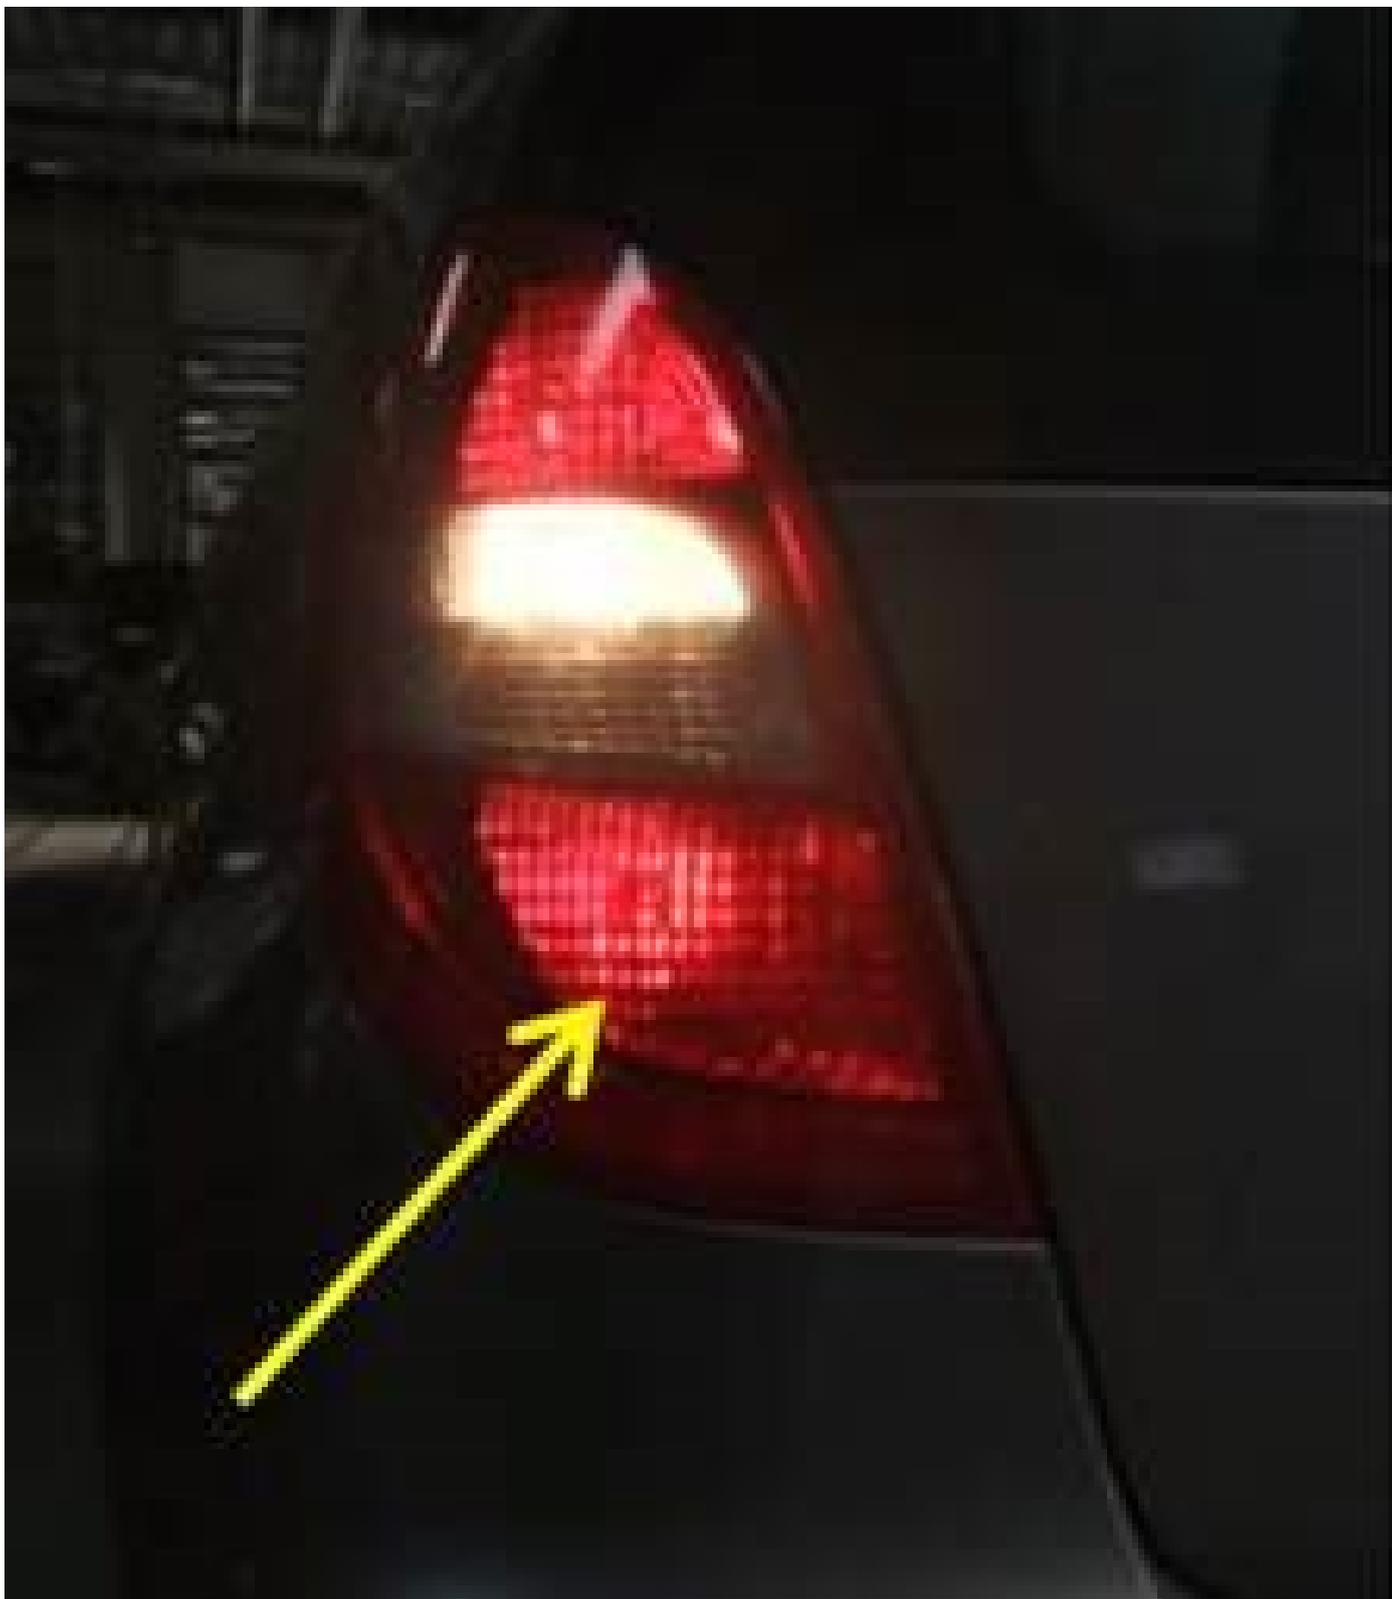
Fig.2

okay_ after repair.

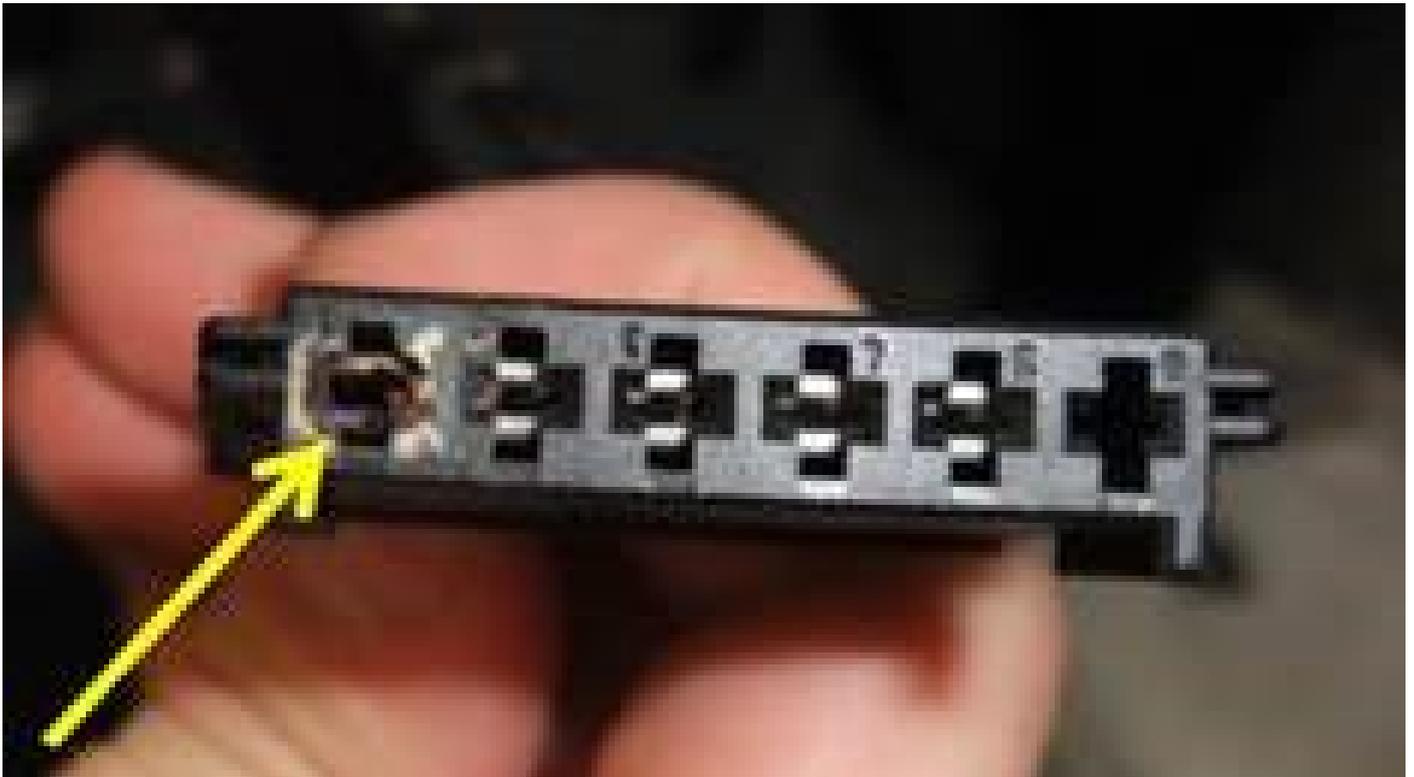
Fig.3

- Opening vehicle rear door.
 - Unclipping left and/or right cover (C-pillar) using e.g. a long wedge.
 - Opening cover of left and/or right storage compartment in trunk.
 - Removing first-aid kit and electric air pump from left storage compartment in trunk (left rear combination lamp).
 - Folding right storage compartment in trunk inside (right combination lamp).
 - Disconnecting electric plug connection.
 - Checking electric cables, plugs, contacts and the rear light for further damage,
- see charred plug socket. (Fig.3).

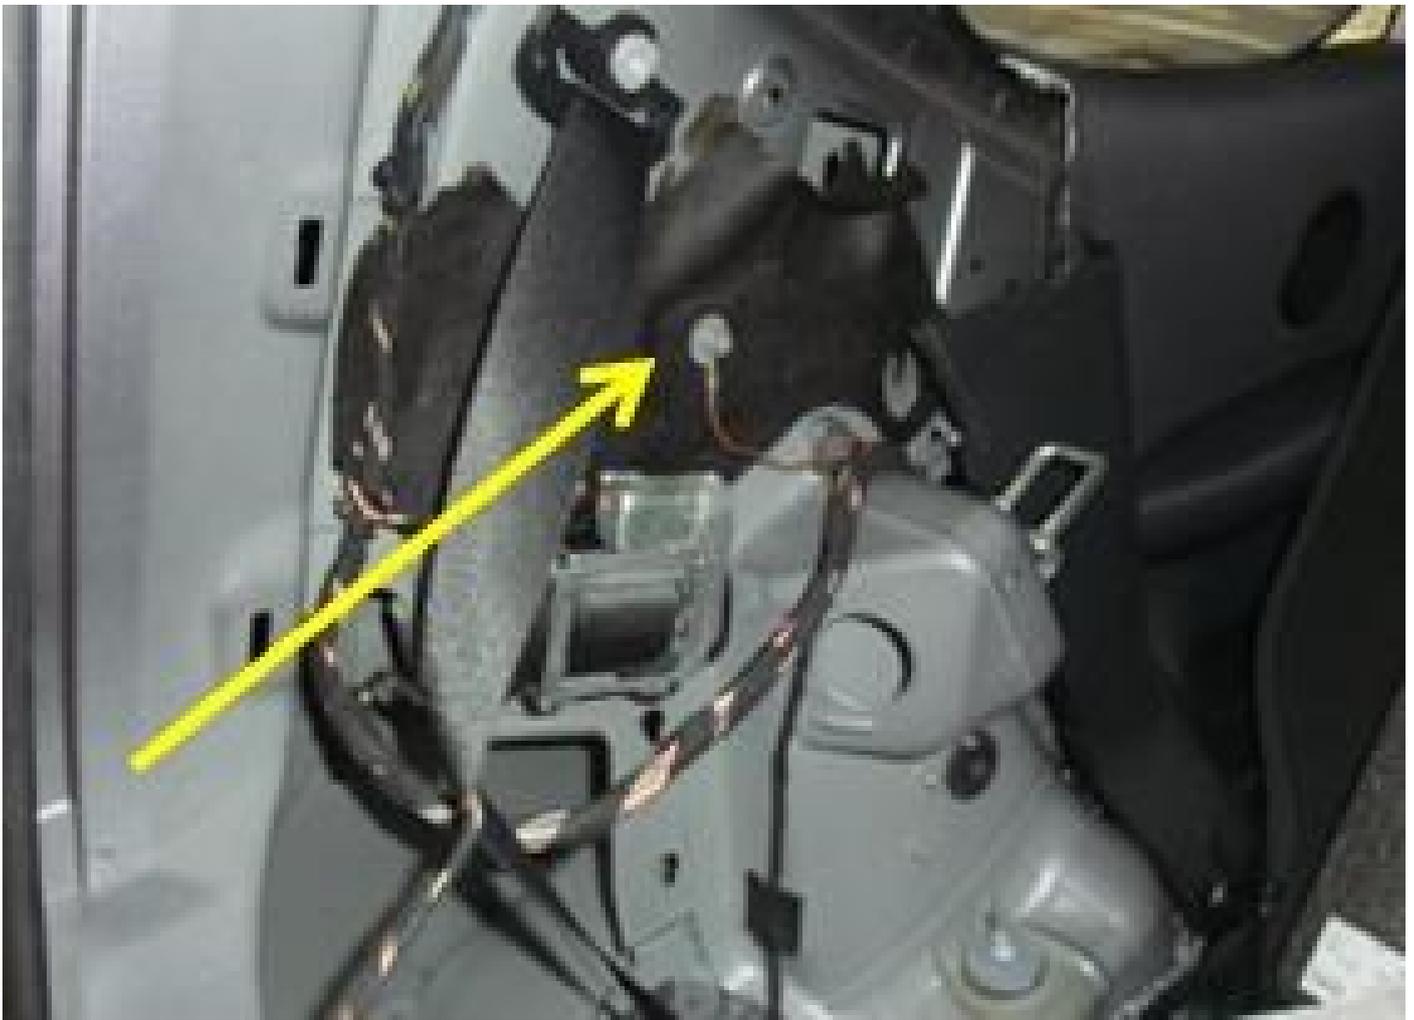
Fig.4

- Checking proper ground connection (corrosion/ transition connection) see Fig. 4.
