Mini F56 - Horn uden funktion

Malfunction of the signal horn caused by faulty connecting cables in the steering wheel

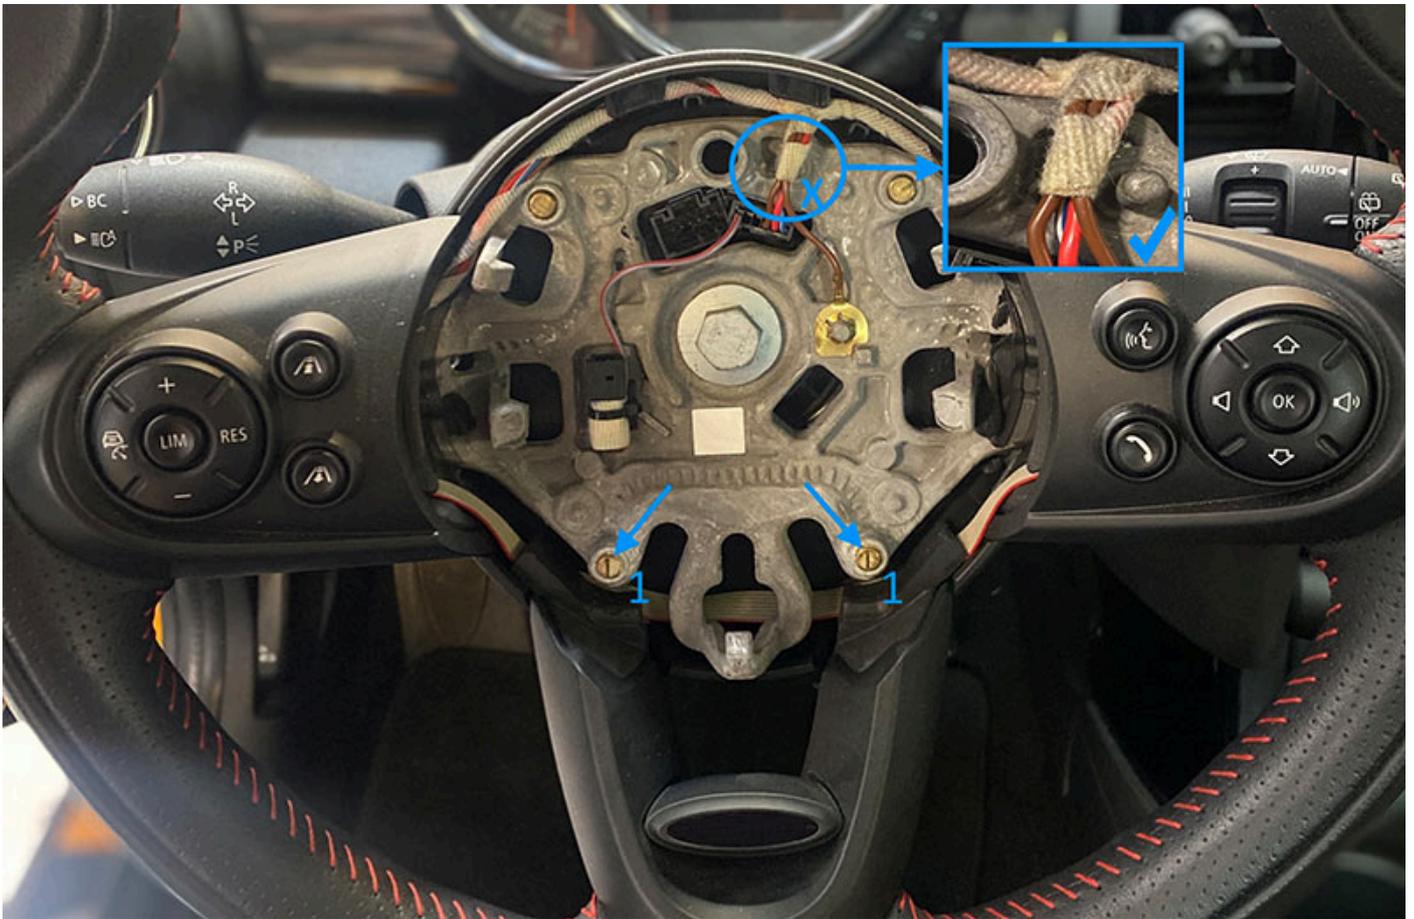
Incorrect routing of the connecting cables in the steering wheel or an unfavourable material pairing on the signal horn contacts between the steering wheel and the airbag unit may be responsible for this defect. Both problems can also occur simultaneously. An error memory entry that indicates a defect is not stored.

If the connecting cable is not laid correctly (see illustration), this has to be rectified. If the cable is visibly damaged, it must be replaced. If contamination is detected on the contact surfaces, a steering wheel with optimised contacts must be installed in accordance with the manufacturer's specifications. The problem has been identified by the vehicle manufacturer and rectified by means of a service solution using modified components.
