# Mini F56 - Vandindtrængning i bilens kabine

## Moisture in the vehicle interior caused by condensation draining from the air-conditioning system

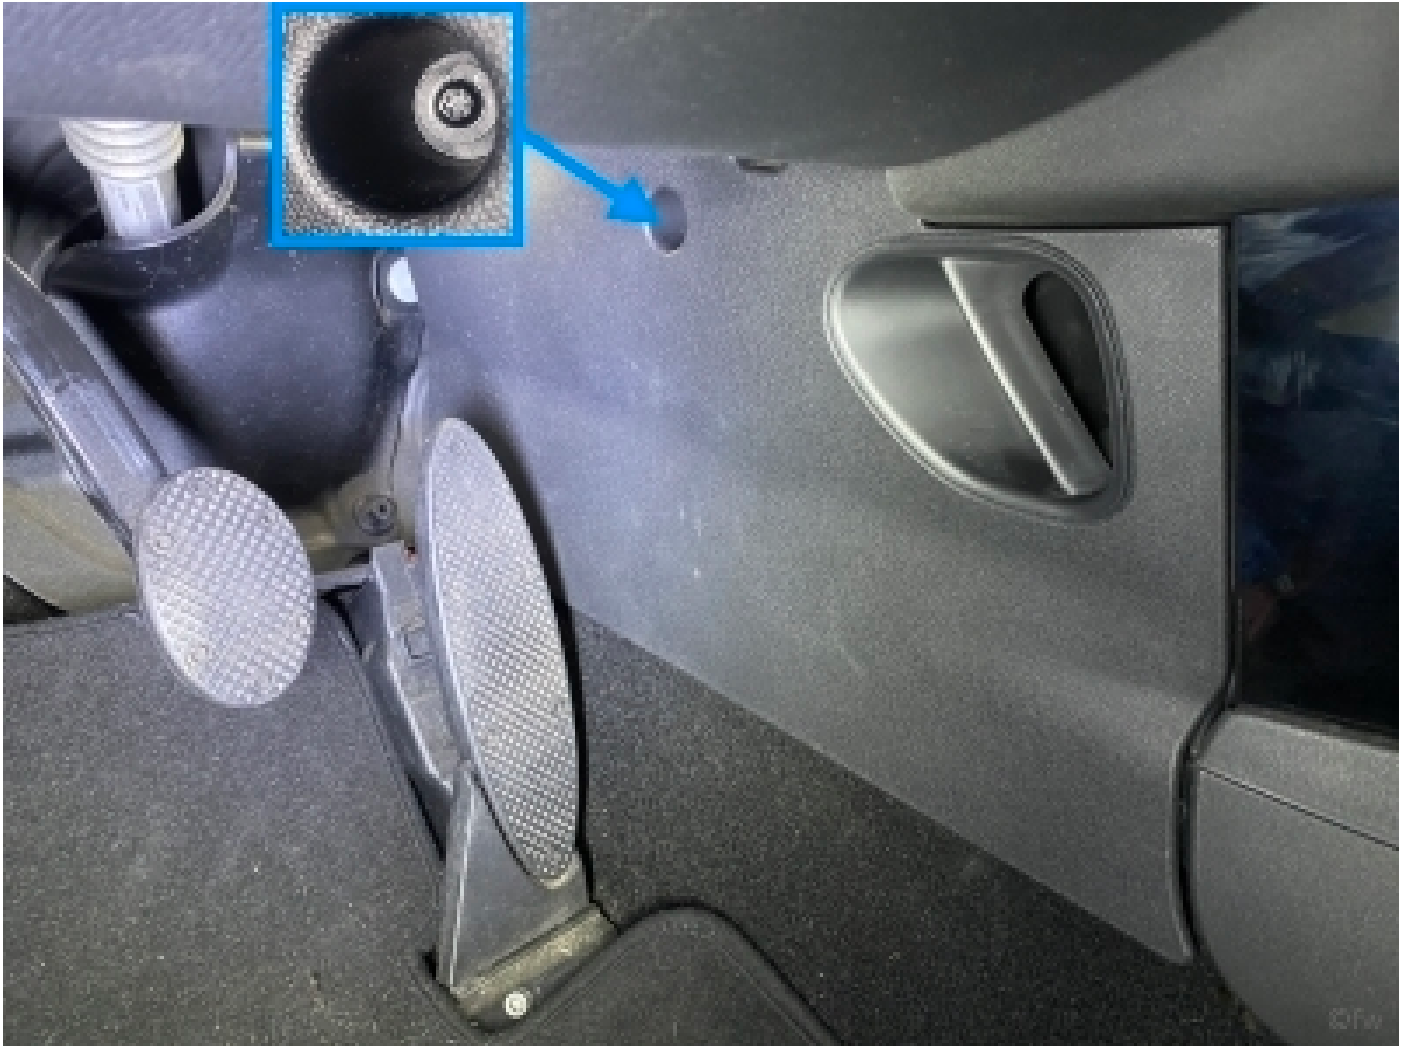
The side panelling (Fig. 1) in the footwell must be removed to carry out the necessary checks. In order to do this, the fastening screw has to be undone and the panelling removed from the brackets. The carpet can be pressed down slightly on the side underneath the air-conditioning unit in order to check it. The rubber seal of the water drain must fit all the way round the air-conditioning unit (Fig. 2) and have no kinks in it.

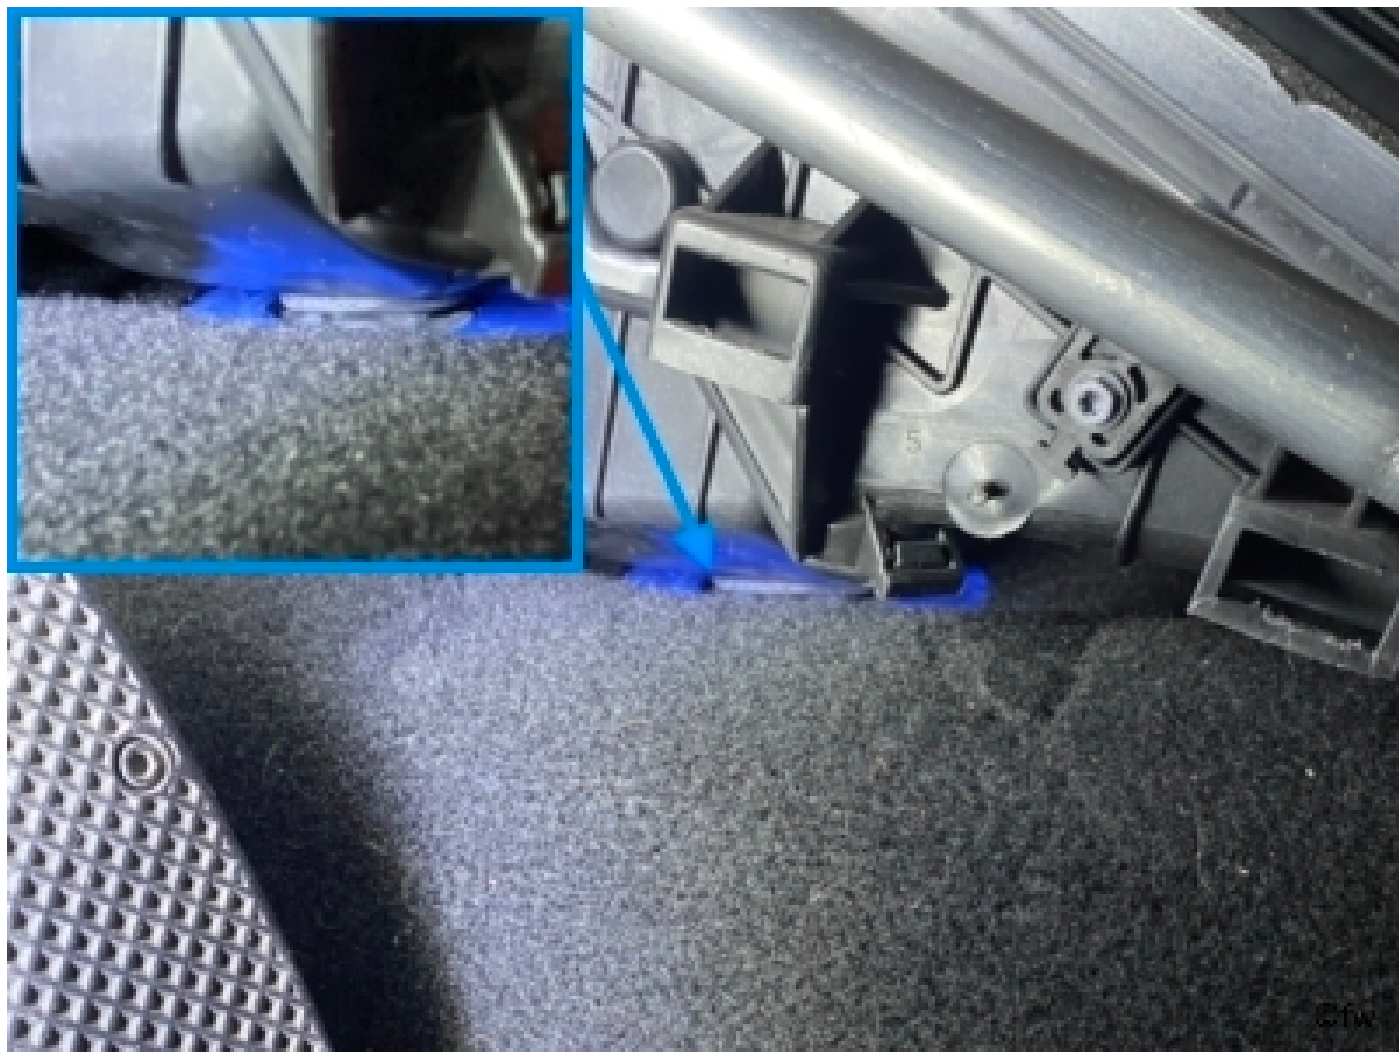
Deformation of the rubber seal means that condensation can no longer drain off properly. The water collects and is not drained off as intended, but enters the vehicle interior as a result of the deformed seal. The interior carpet absorbs the water, which can lead to unpleasant odours and, under certain circumstances, mould growth.

An endoscope is recommended for easier inspection. In the event of a fault, traces of water are usually visible on the side of the drain, indicating that the seal does not fit properly.

One test option is to set the air-conditioning system at maximum cooling capacity. In warm ambient temperatures, this causes condensation. In the event of a fault, this condensation would then run visibly past the seal and into the vehicle interior. If kinks or traces of water are visible, the condensation drain must be replaced. If mould is visible on the interior carpet, this should also be replaced.
