# Opel Astra H - Støj fra motorrummet | HELLA

**Astra H**

**Model years: 2004 -**

## **Noise from the engine compartment**

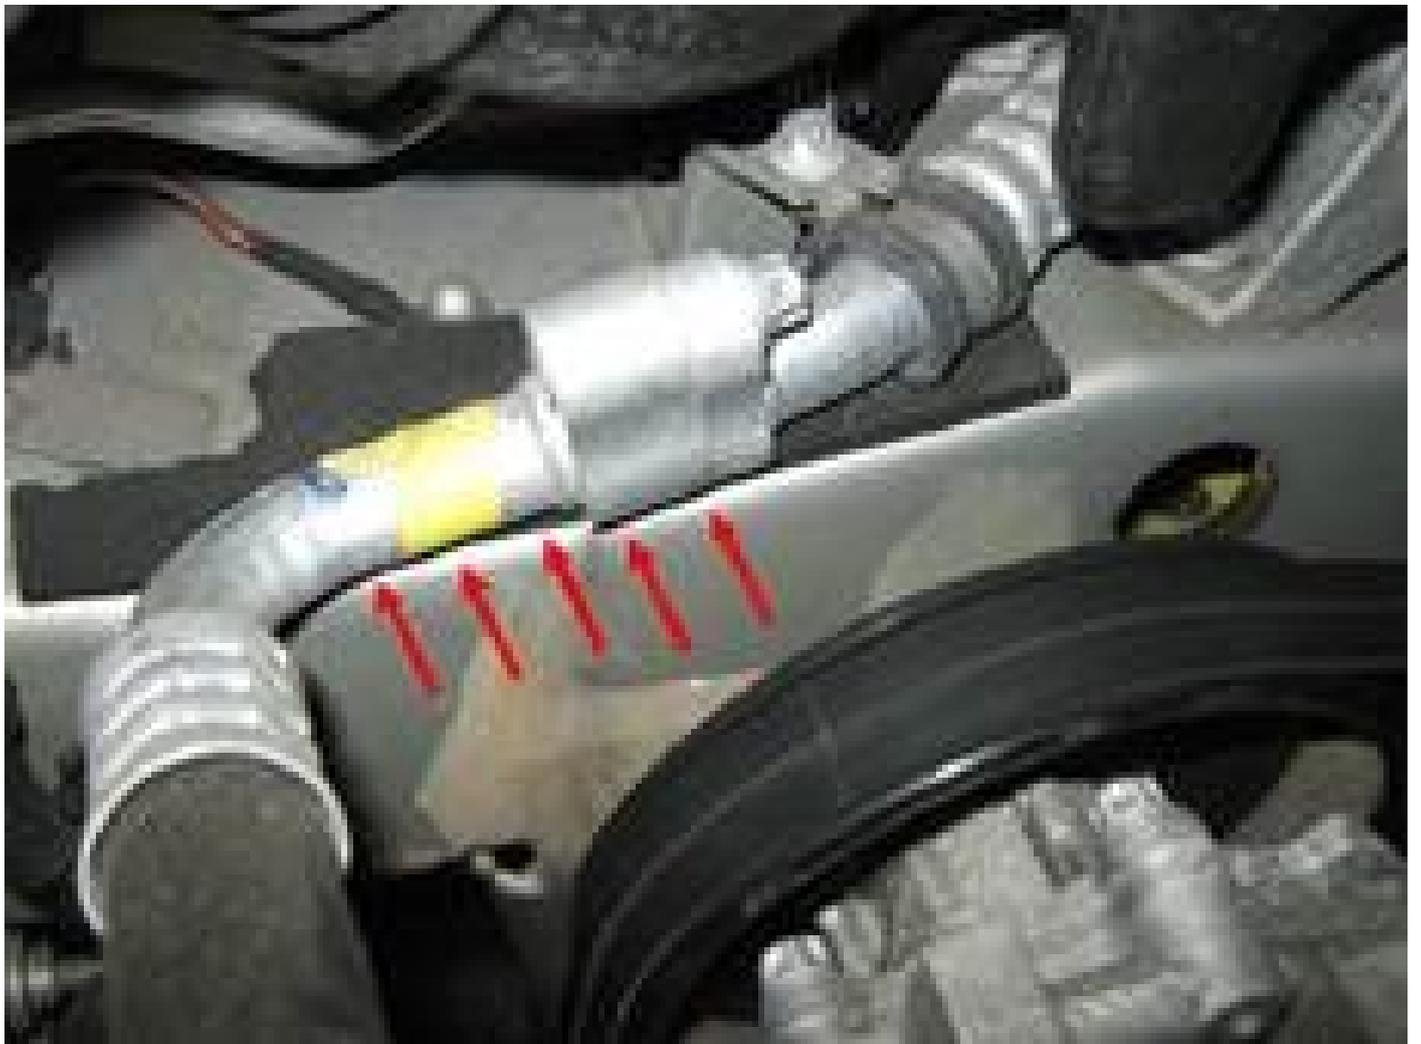
Noise may be coming from the engine compartment in the above vehicles when the engine is running at operating temperature. This occurs in particular during acceleration of the vehicle and an engine speed between 2000 and 3000 rpm.

The cause may be a missing or misplaced damper strip between the frame rail and the refrigerant line (see image).

Make sure that the damping strip is present and correctly installed. If necessary, attach a new damping strip. When doing so, make sure that the refrigerant line does not come into contact with the frame rail.

Otherwise, the flow noise of the refrigerant may be transmitted through the body into the vehicle interior. It is important to ensure that the damping strip extends approx. 5mm beyond the edge of the frame rail.

Note: A suitable damping strip is Hella part no. 9MJ 351 018-011
