# Opel Astra - Støj fra loftsbeklædningen| HELLA

Astra J GTC

Chassis number\_ CG000001 – CG107856

## Noise in the roof lining area

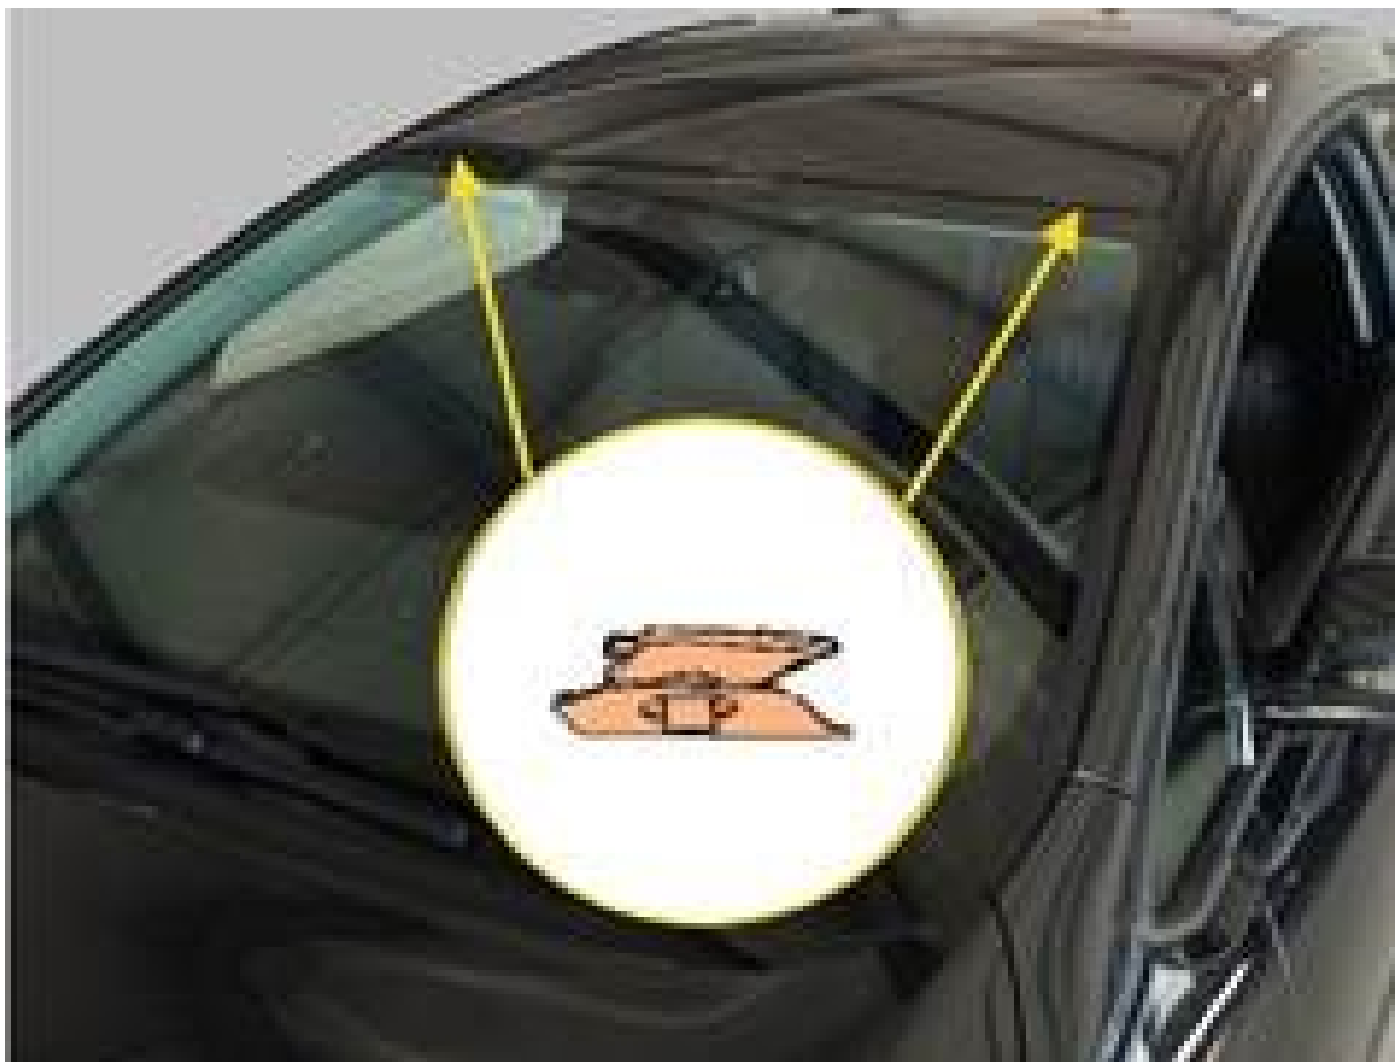
Figure 1

The cause of this noise development could be the clips that were used as a mounting aid for the panorama windshield (figure 1).

The clips may come loose due to heat generation (insolation) for example.
