Opel Insignia - Nedsat motoreffekt | HELLA

Insignia

Model year: 2012 – 2013

With engine: 1.6L (LLU) A16LET

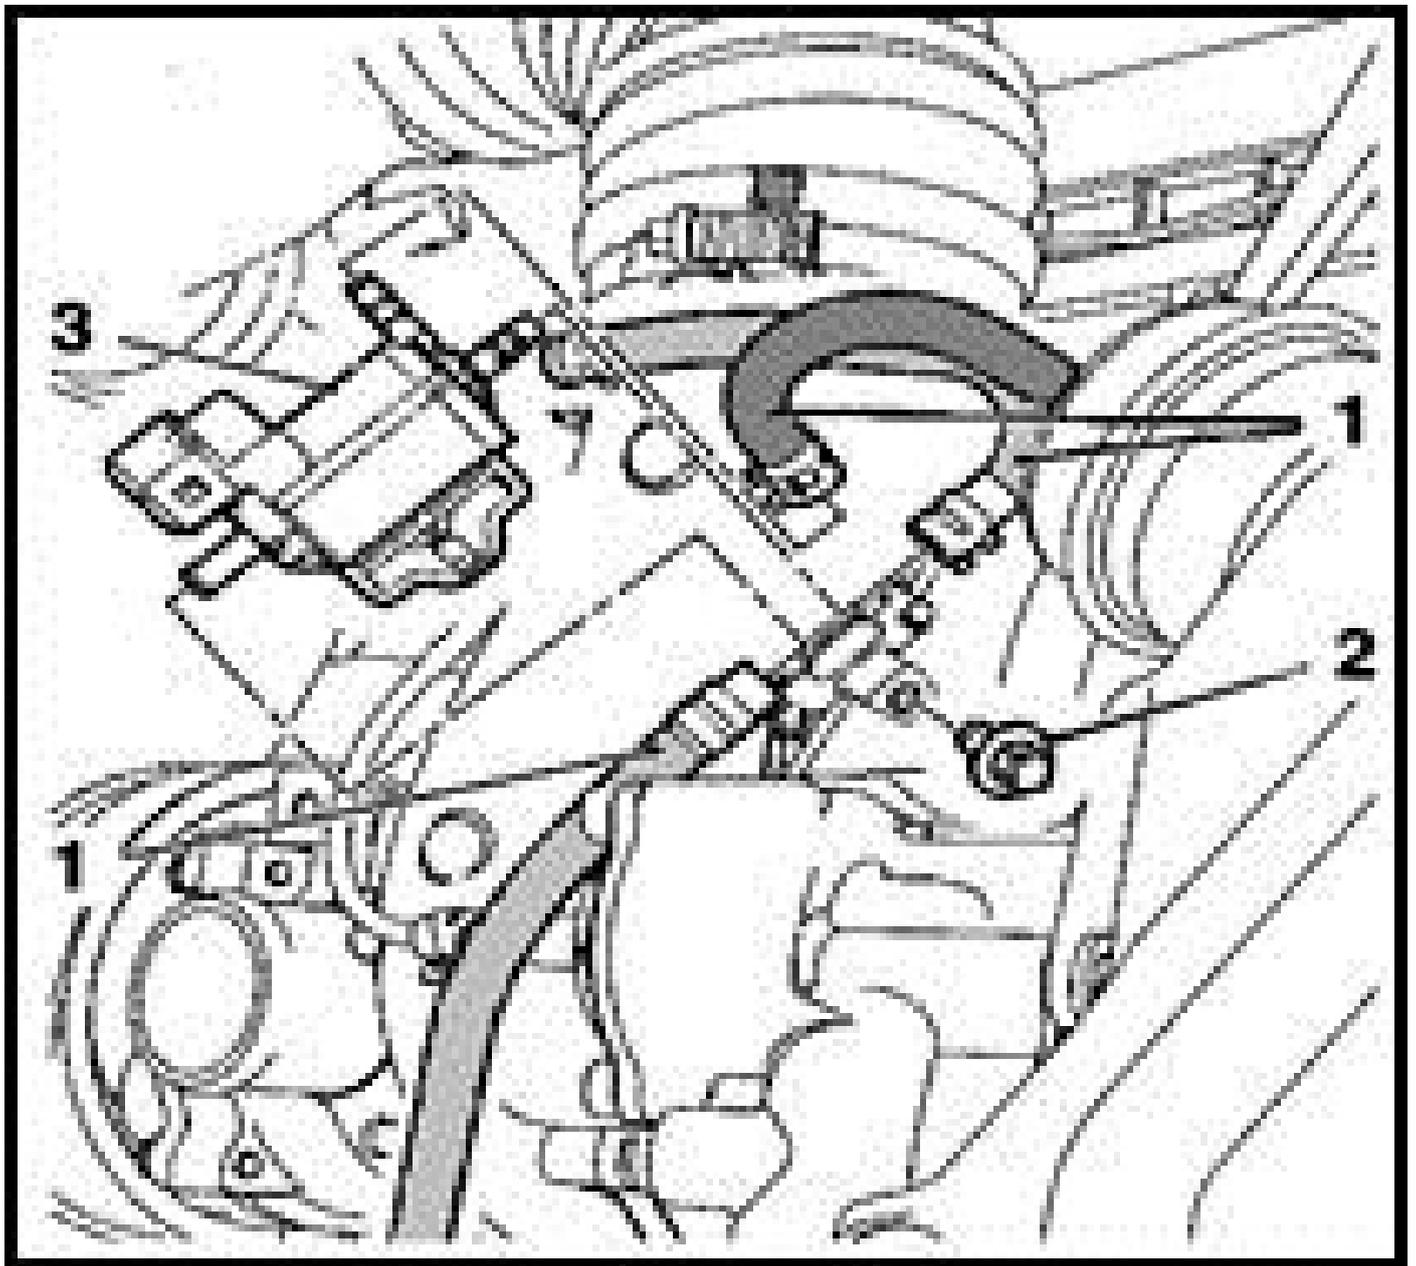
If there are reports of a loss of engine power and the engine warning light comes on for these vehicles, a malfunction of the turbocharger's solenoid valve (wastegate) should be considered as a potential cause.

In addition, the error codes P0234 and P0299 may be stored in the engine control unit's error memory.

Sticky residue in the solenoid valve's steel nozzle (plug side) can hinder the switching function. The cause of this could stem from the use of a lubricant for making assembly easier during the production or assembly process.

The turbocharger solenoid has to be replaced to correct the error.

- Spare part No.: 8 50 350 (GM No.:55574902).

- Ensure the section has been de-energized or disconnect the solenoid valve from the power.
- Disconnect the hoses (Figure, item 1).
- Unscrew the screw (Figure, item 2).
- Replace the turbocharger's shift solenoid valve (Figure, item 3).
- Then reattach the screw and hoses.
- Clear the error codes.
