# Opel Insignia - Tab af kølevæske ved EGR-køler | HELLA

Opel Insignia Årgang: 2009 - Motor: A20DT / A20DTH / A20DTJ / A20DTR / A20DTCKølevæsketab ved EGR-kølerI ovennævnte modeller kan der opstå utæthed for kølevæske ved køleren for udstødningsrecirkulation (EGR-køleren). Ved kontrol af kølesystemet skal man være særlig opmærksom på EGR-kølerens hus. Det kan have en revne, som kølevæsken kan trænge ud af. Afhjælpning sker som beskrevet i det følgende, og der benyttes et reparationssæt (illustration) bestående af hus, 2 pakninger og 2 clips: Lad motoren køle af Afmonter EGR-kølerens hus (opsaml kølevæsken) Afmonter EGR-køleren fra huset Rens pakfladerne Brug reparationssættet (res.nr.: 55590953): Monter EGR-køleren i den nye hus Monter kølerens hus, og brug de nye pakninger Påfyld kølevæske Udluft kølesystemet Foretag en tæthedskontrol

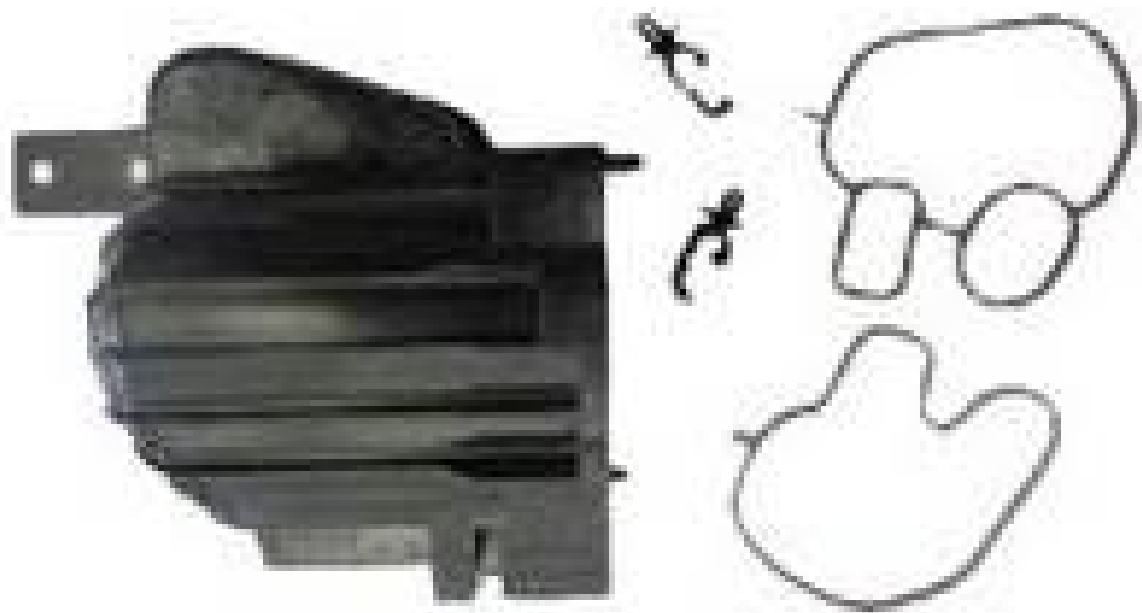
If you suspect a leak in the cooling system, special attention should be paid to the EGR cooler. A crack in the housing can lead to a slow, gradual loss of coolant.
