# Saab 9-3 - Tab af kølevæske | HELLA

9-3

Engine code: B284.

## Loss of coolant

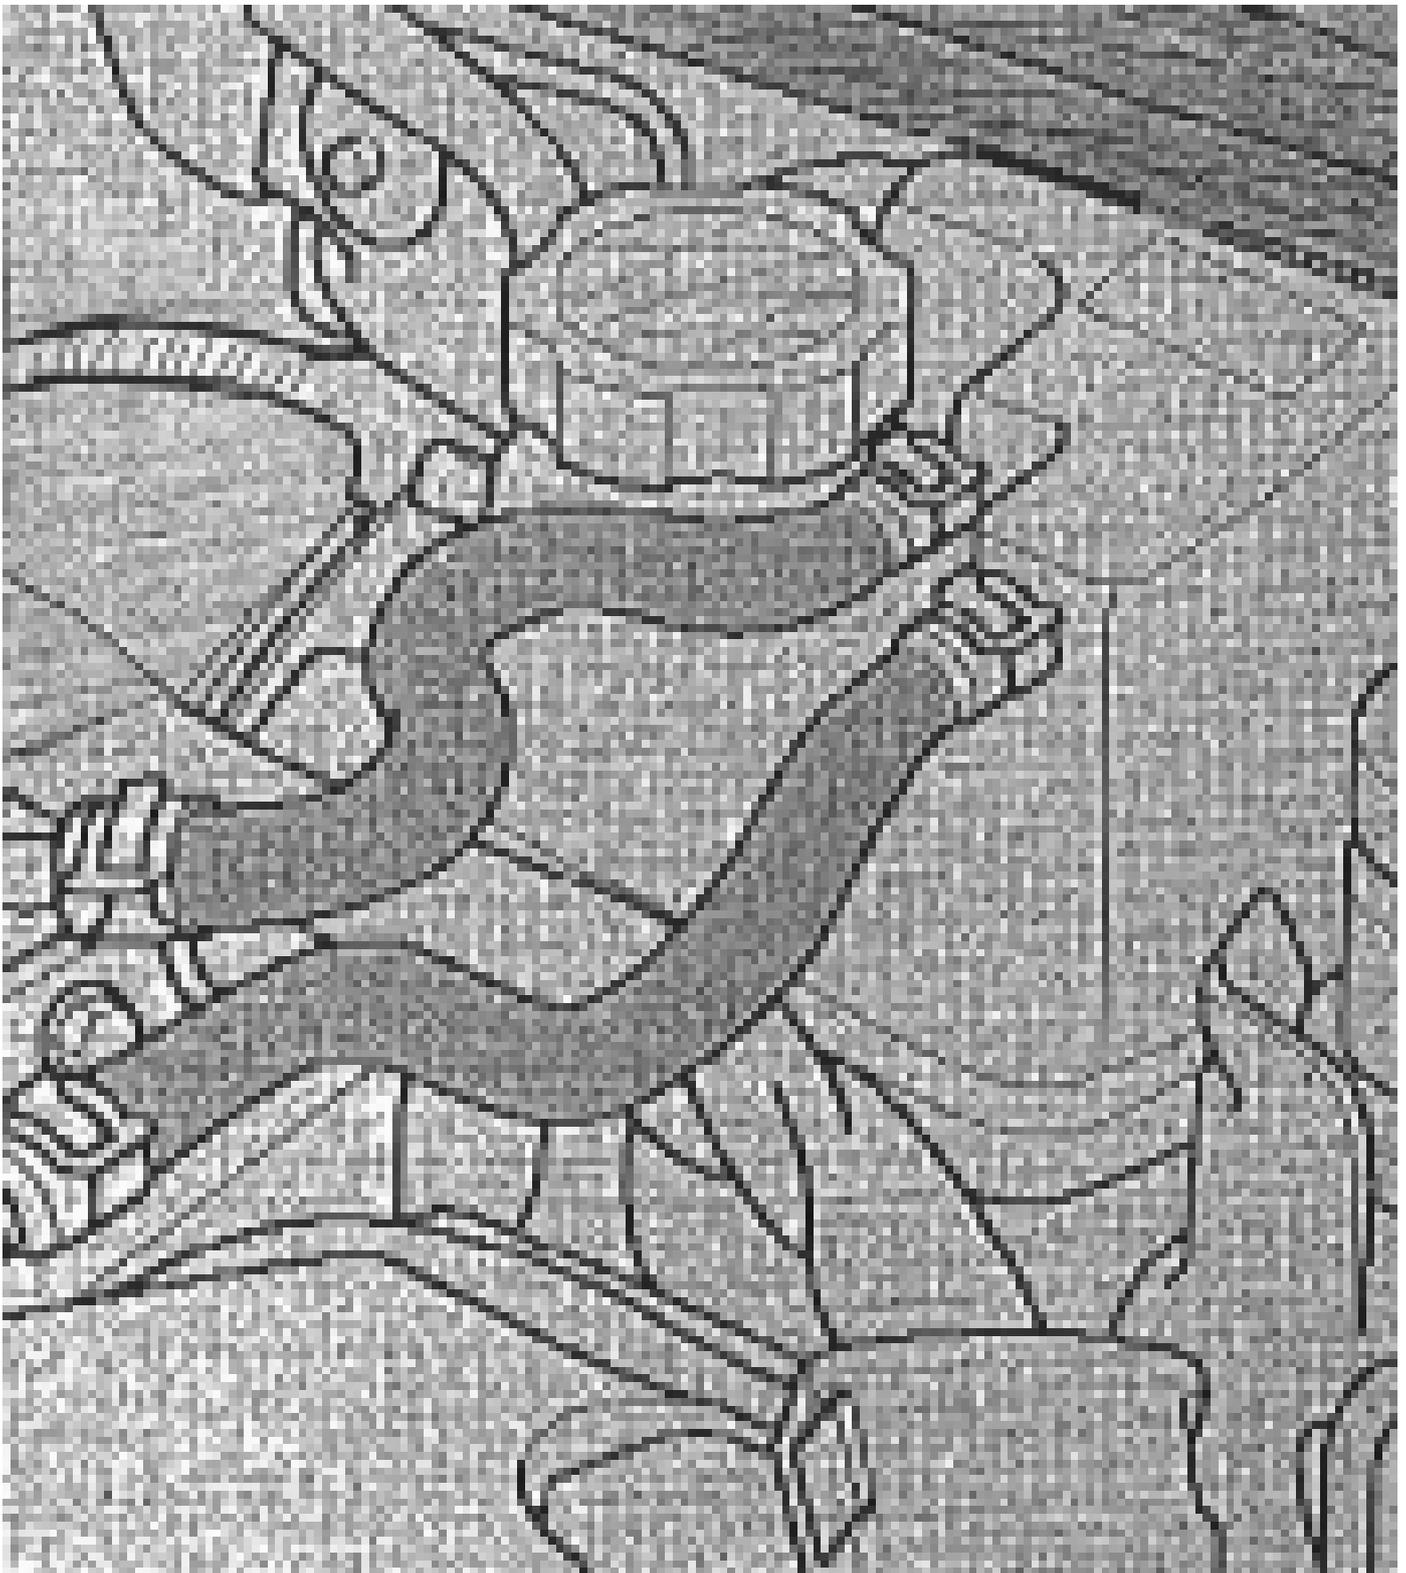
Figure 1

In the case of the above-mentioned vehicles, problems can arise because of loss of coolant. The cause of this can either be a defective coolant expansion tank or damaged engine coolant hoses on the coolant expansion tank.

(Old layout)

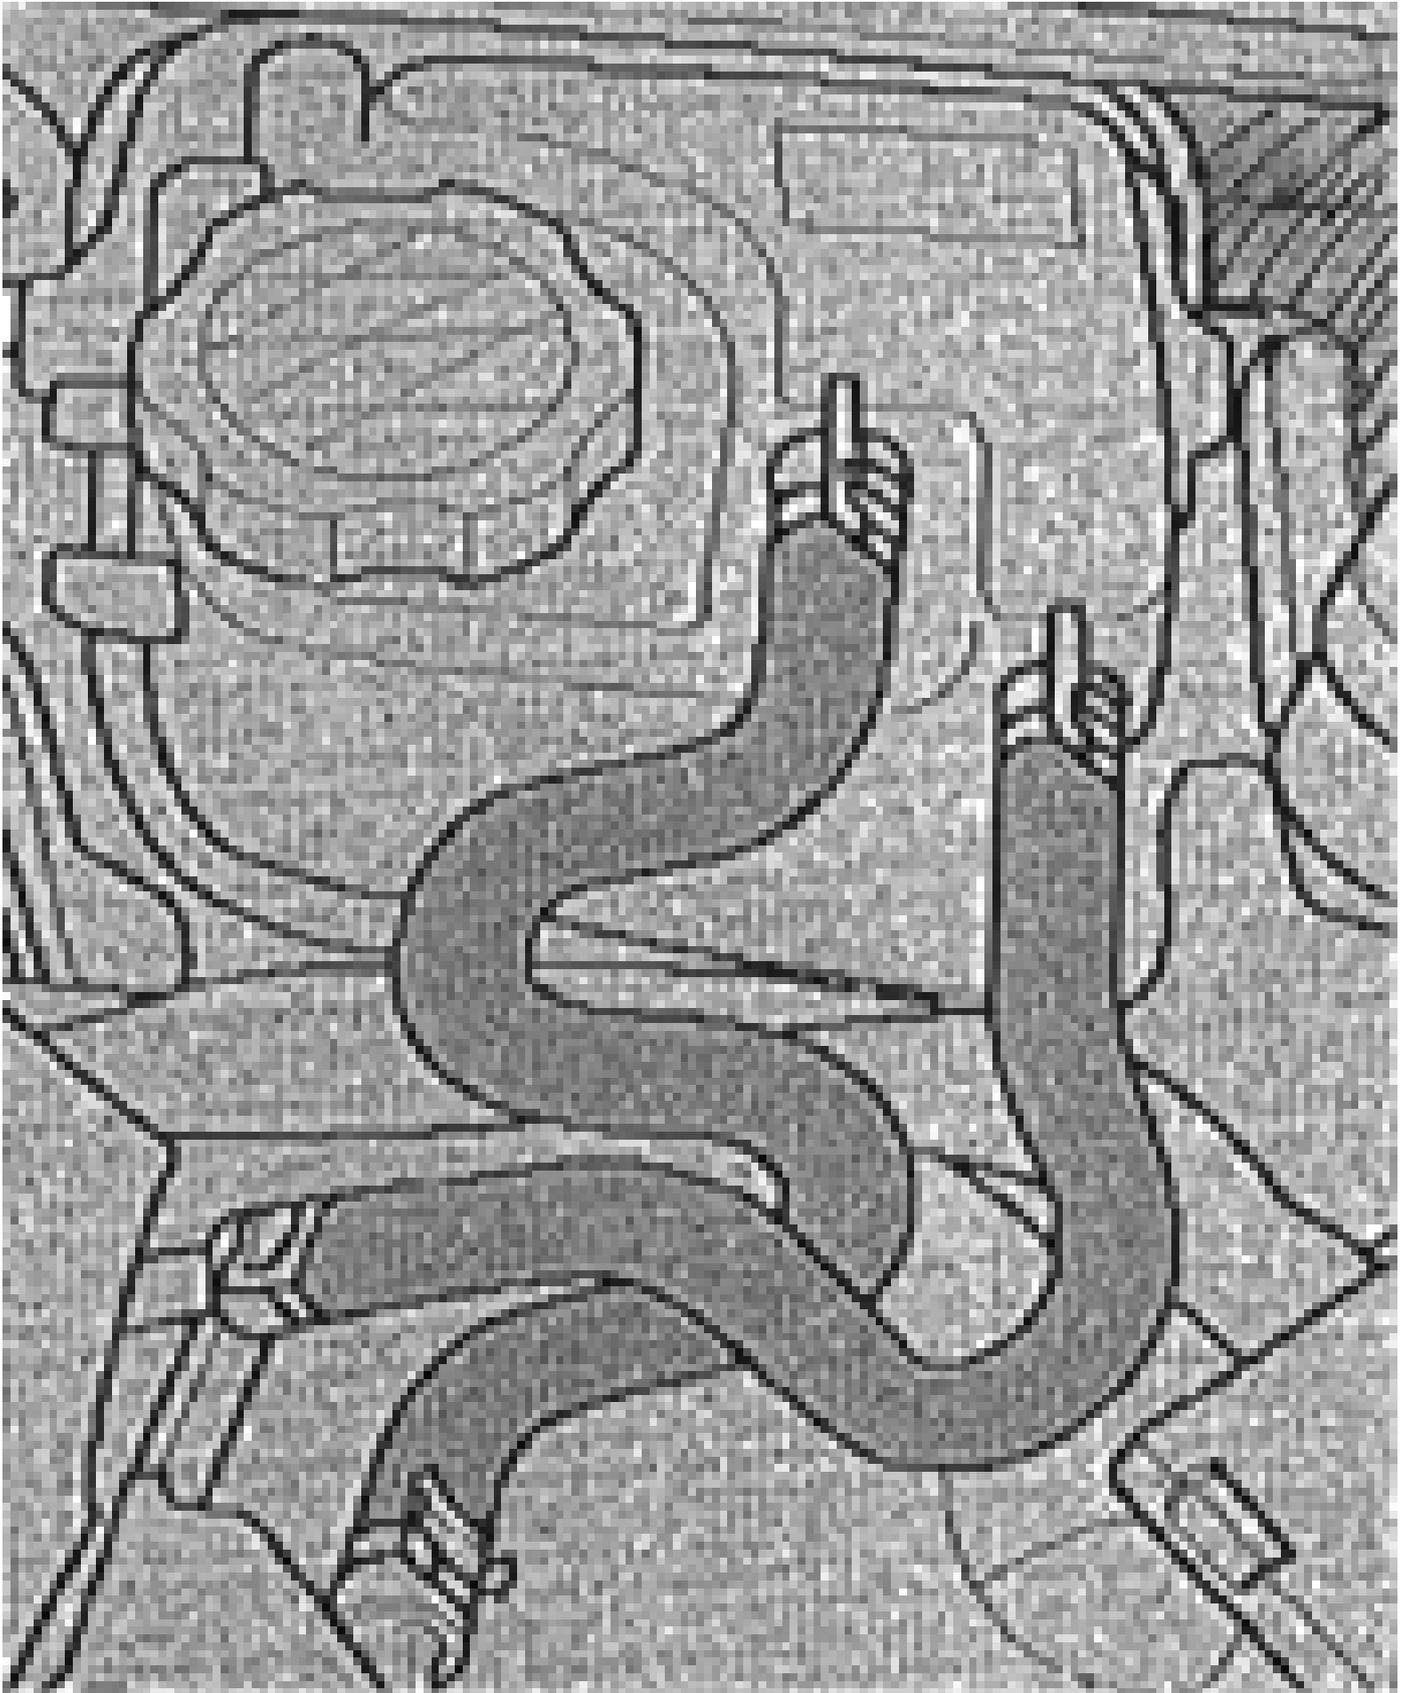
Figure 2

(Modified layout)
