VW Golf V - Startvanskeligheder | HELLA

Golf V

1.9D TDI PD

Engine code: BKC

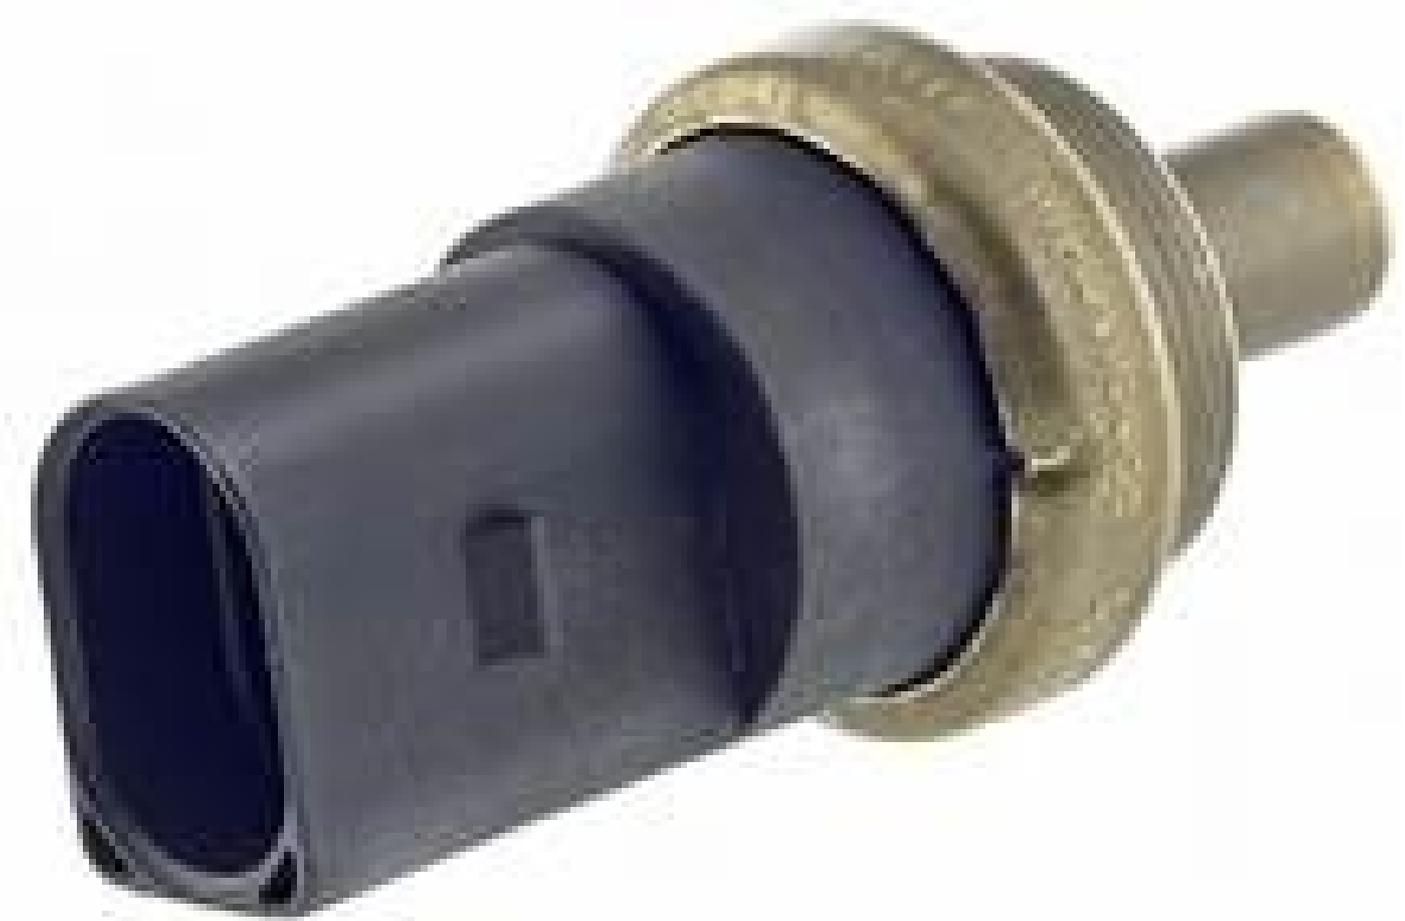
Figure 1.

Poor engine starting performance.

Engine is operating in emergency mode.

If the fault pattern listed above is reported, the cause may be a defective coolant temperature sensor. In addition, error codes (triggered by implausible sensor values) may be stored in the engine control unit.

- P1556, 'Charge pressure control negative'.

In addition, with the potentially misleading turbocharger pressure error code (P1556), excessive engine knocking while idling could be indicative of a faulty sensor.

- Disconnect wire harness multi-plug from the engine control unit and the coolant temperature sensor and perform a continuity test.
- Check the contacts on both sides for corrosion and mechanical damage and repair them if necessary.
- Check the ground connections.
- Check that coolant temperature sensor is functioning properly. As guidelines, the specified resistance value should be $\approx 2080 \Omega$ at 25°C and $\approx 289 \Omega$ at 85°C respectively.

Replace the sensor if necessary (see Figure 1.).

Hella coolant temperature sensor: 6PT009309-331

Then clear the entries present in the error memory.
