# **Mercedes-Benz A-Class - Rear combination lamp with reduced luminosity**

Model years: 2004 - 2009

## **Rear combination lamp with reduced luminosity**

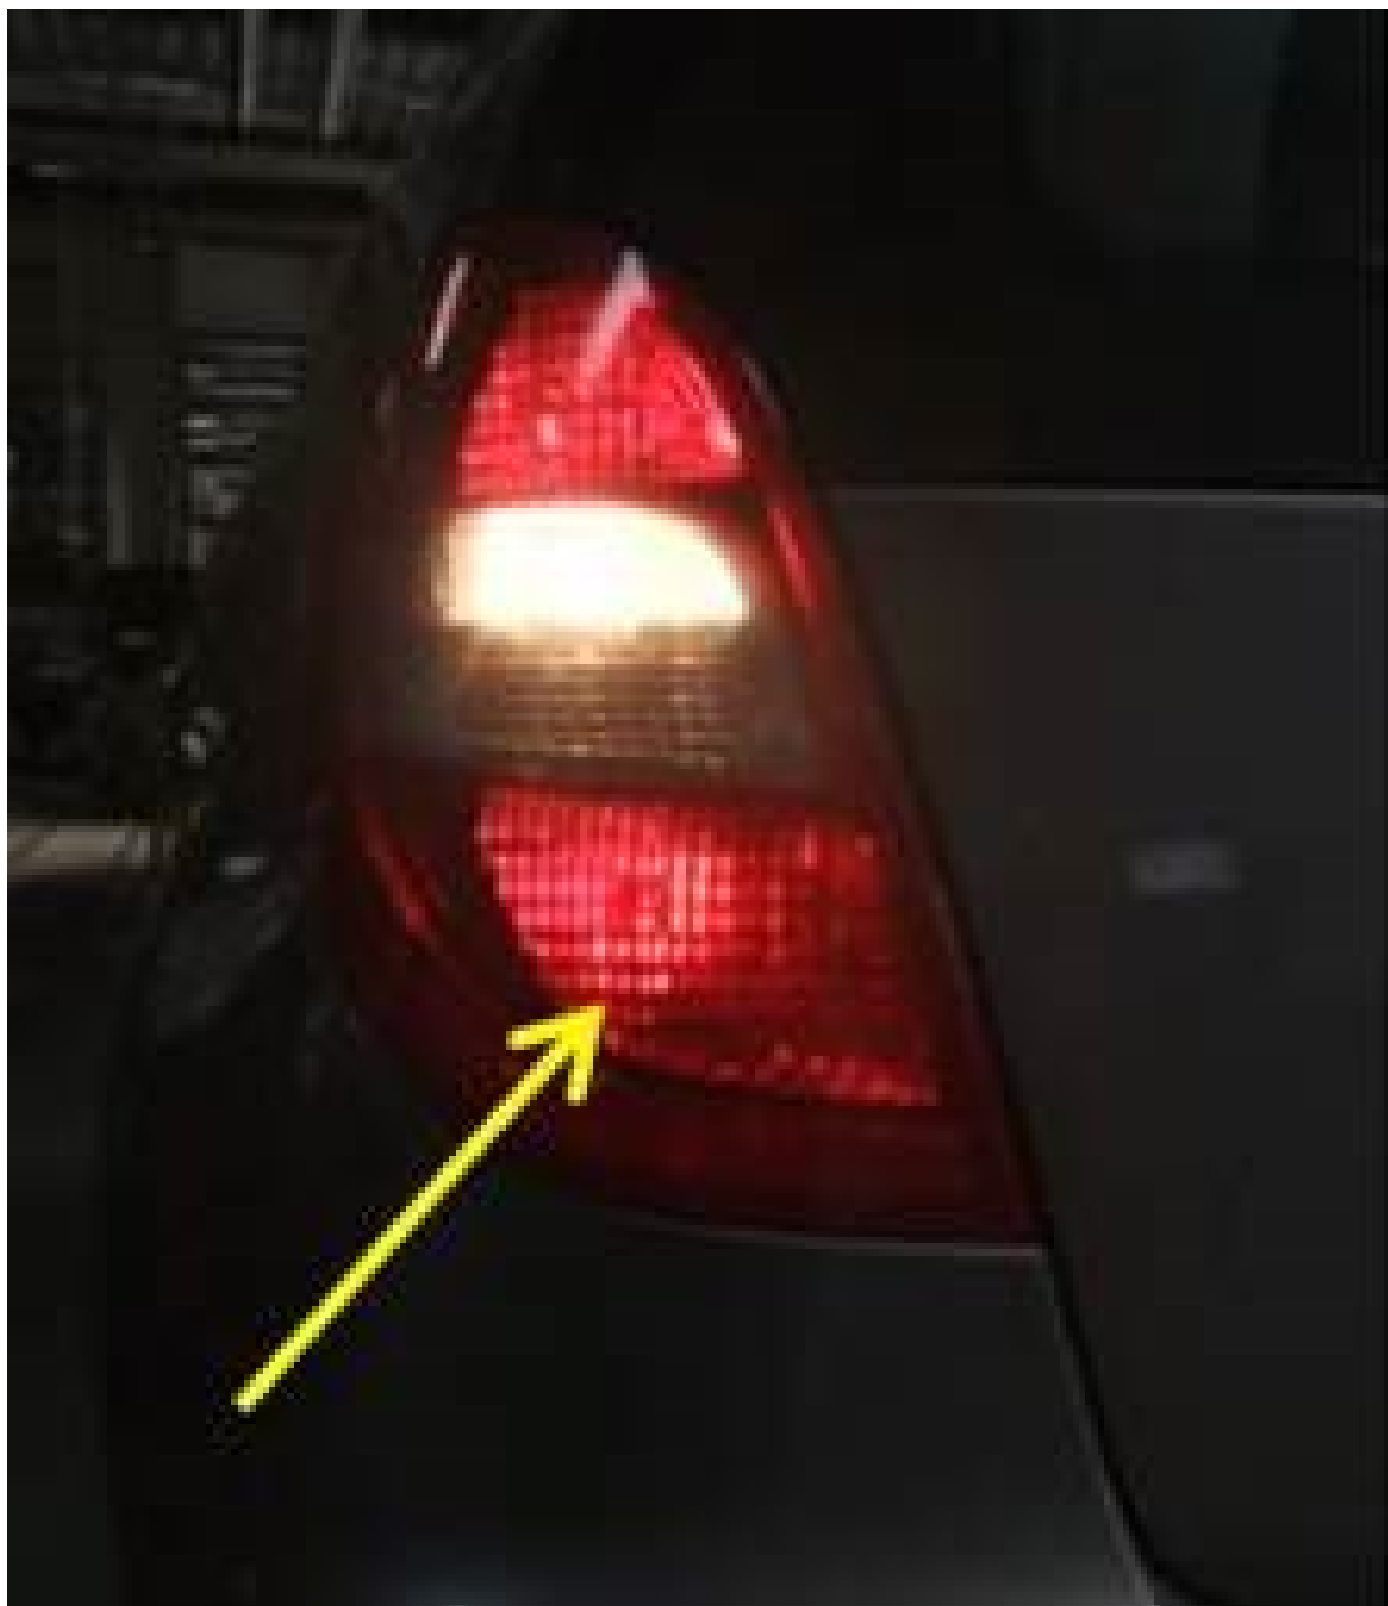
Fig.2

okay\_ after repair.

- Opening vehicle rear door.
- Unclipping left and/or right cover (C-pillar) using e.g. a long wedge.
- Opening cover of left and/or right storage compartment in trunk.
- Removing first-aid kit and electric air pump from left storage compartment in trunk (left rear combination lamp).
- Folding right storage compartment in trunk inside (right combination lamp).
- Disconnecting electric plug connection.
- Checking electric cables, plugs, contacts and the rear light for further damage,

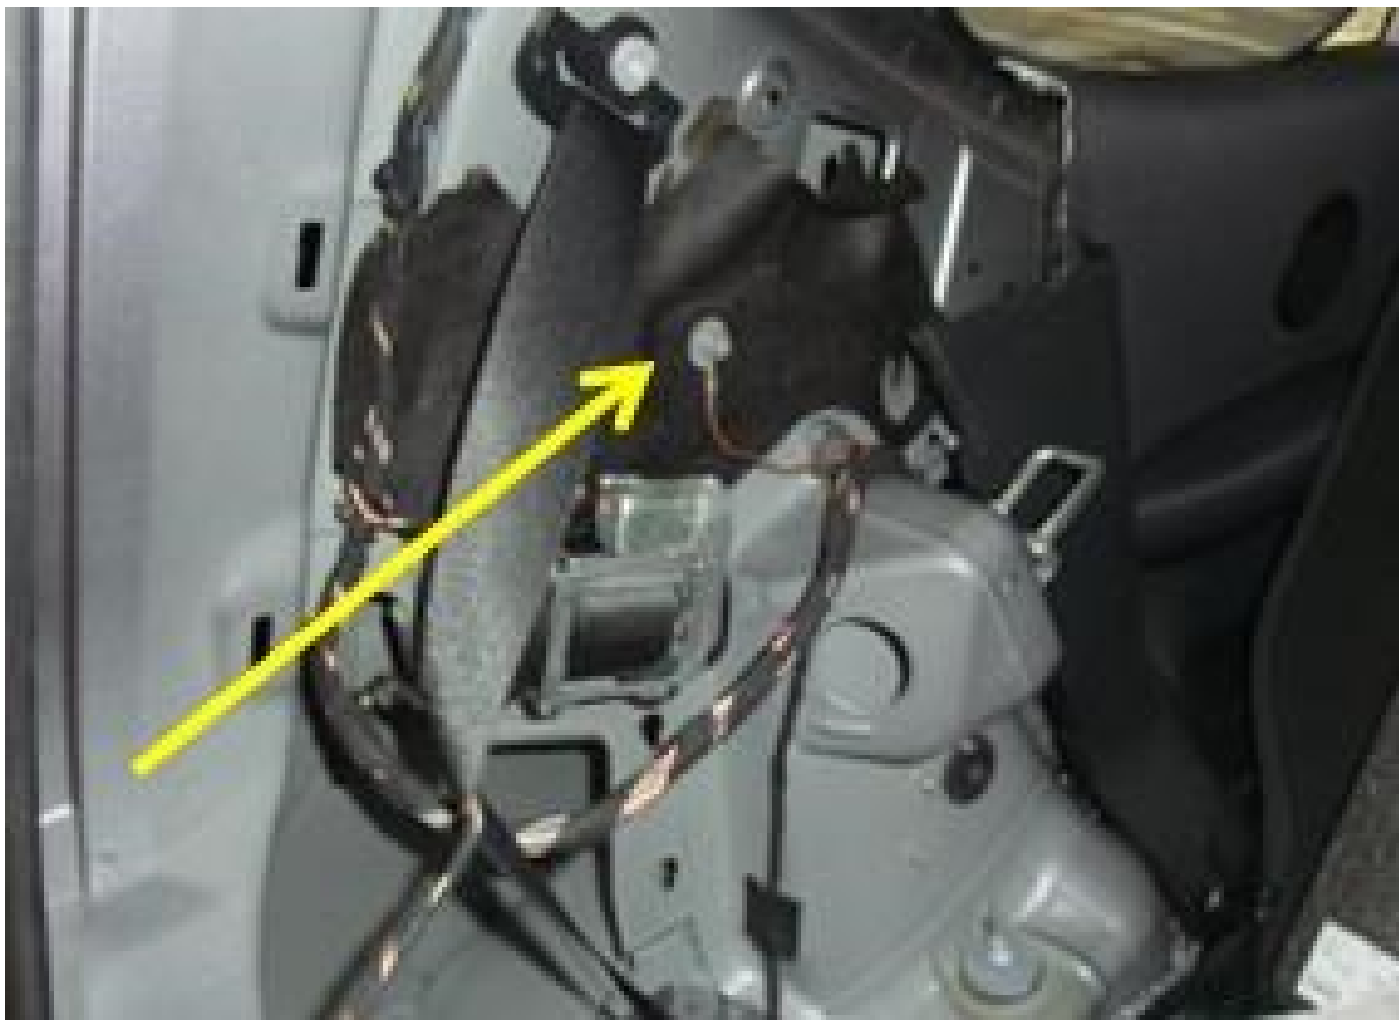
Fig.4

- Checking proper ground connection (corrosion/ transition connection) see Fig. 4.
