## Mini F56 - signal horn not functioning

| Data sheet | |
|---|---|
| Vehicle model | F56 Cooper S |

## Malfunction of the signal horn caused by faulty connecting cables in the steering wheel

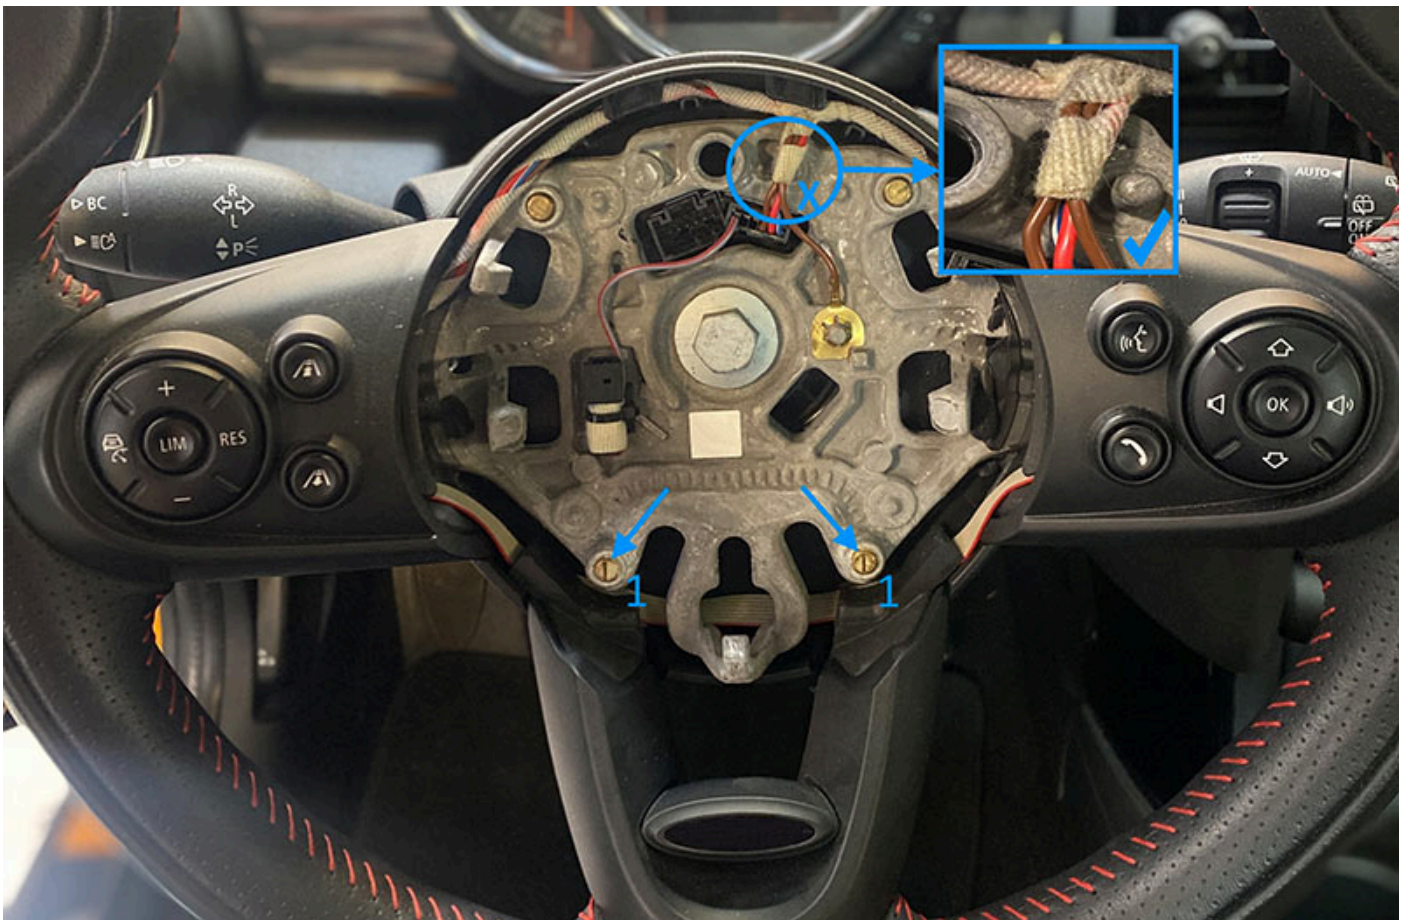
Incorrect routing of the connecting cables in the steering wheel or an unfavourable material pairing on the signal horn contacts between the steering wheel and the airbag unit may be responsible for this defect. Both problems can also occur simultaneously. An error memory entry that indicates a defect is not stored.

If the connecting cable is not laid correctly (see illustration), this has to be rectified. If the cable is visibly damaged, it must be replaced. If contamination is detected on the contact surfaces, a steering wheel with optimised contacts must be installed in accordance with the manufacturer's specifications. The problem has been identified by the vehicle manufacturer and rectified by means of a service solution using modified components.
