# Mini F56 - water ingress in the vehicle interior

Data sheet	
Manufacturer	Mini
Vehicle model	F56
Engine	2.0i
Engine code	B48
Year of manufacture	2014
Symptoms	Water ingress in the footwell

## Moisture in the vehicle interior caused by condensation draining from the air-conditioning system

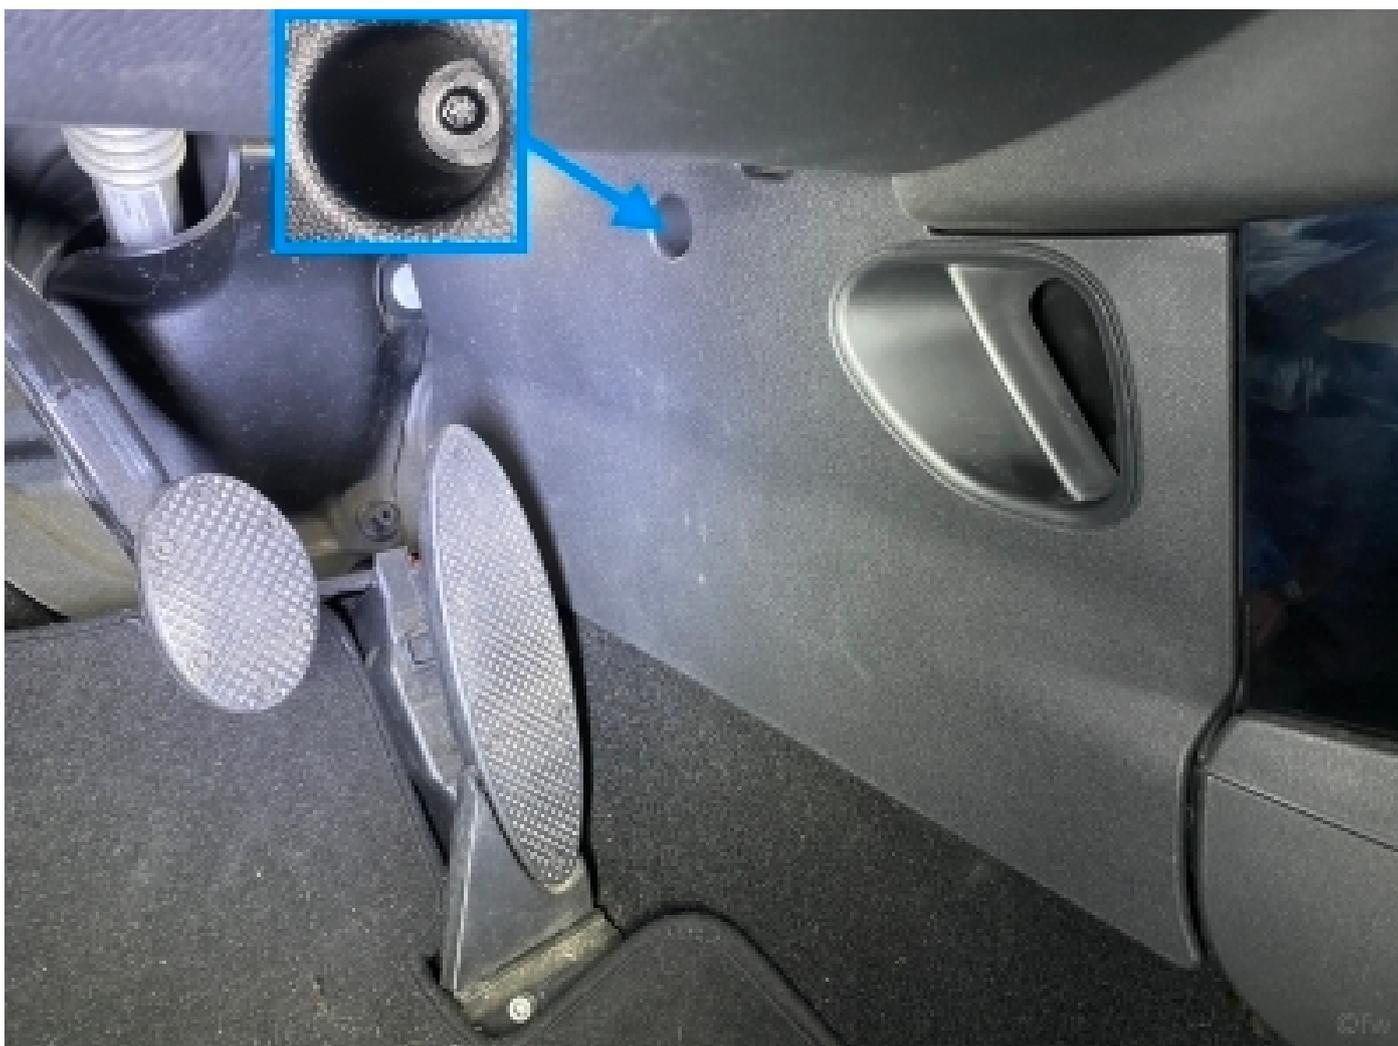
The side panelling (Fig. 1) in the footwell must be removed to carry out the necessary checks. In order to do this, the fastening screw has to be undone and the panelling removed from the brackets. The carpet can be pressed down slightly on the side underneath the air-conditioning unit in order to check it. The rubber seal of the water drain must fit all the way round the air-conditioning unit (Fig. 2) and have no kinks in it.

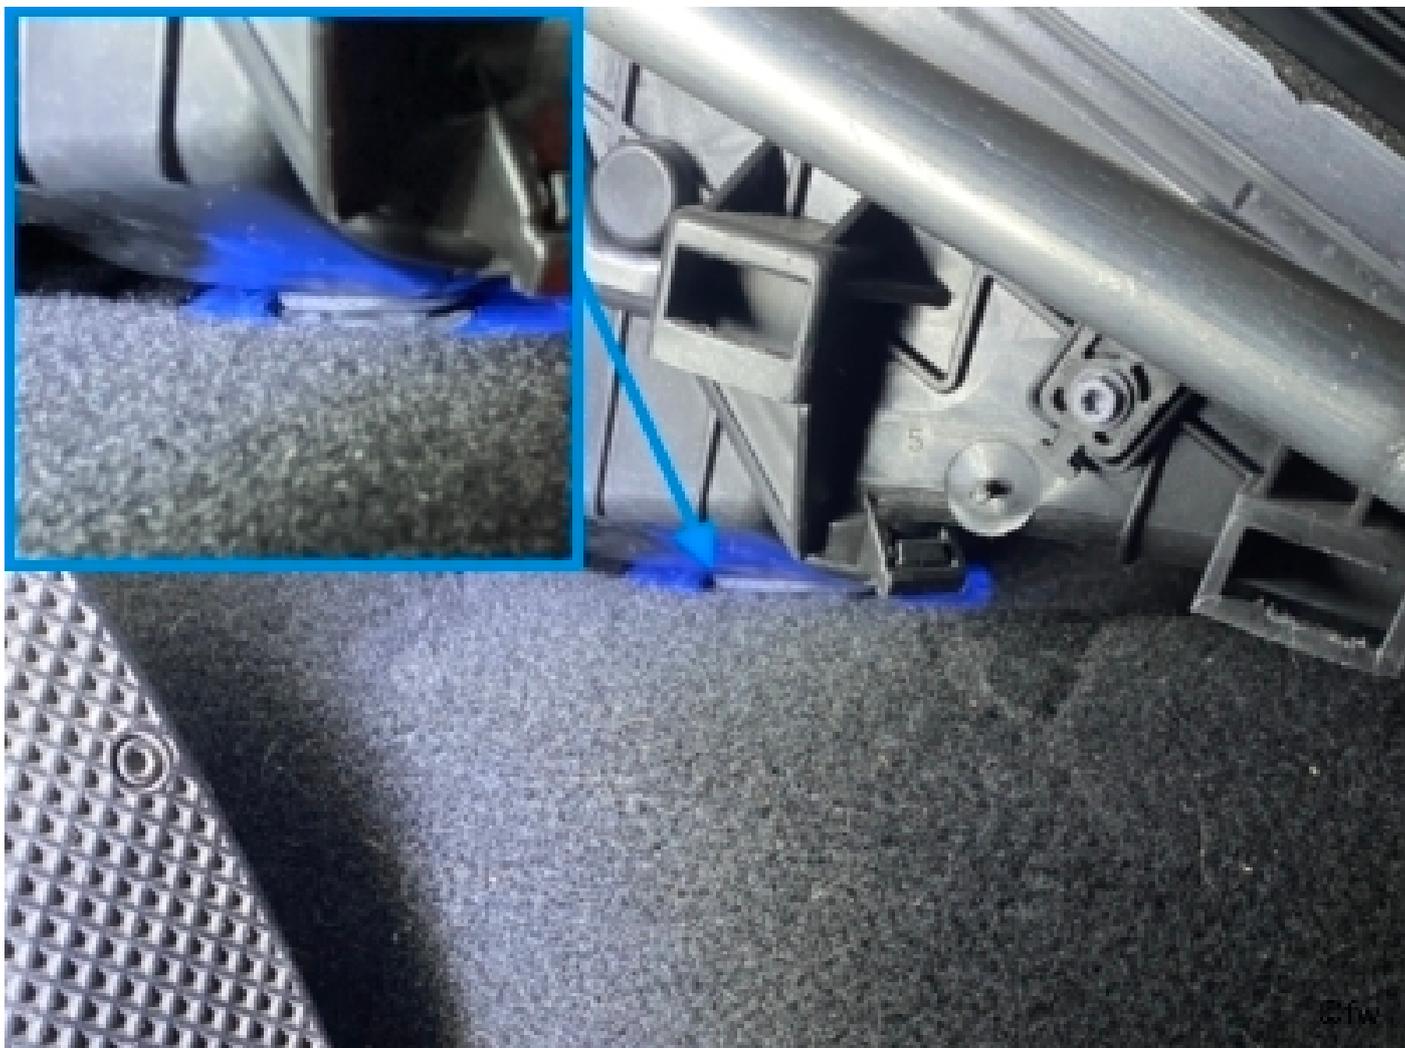
Deformation of the rubber seal means that condensation can no longer drain off properly. The water collects and is not drained off as intended, but enters the vehicle interior as a result of the deformed seal. The interior carpet absorbs the water, which can lead to unpleasant odours and, under certain circumstances, mould growth.

An endoscope is recommended for easier inspection. In the event of a fault, traces of water are usually visible on the side of the drain, indicating that the seal does not fit properly.

One test option is to set the air-conditioning system at maximum cooling capacity. In warm ambient temperatures, this causes condensation. In the event of a fault, this condensation would then run visibly past the seal and into the vehicle interior. If kinks or traces of water are visible, the condensation drain must be replaced. If mould is visible on the interior carpet, this should also be replaced.
