# **Nissan X-Trail (T31) - Leak from the fuel level sensor | HELLA**

**X-Trail (T31)**

**Engine: 2.5 i 16V**

## **Leak from the fuel level sensor**

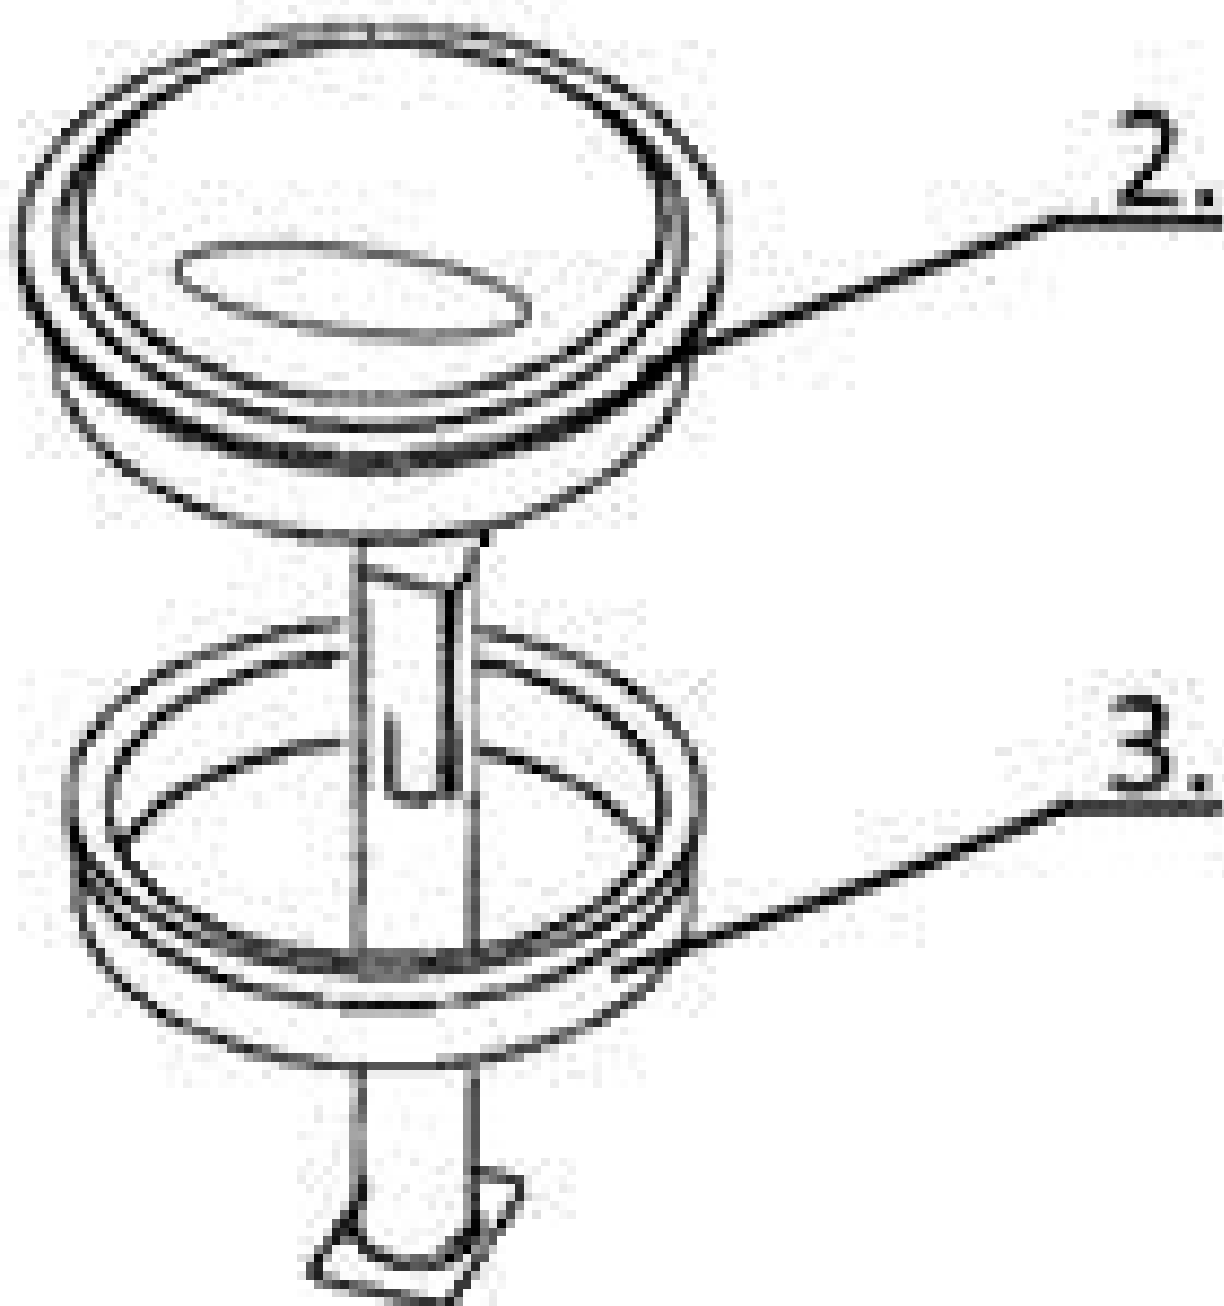
In most cases, the problem mentioned above only occurs when the tank is full.

The cause in such a case is inadequate sealing of the gas tank sensor because of a faulty seal.

Replace the defective gasket (Diagram - position 3) with a new one in accordance with the vehicle manufacturer's specifications.

Access to the mounting opening of the fuel level sensor unit is located below the rear seating area.

- Gasket 1734279900 (Diagram - position 3)

- Circlip 17343JG00A (Diagram - position 1)

- Fuel level sensor unit 25060JG00A (Diagram - position 2)
