Opel Astra K - Noises in the area of the C-pillar | HELLA

Astra K

Model year: 2015-2018

Noises in the area of the C-pillar

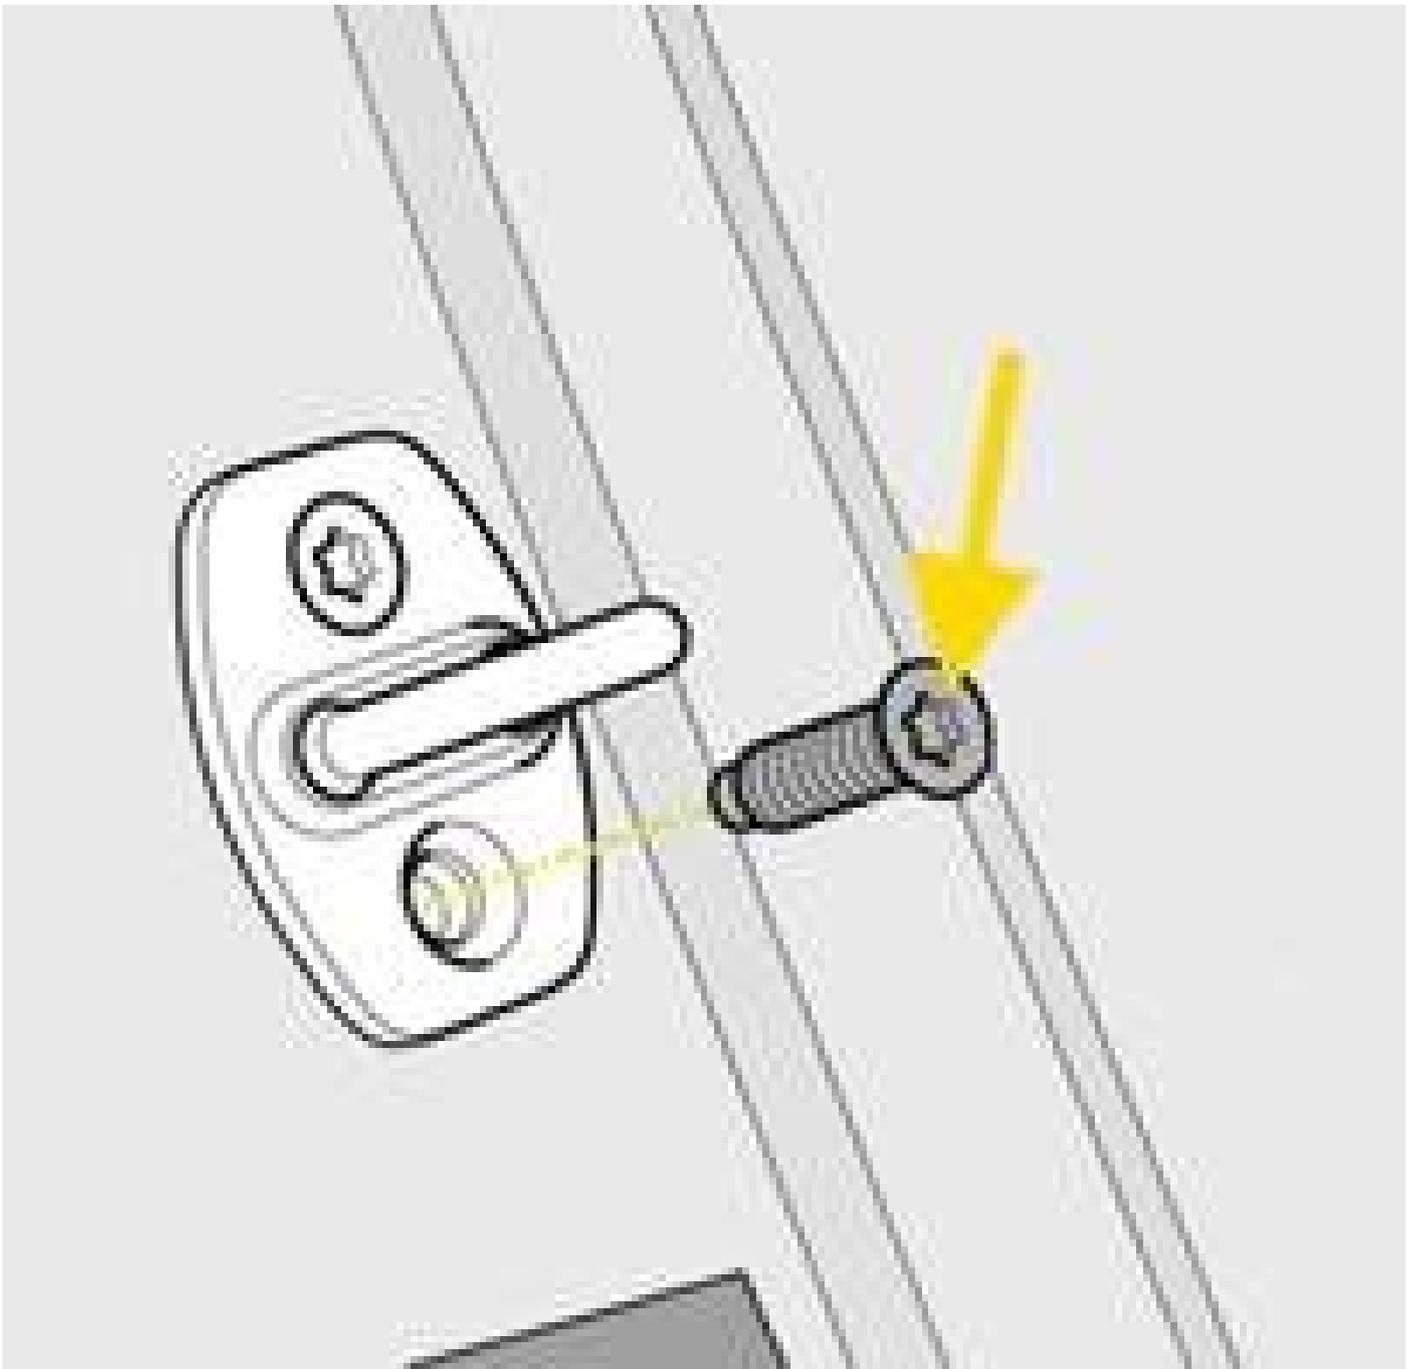
Figure 1

When checking the door lock mechanism, it emerges that the lower fixing screw (figure 1) of the door locking plate has been made too long. This results in contact between the screw tip and the inner sheet metal of the right C-pillar (can also affect the left C-pillar).

- Disassemble the fixing screw (figure 1)
- Shorten the screw by approx. 1.5 mm at the screw tip (figure 2)
- Install the fixing screw and tighten to the torque specified by the vehicle manufacturer
- Repeat this measure on the left side if necessary (locking plate of the left C-pillar)
