Opel Insignia - malfunctioning of hatchback

Data sheet

Manufacturer	Opel/Opel
Vehicle model	Insignia A
Engine	2.0 CDTI
Year of manufacture	2014 to 2017
Symptoms	Malfunctioning of hatchback lift
Recommended HGS tool	megamacsX

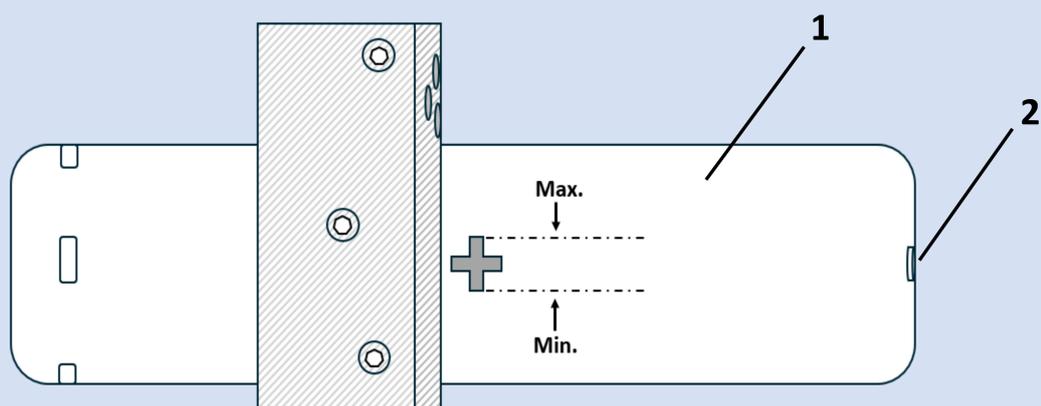
The hydraulic pump is installed behind the side panel on the right in the luggage compartment. In order to carry out the oil level adjustment correctly, the pump must be removed from the vehicle in accordance with the manufacturer's instructions and placed horizontally to the "+" sign on the expansion tank (1) on a straight, clean surface. Leave the pump rest in this position for one minute. The oil level should be at the maximum mark after the specified waiting time. If this is not the case, the fill level must be corrected.

To do this, turn the pump unit with the filler screw (2) upwards and loosen the screw. Fill with the hydraulic oil approved by the manufacturer up to the specified maximum fill level mark. Make sure that no dirt gets into the container during the filling process. Screw the locking screw back into place and reinstall the pump first without the casing to carry out the functional test. By activating the hatchback several times, the system will be refilled with oil.

Finally check the oil level in the expansion tank once again. If necessary, top up the oil again and once more set the hatchback in motion several times. The hatchback should open and close smoothly again after the completion of these measures. Once the oil level has been adjusted, visually check the hydraulic cables, connections and also the hydraulic damper for any sign of oil loss. If any abnormalities are visible here, the defective components must be replaced.
