# Opel Astra K - power steering failure

| Vehicle model | Astra K |
| Engine | 1.4 16V Turbo (B14XFT) |
| Year of manufacture | 2019 |

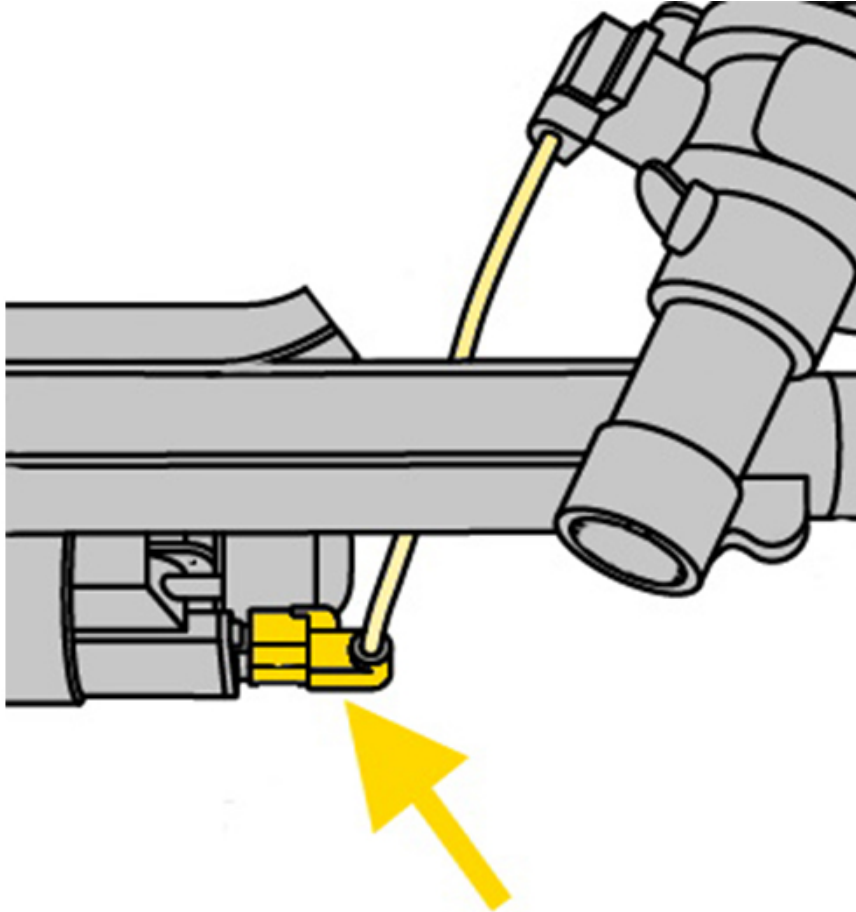
The following problem is observed in the vehicles mentioned above: Vehicle steering sluggish.

The reason for this is an insufficient plug connection between the steering angle sensor and the wiring harness (see figure).

First disconnect the plug connection and check for dirt and damage; if necessary, clean and repair it according to the manufacturer's instructions. Then reconnect the connectors, making sure that the plug connection is correctly seated.

Subsequently run a fault code query and go for a test drive to check the measure.
