## Peugeot 307cc- engine cuts out

| Manufacturer | Peugeot |
| Vehicle model | 307cc |
| Engine | 2.0 16 V |

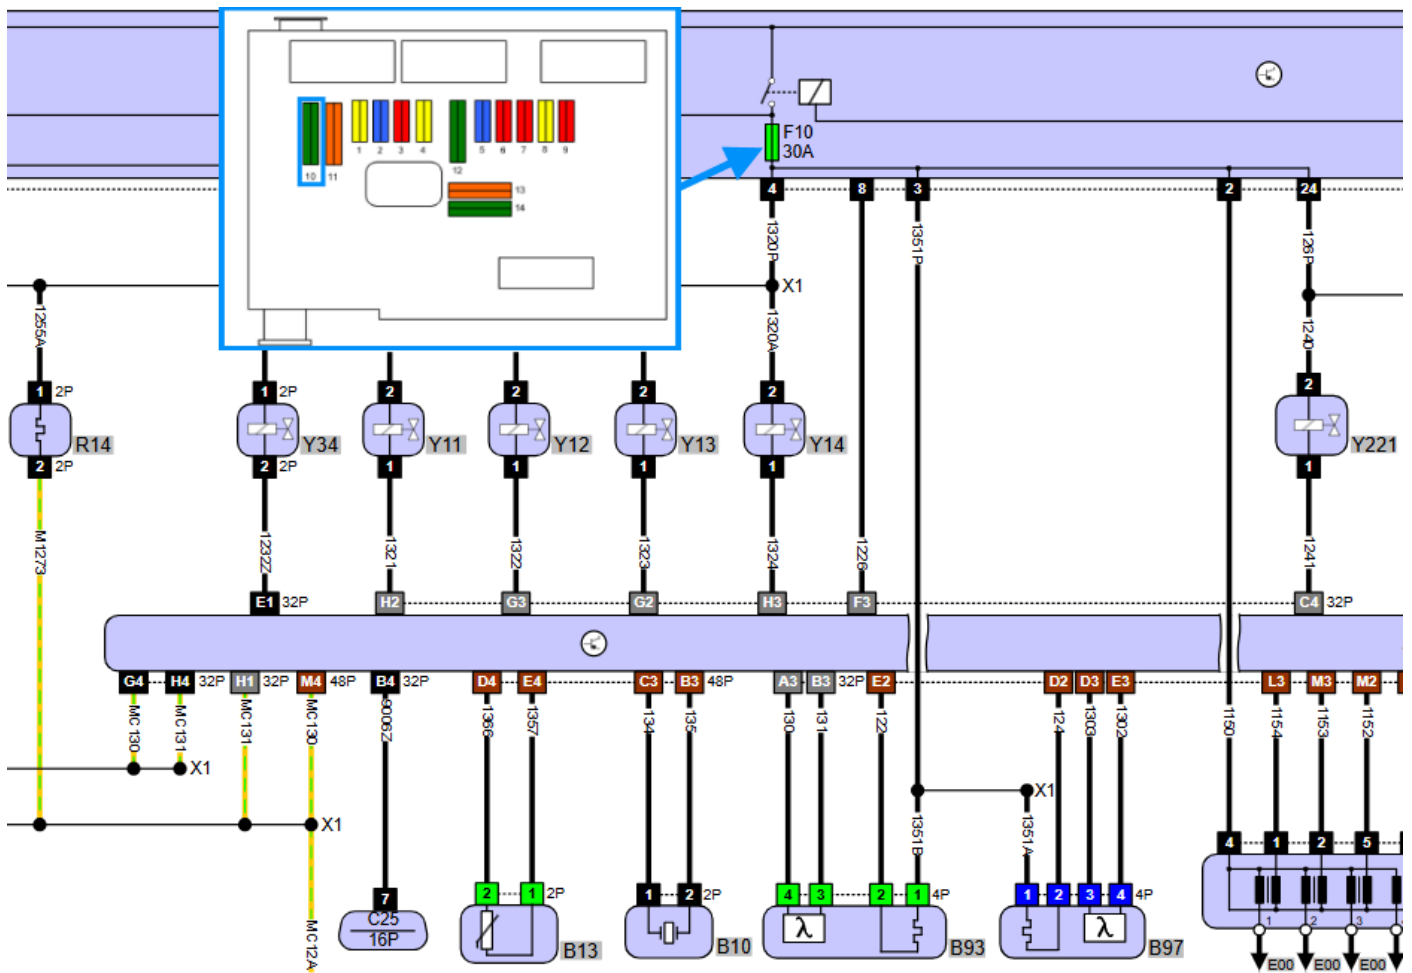
The fuses should be carefully checked as the first troubleshooting step. Pay particular attention to fuse F10 (30A) in the fuse and relay box in the engine compartment. The fuse must be removed and visually inspected for defects. If there are no obvious defects on the fusible wire, a continuity test can be carried out with a suitable measuring device for a more precise check. If the fuse is visually defective or measurements are out-of-spec, a possible cause may be a defective heating element on one of the two lambda sensors.

The fuse F10 (30A) not only protects the power supply to the lambda sensor heating elements, but also other components such as the crankcase ventilation heater or the ignition coils. This means that other components as well as the heating elements may also be a cause of the faults. It is therefore recommended to use the circuit diagram that matches the vehicle and the system so as to achieve precise troubleshooting.

In order to check whether the lambda sensors are responsible for tripping the fuse, a circuit breaker with 30 A can be temporarily inserted in the slot of fuse F10 for troubleshooting purposes. This circuit breaker trips in the event of a short circuit and can then be switched on again. After inserting the circuit breaker, the plug connections of the sensors are disconnected one after the other. Each time the plug connection is disconnected, the engine has to be started and, if necessary, a test drive carried out to check whether the short circuit is still present. If the circuit breaker no longer trips, the fault is in the previously disconnected component.

Once the cause of the fault has been rectified, delete the error memory and then carry out a test drive.
