Tesla Y - water ingress in interior fan

Data sheet

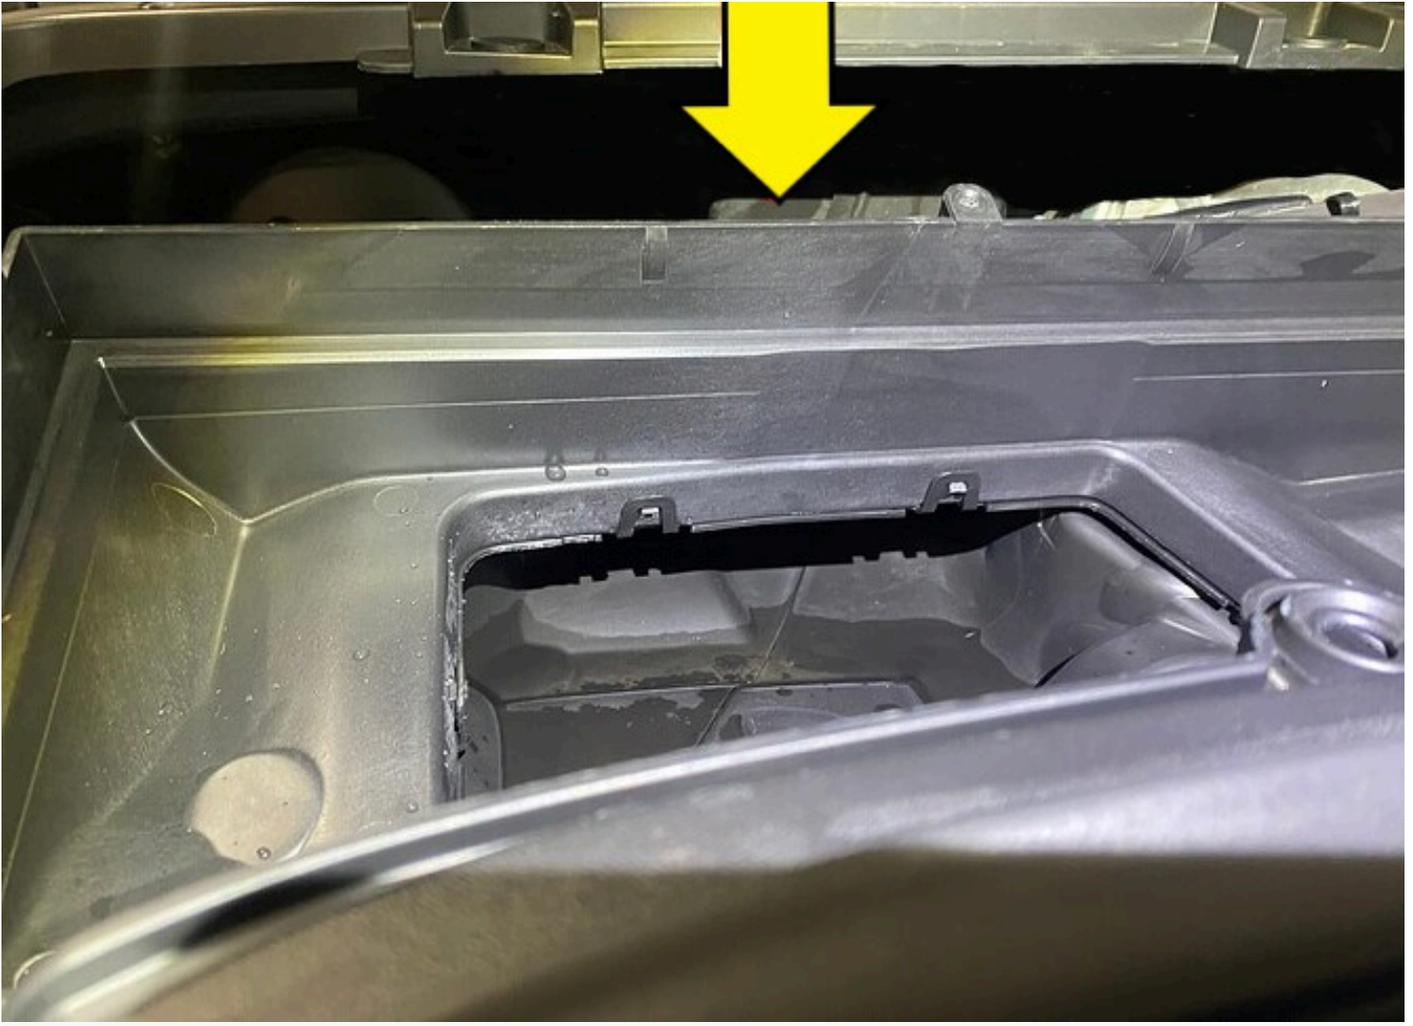
In the above-mentioned vehicle, water can enter the passenger footwell as a result of faulty sealing on the cabin air filter box. This is particularly noticeable during rapid acceleration. Car carpet and floor mats can then become quite wet. Water can also get into the interior fan, which leads to loud, squeaky noises being emitted from the fan.

In order to confirm the cause, the cabin air filters should be removed. These can be reached from the engine compartment (underneath the water box cover). A seal should be visible above the vent box. If it is only loosely attached or shows no real contact pressure, water will enter the vehicle interior via the ventilation housing and the ventilation shafts when it rains.

Sealing the ventilation box of the cabin air filter

Remedy or repair measures are to be carried out in accordance with the vehicle manufacturer's instructions.
