# Volkswagen Up/Seat Mii - engine start impaired: Error code 4629

## Data sheet

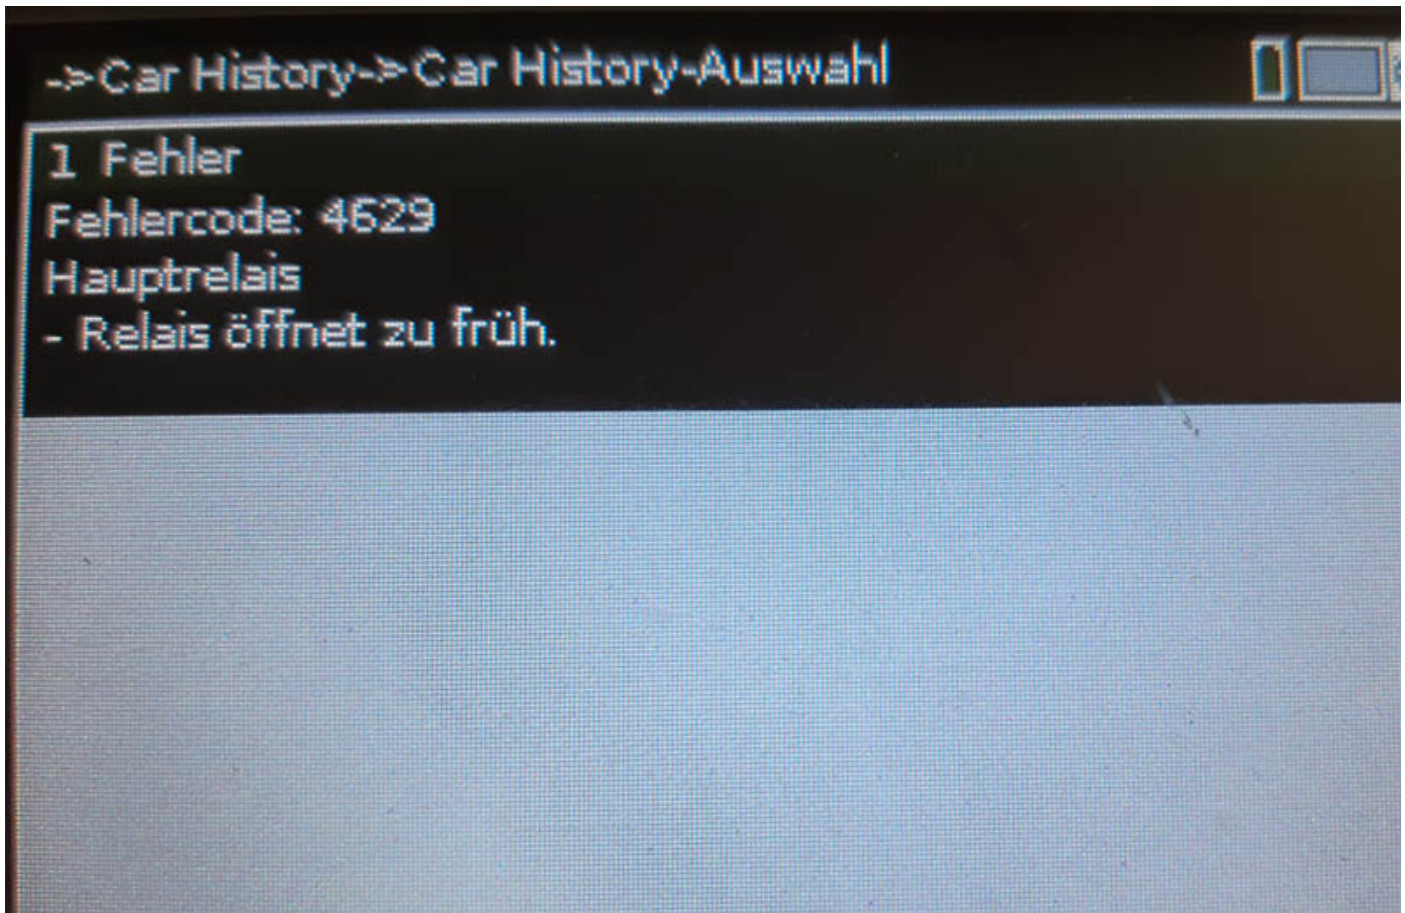
The first step is reading out the error memory. Error code 4629 (main relay opens too early) may be stored. ([Fig. 1](#)) This leads to the assumption that a relay is faulty. The relays can be reached relatively easily after removing the left cover on the dashboard. ([Fig. 2](#)) The position of the main relay(s) should be identified using a relay plan ([Fig. 3](#)). One of the relays controls the fuel pump. If the relay is defective, this would explain why the engine does not start.

Error code 4629
