VW T6 - fuel loss

Data sheet

Manufacturer	Volkswagen
Vehicle model	Transporter T6
Engine	2.0 TDI
Symptoms	Fuel loss

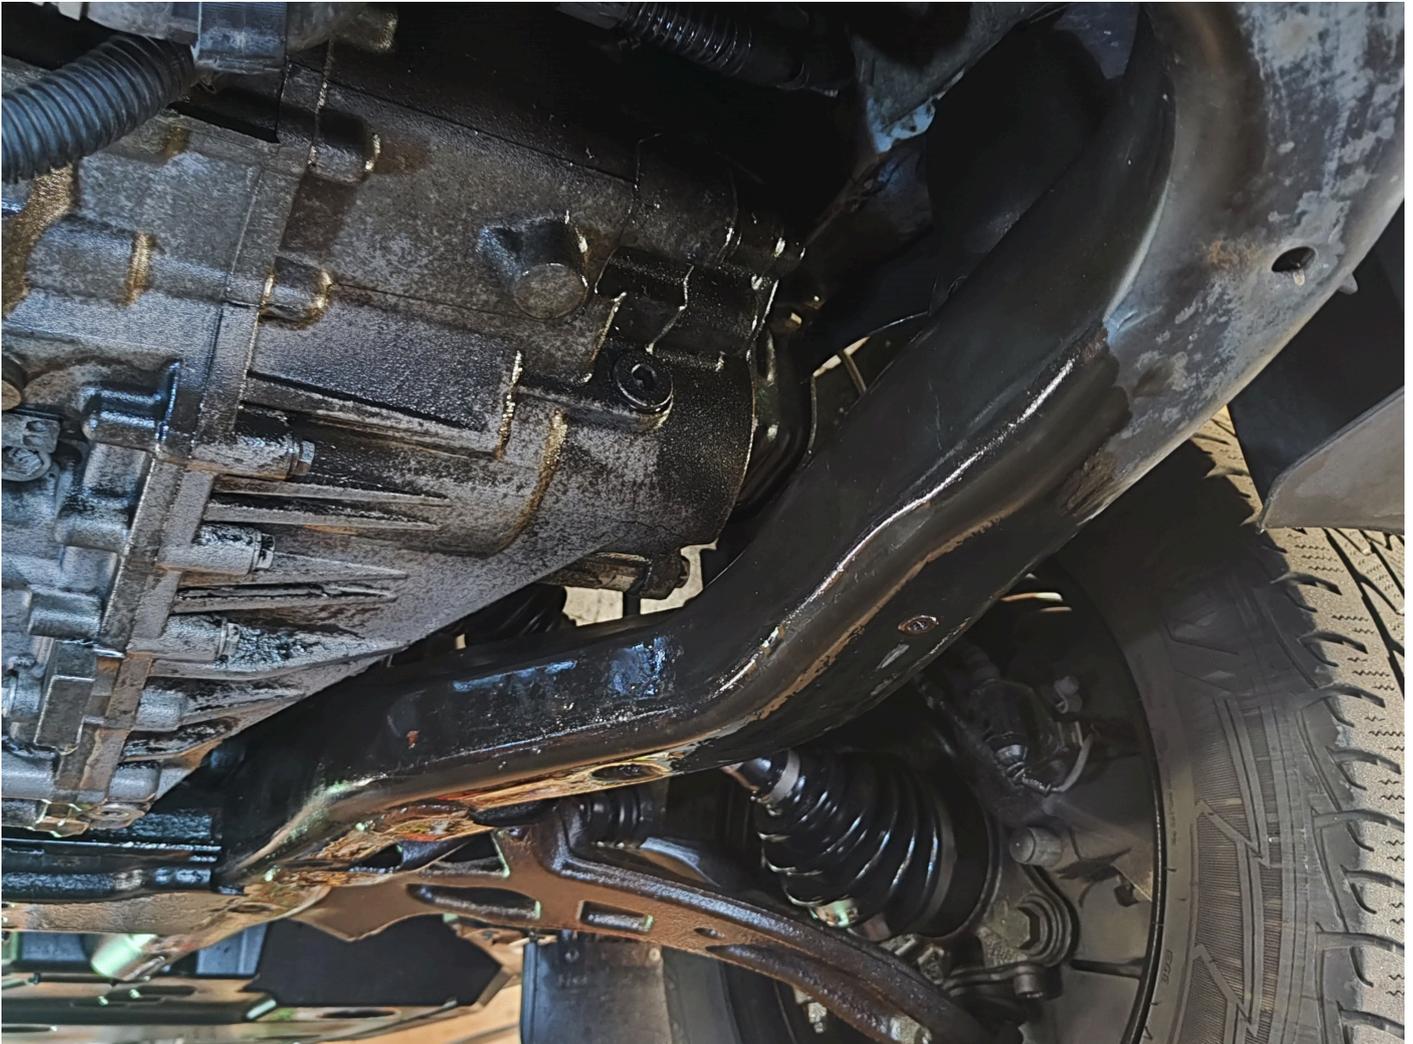
Fuel loss T6

On the vehicle mentioned above, it can happen that a strong smell of diesel suddenly becomes very noticeable. Leaking fuel may also have accumulated in the engine compartment or under the vehicle. The cause of this is not always immediately recognisable. Firstly, the fuel lines and their connections in the engine compartment should be checked. If no leak is found, the fuel filter housing may be the cause of the diesel loss.

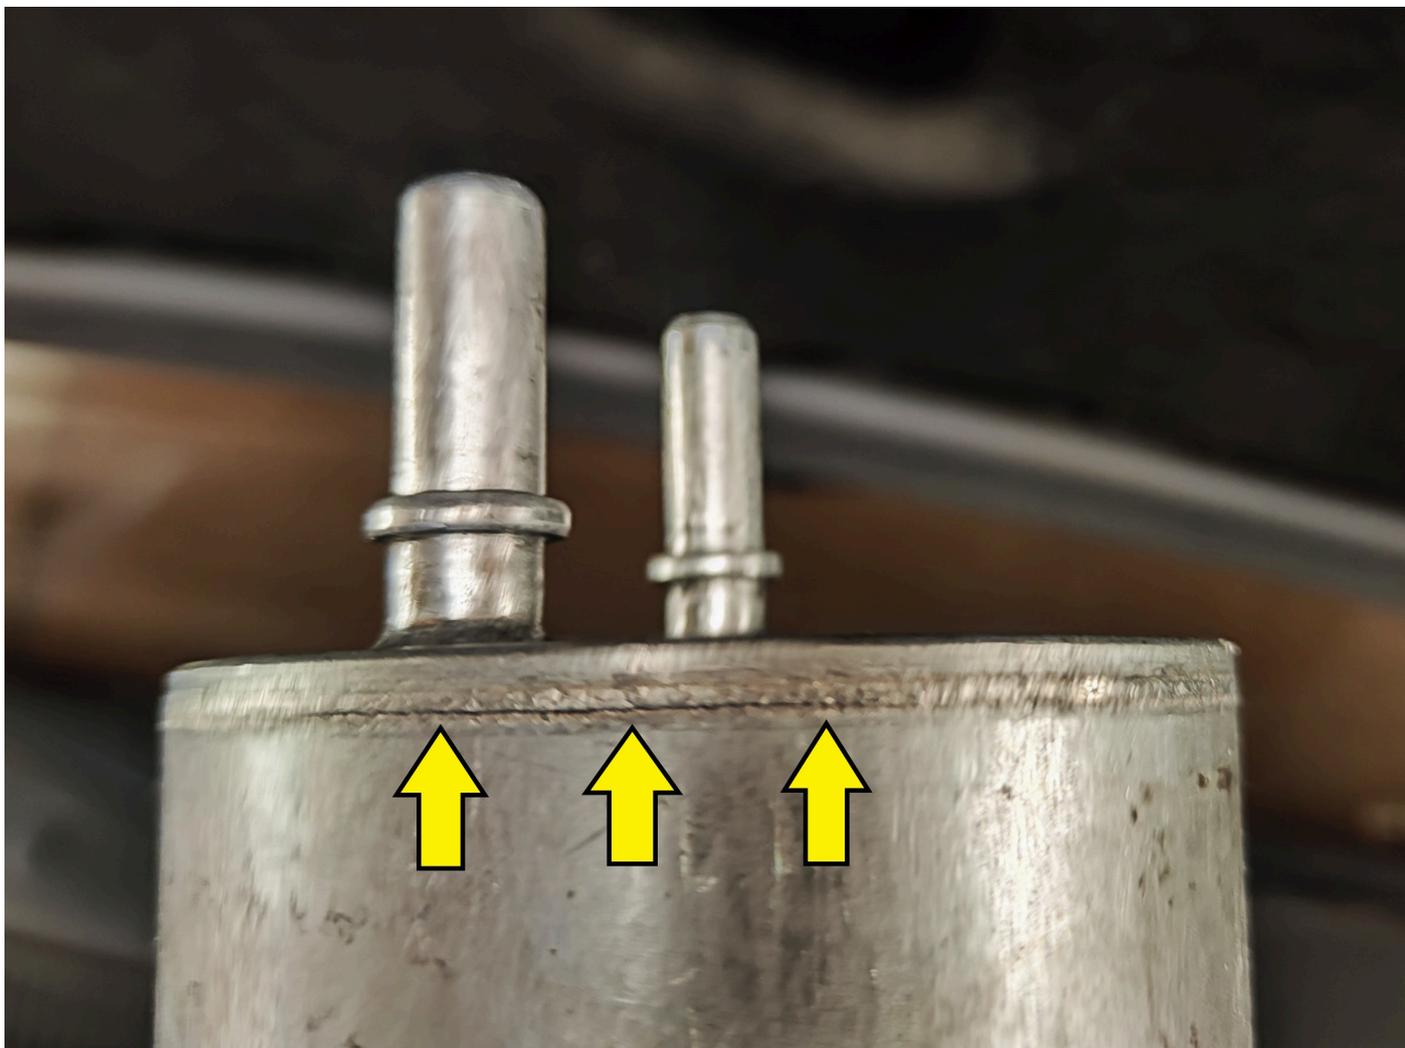
Fuel filter T6

If you now take a look at the upper area of the filter, in some cases a horizontal hairline crack can be seen, which is responsible for the leak.

In order to remedy the situation, the filter should be replaced and the fuel system bled in accordance with the vehicle manufacturer's instructions. We recommend cleaning the engine compartment as a final step of the repair.
