# VW Transporter T6 - coolant loss

## Data sheet

| Vehicle model | Transporter T6 |
| Engine | 2.0 TDI |

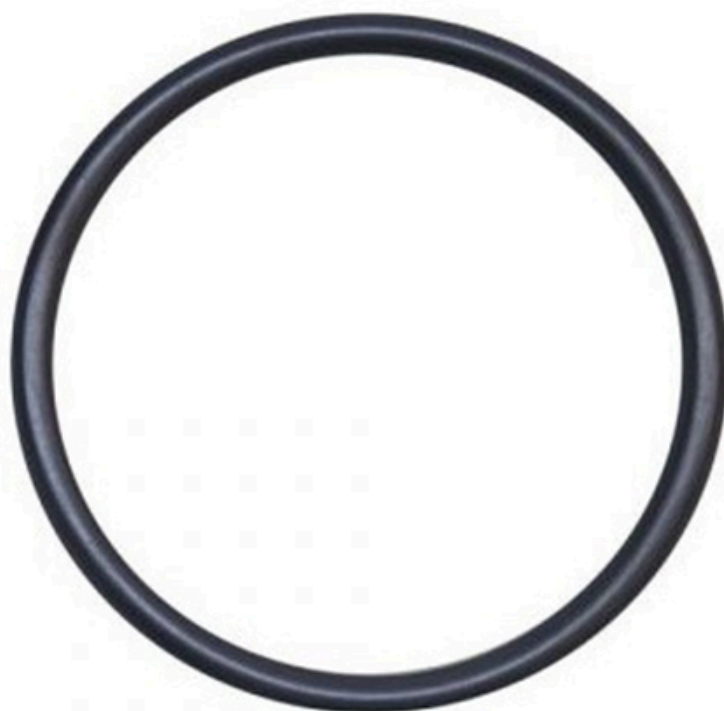
When identifying the leak, pay special attention to the thermostat housing. Coolant loss here may be caused by a faulty O-ring. When replacing the O-ring, make sure that the contact surfaces on the thermostat housing and engine block are sufficiently cleaned.

Simultaneously also replace the thermostat when replacing the O-ring (06B1211119B)
