Mini F56 - L'avertisseur sonore ne fonctionne pas

Malfunction of the signal horn caused by faulty connecting cables in the steering wheel

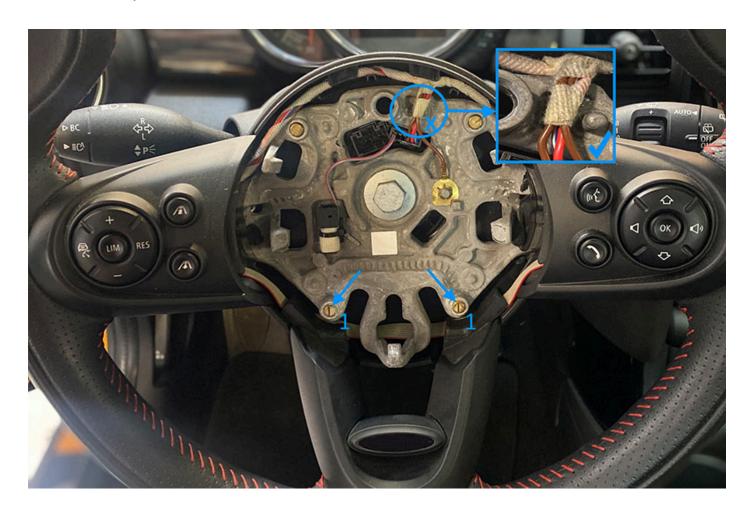
Incorrect routing of the connecting cables in the steering wheel or an unfavourable material pairing on the signal horn contacts between the steering wheel and the airbag unit may be responsible for this defect. Both problems can also occur simultaneously. An error memory entry that indicates a defect is not stored.

If the connecting cable is not laid correctly (see illustration), this has to be rectified. If the cable is visibly damaged, it must be replaced. If contamination is detected on the contact surfaces, a steering wheel with optimised contacts must be installed in accordance with the manufacturer's specifications. The problem has been identified by the vehicle manufacturer and rectified by means of a service solution using modified components.
