# Mini F56 - Pénétration d'eau dans l'habitacle du véhicule

## Moisture in the vehicle interior caused by condensation draining from the air-conditioning system

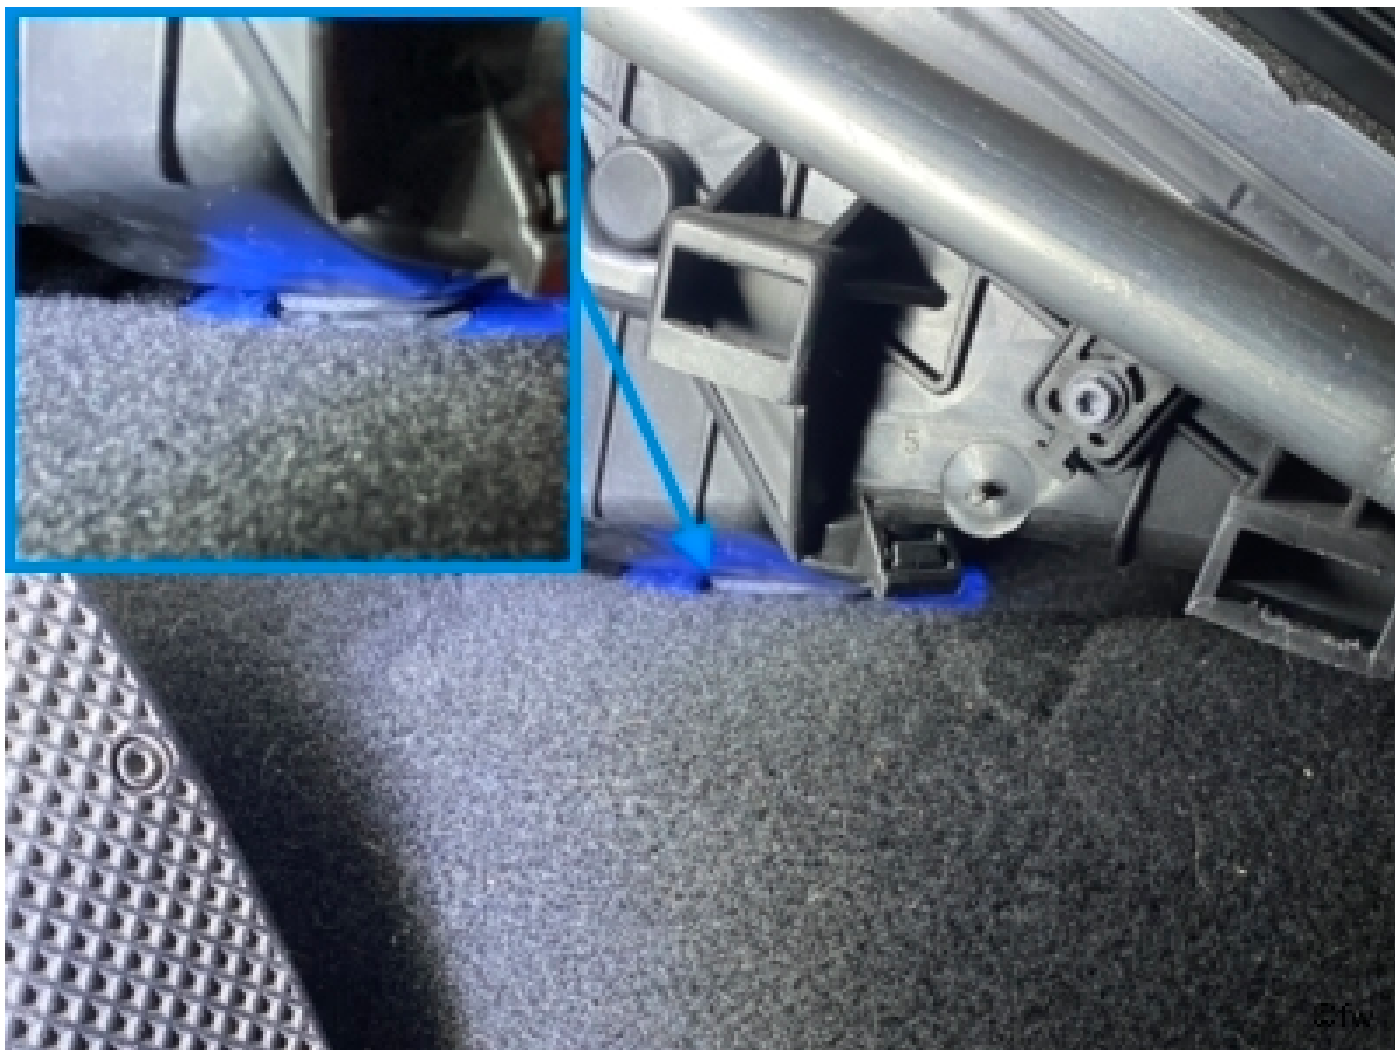
Deformation of the rubber seal means that condensation can no longer drain off properly. The water collects and is not drained off as intended, but enters the vehicle interior as a result of the deformed seal. The interior carpet absorbs the water, which can lead to unpleasant odours and, under certain circumstances, mould growth.

The side panelling (Fig. 1) in the footwell must be removed to carry out the necessary checks. In order to do this, the fastening screw has to be undone and the panelling removed from the brackets. The carpet can be pressed down slightly on the side underneath the air-conditioning unit in order to check it. The rubber seal of the water drain must fit all the way round the air-conditioning unit (Fig. 2) and have no kinks in it.

An endoscope is recommended for easier inspection. In the event of a fault, traces of water are usually visible on the side of the drain, indicating that the seal does not fit properly.

One test option is to set the air-conditioning system at maximum cooling capacity. In warm ambient temperatures, this causes condensation. In the event of a fault, this condensation would then run visibly past the seal and into the vehicle interior. If kinks or traces of water are visible, the condensation drain must be replaced. If mould is visible on the interior carpet, this should also be replaced.
