## Tesla Y - water ingress in interior fan

## Water ingress on passenger side, interior fan noise

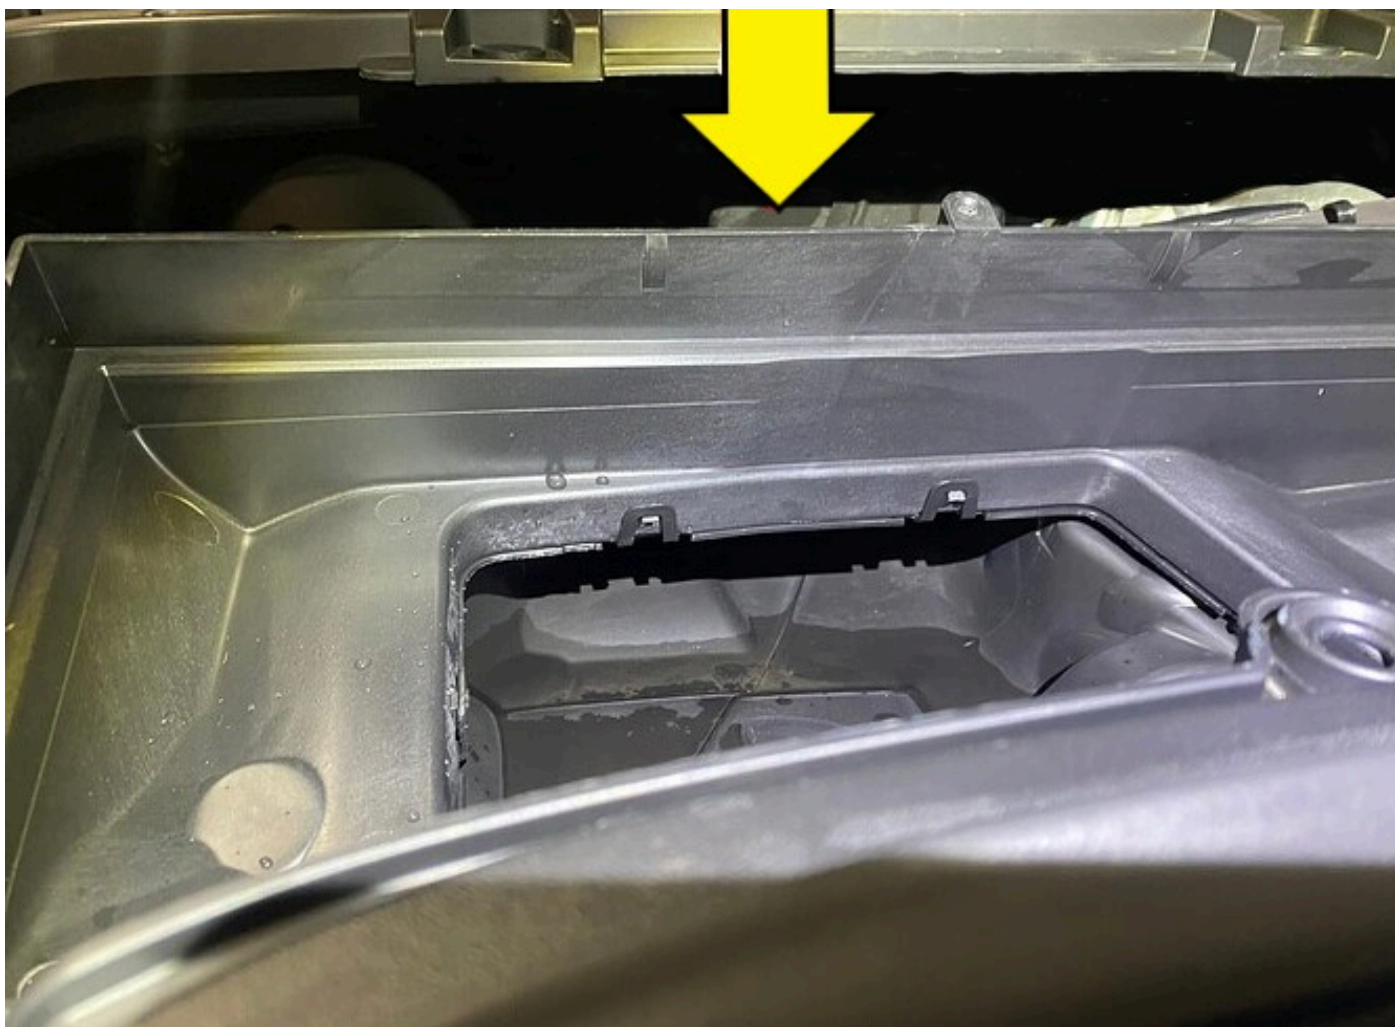
In the above-mentioned vehicle, water can enter the passenger footwell as a result of faulty sealing on the cabin air filter box. This is particularly noticeable during rapid acceleration. Car carpet and floor mats can then become quite wet. Water can also get into the interior fan, which leads to loud, squeaky noises being emitted from the fan.

In order to confirm the cause, the cabin air filters should be removed. These can be reached from the engine compartment (underneath the water box cover). A seal should be visible above the vent box. If it is only loosely attached or shows no real contact pressure, water will enter the vehicle interior via the ventilation housing and the ventilation shafts when it rains.

Sealing the ventilation box of the cabin air filter

Remedy or repair measures are to be carried out in accordance with the vehicle manufacturer's instructions.
